SERVICE ACTION

Service Action Number:
Q049

Engine Oil Pan Damage

Publication No.:	303-Q049v3
Model:	Defender Puma Diesel
Model Year:	2007 and 2008
VIN Range:	LD 732615 – LD 758400
Date of Issue:	20 March 2009
Expiry Date:	31 July 2010

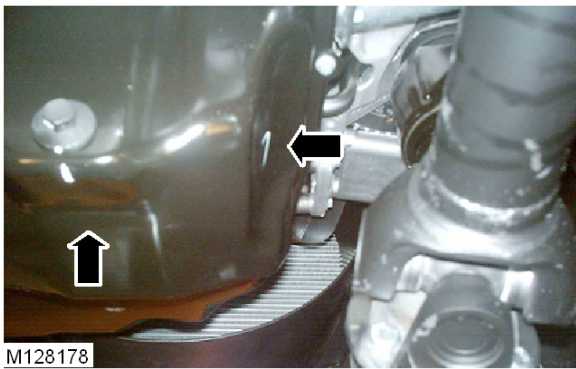
Item	Description	
1	<p>Note: The latest level oil pan has two indentations (see Fig. 1).</p> <p>Visually inspect the oil pan.</p> <ul style="list-style-type: none"> If the oil pan is the latest level, no further action is required. If not the latest level, carry out step 2.

<p>M128178</p>
		Fig. 1
2	Install a new oil pan (see Global Technical Reference (GTR) Workshop Manual, section: 303-01).
