SERVICE ACTION

Service Action Number:
Q055

Subject: 'A' Frame Suspension Arm	Publication No.:	204-Q055
	Model:	Defender
	Model Year:	2009
	VIN Range:	LD771715 – LD772545
	Date of Issue:	03 February 2009
	Expiry Date:	28 February 2011

RE: 'A' Frame Suspension Arm

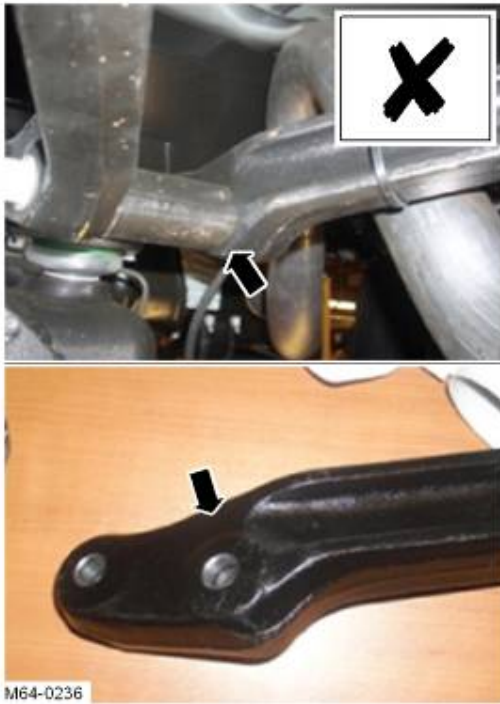
<p>M64-0236</p>
		Fig. 2

<p>M64-0237</p>
		Fig. 1
2	Upper arms with no machined surface at the axle ball joint end inner joint (see Fig. 2).

Both upper arms show a machined surface – no further action required. LH upper arm shows no machined surface – carry on from step 3. RH upper arm shows no machined surface – carry on from step 3. Both upper arms show no machined surface– carry on from step 3.
3	Install new LH/RH or both Upper arms (see Global Technical Reference GTR Workshop Manual, section: 204-02). <ul style="list-style-type: none">• Carry out removal procedure steps 1 to 6, and then the full Installation procedure.
