STM32L496xx/4A6xx device errata

Applicability

This document applies to the part numbers of STM32L496xx/4A6xx devices and the device variants as stated in this page. It gives a summary and a description of the device errata, with respect to the device datasheet and reference manual RM351. Deviation of the real device behavior from the intended device behavior is considered to be a device limitation. Deviation of the description in the reference manual or the datasheet from the intended device behavior is considered to be a documentation erratum. The term “*errata*” applies both to limitations and documentation errata.

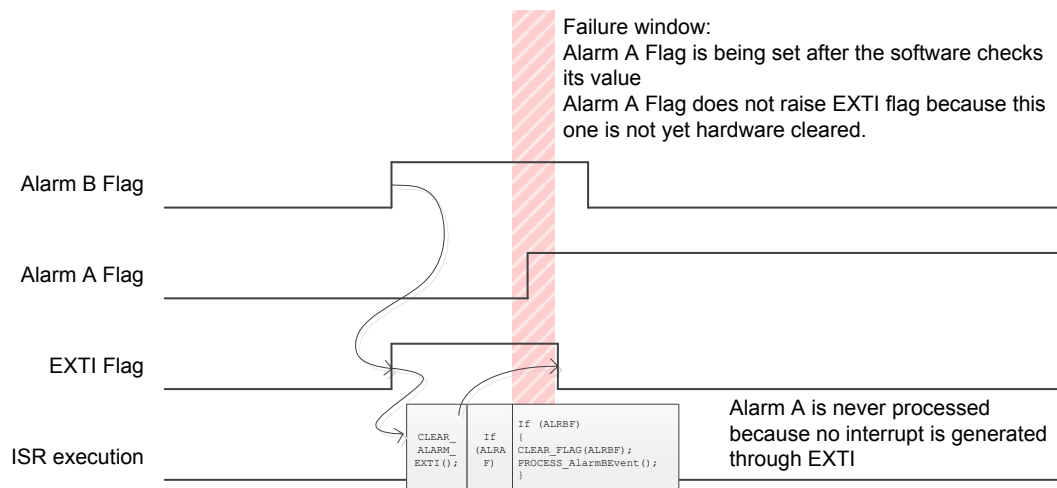
Figure 1. Masked RTC interrupt

The following code example and figure illustrate the failure mechanism: The Alarm A event is lost (fails to generate interrupt) as it occurs in the failure window, that is, after checking the Alarm A event flag but before the effective clear of the EXTI interrupt flag by hardware. The effective clear of the EXTI interrupt flag is delayed with respect to the software instruction to clear it.

In the interrupt service routine, apply three consecutive event flag checks - source one, source two, and source one again, as in the following code example:
