Property Description Data

Environmental Issues: Historic railroad and roundhouse

Site Name: Vacant property and snowmobile trail

Current Use: Overgrown property with DNR-owned snowmobile trail; no structures present at the property

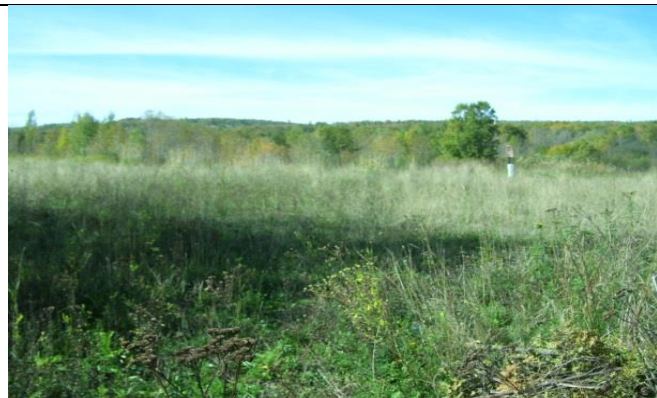
Looking west across the property

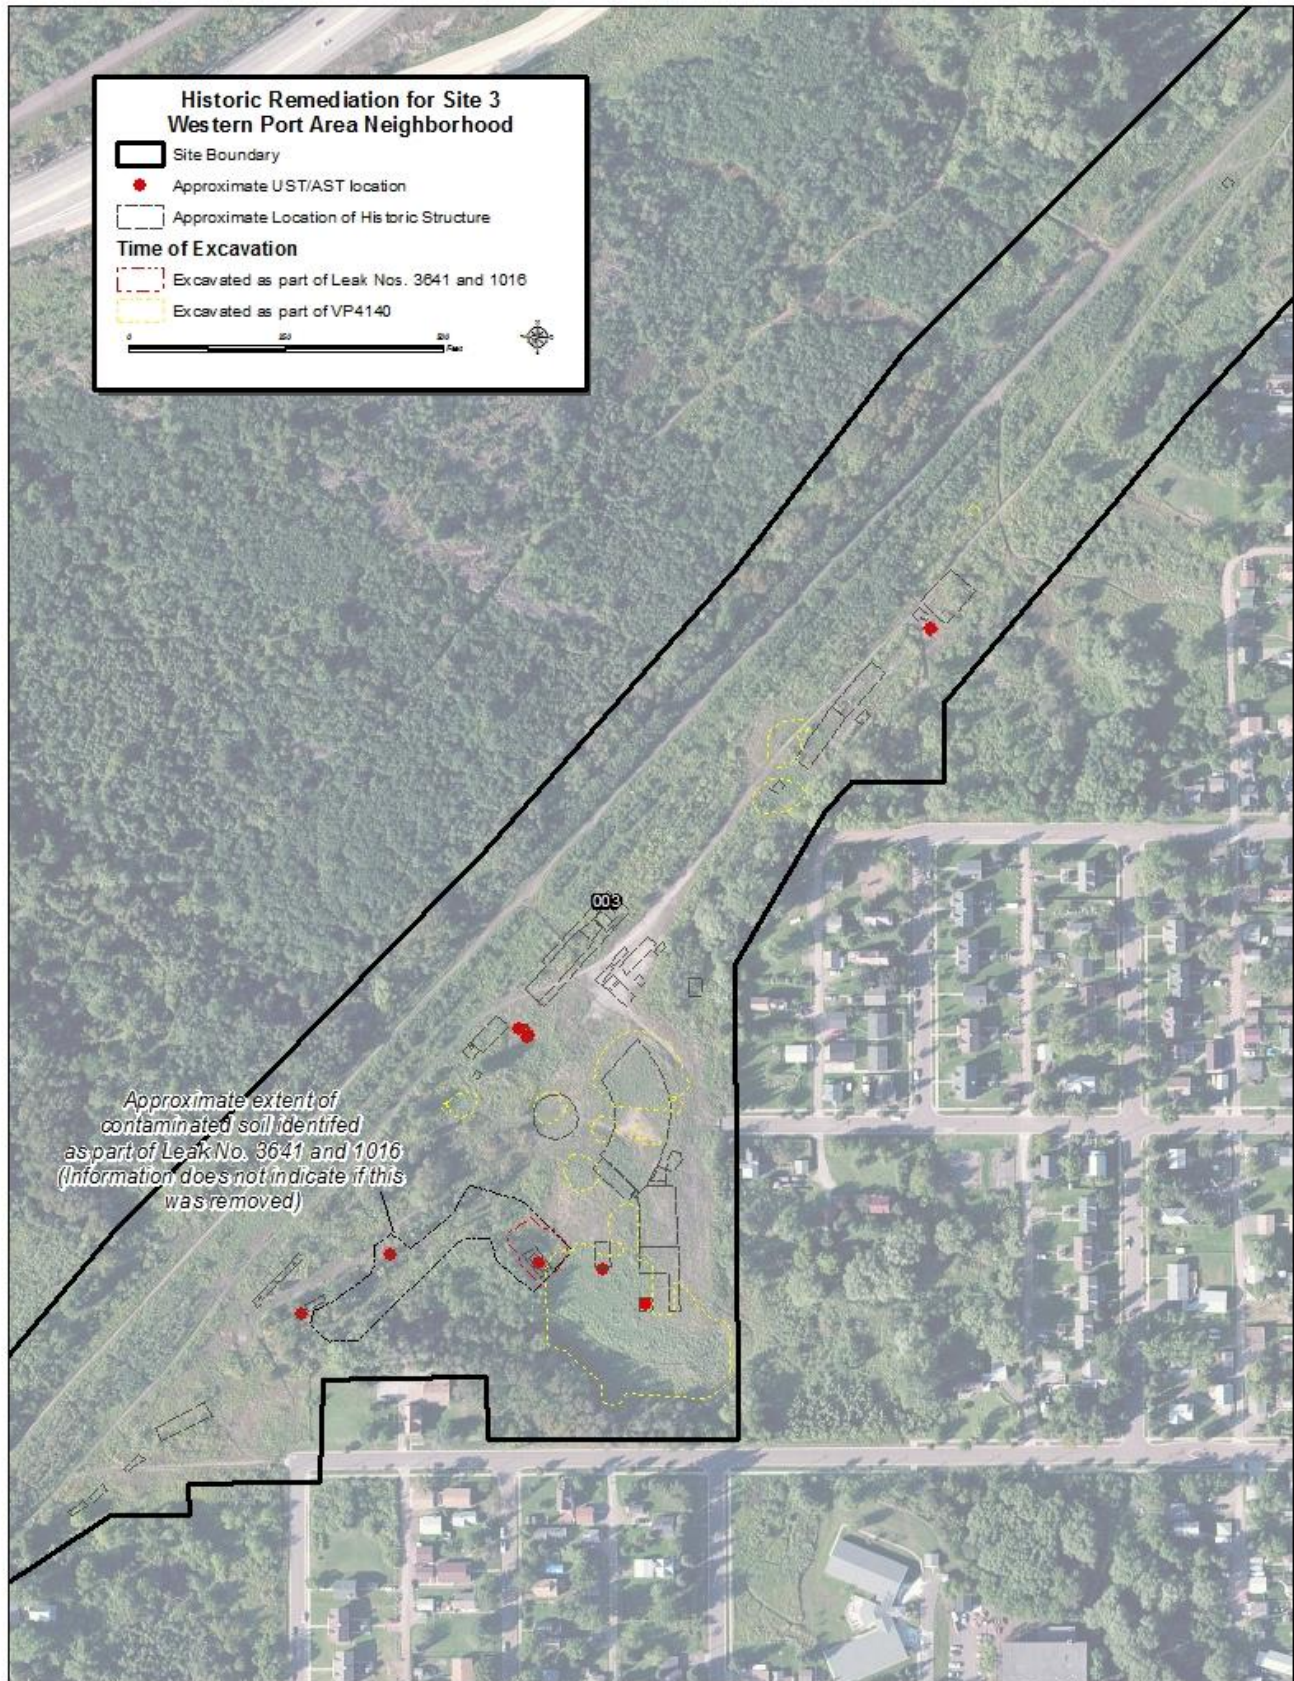
Based on this information, identified soil impacts (copper, lead, and BaP equivalents exceeding the NTE threshold and lead and PAH/BaP equivalents exceeding industrial SRVs) were removed by 2010. Leak site file information indicates that petroleum-impacted soil was removed from the property; however, it is unclear if an identified 9,000-cubic yard petroleum-impacted area was excavated. Additionally, response actions conducted at the property were focused on specific areas, and not all areas of the property were excavated. Future development at the property may encounter petroleum-contaminated soil or ACM, and a Construction Contingency Plan should be prepared to address the handling and disposal of unanticipated impacts during future development. Our review indicates that additional file and correspondences related to the Property likely exist. Additional Freedom of Information Act requests to obtain additional environmental information from MnDOT or the MPCA would be advisable prior to changes in land use, construction, grading, or a real estate transfer.
