Confidential Inspection Report

**2870 Bridgeport Ave SE
Salem, OR 97306-2541**

Report: 20987

Date: January 16, 2020

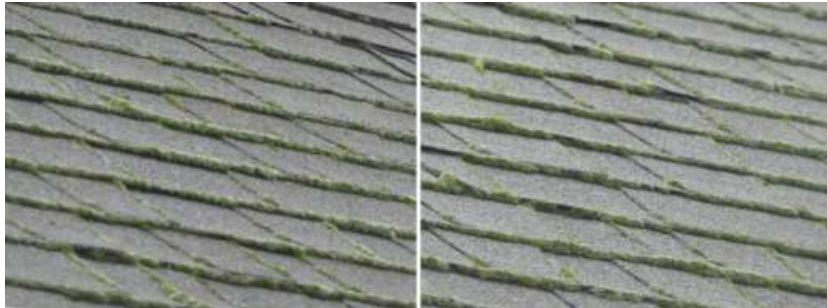
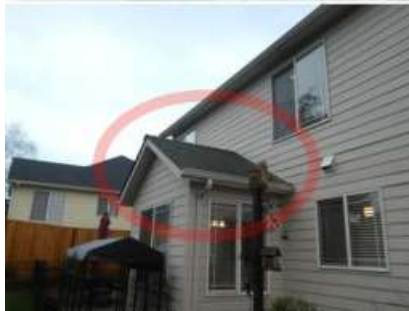
- 2.5 Roof Covering Condition: ☐ ☐ ☒ Moss growth was observed, killing and proper removal of moss growth recommended. The materials hidden under the moss growth were not observable/inspected.

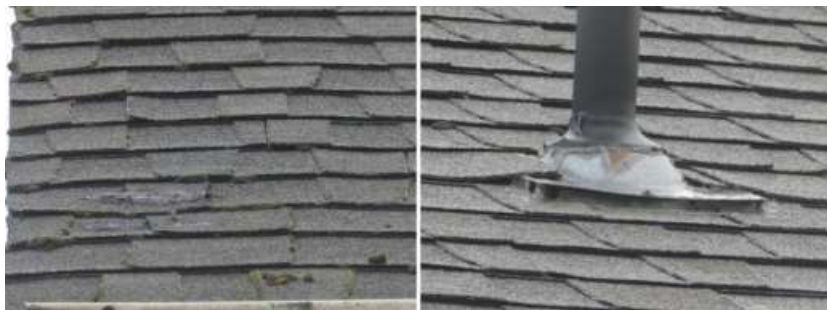
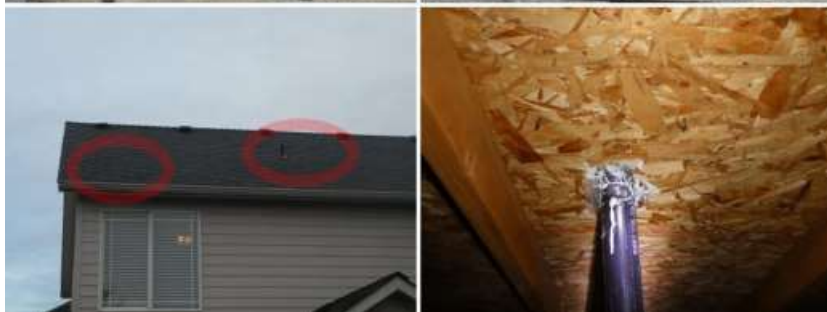
2.6 Roof Covering Condition:

Shingles appeared to be repaired with caulking materials. The origins of the damage or the full extend of the damaged materials was unknown. Recommend regular checks of the caulking materials for cracks/deterioration and re-apply if needed.

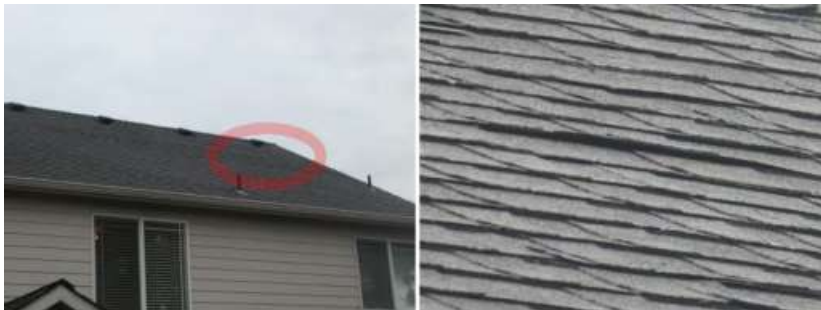
2.7 Roof Covering Condition:

Shingle Condition: A few shingles at the time of the inspection appeared to be warped/bent, revealing a gap between the materials. Repair or replacement of the damaged roofing material is recommended.

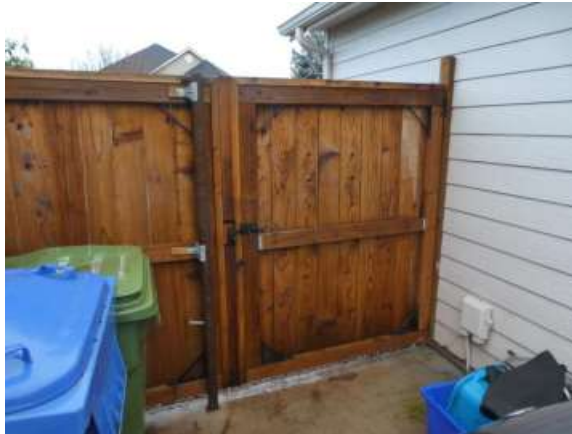
OK	MM	RR	
3.1 Driveway:	<input checked="" type="checkbox"/>	<input type="checkbox"/>	<input type="checkbox"/>	Driveway type: Concrete, typical cracks were observed.
3.2 Walks:	<input checked="" type="checkbox"/>	<input type="checkbox"/>	<input type="checkbox"/>	Sidewalk type: Concrete, typical cracks were observed.
3.3 Fences And Gates Condition:	<input type="checkbox"/>	<input type="checkbox"/>	<input checked="" type="checkbox"/>	Gate was difficult to operate. Recommend adjustment of gate hardware.

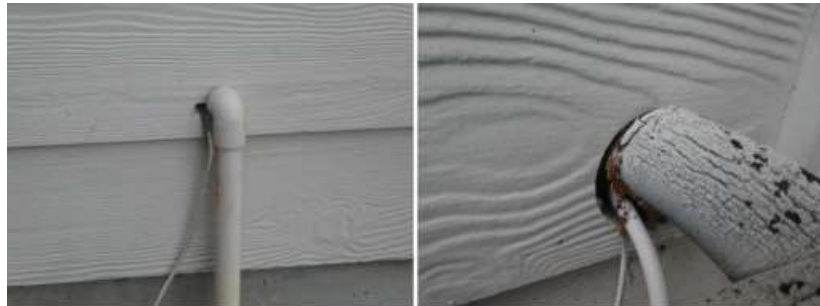
4.2 Exterior Wall Condition:

Penetration(s) in structure were not properly sealed. Recommend sealing all penetration(s) in the structure to prevent water from freely flowing into the wall cavity.

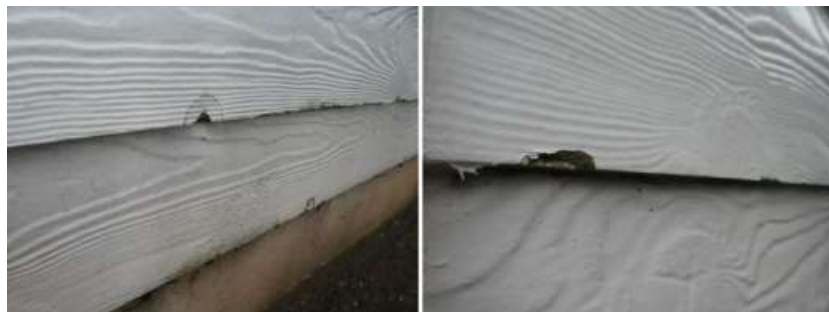
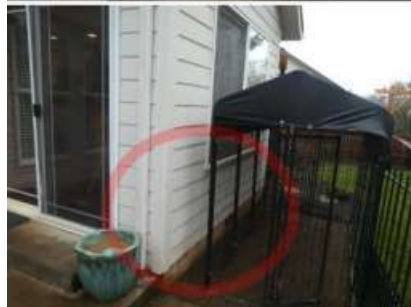
4.3 Exterior Wall Condition:

Damaged materials were observed. Repair/replacement of all damaged materials is recommended.

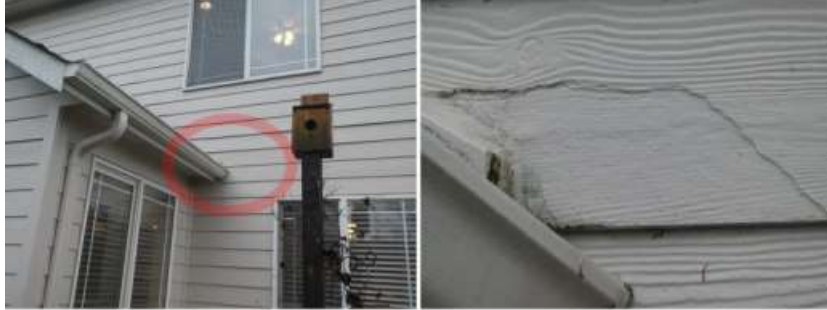
4.4 Exterior Wall Condition:

Damaged materials were observed. Materials appeared to have

cracked/split.

Repair/replacement of all damaged materials is recommended.

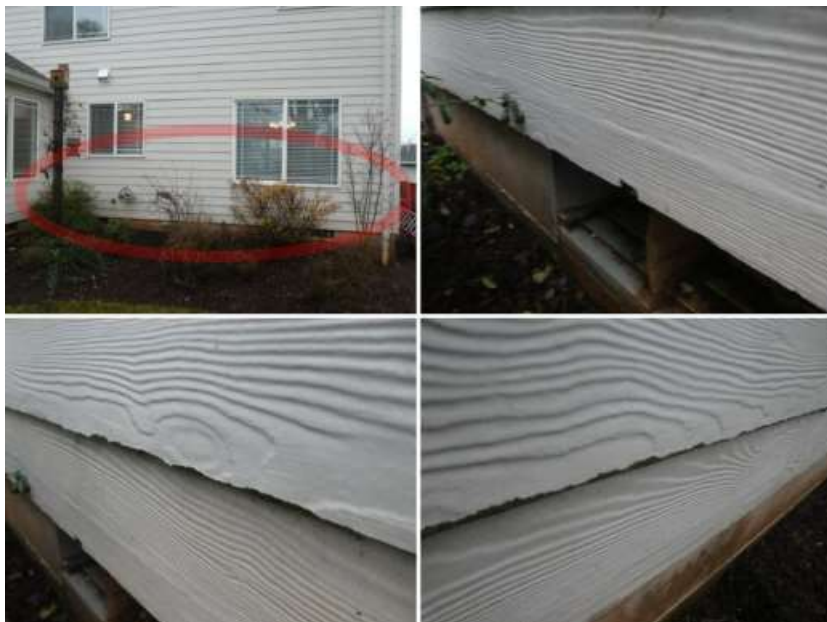
4.5 Exterior Wall Condition:

Damaged materials were observed. Repair/replacement of all damaged materials is recommended.

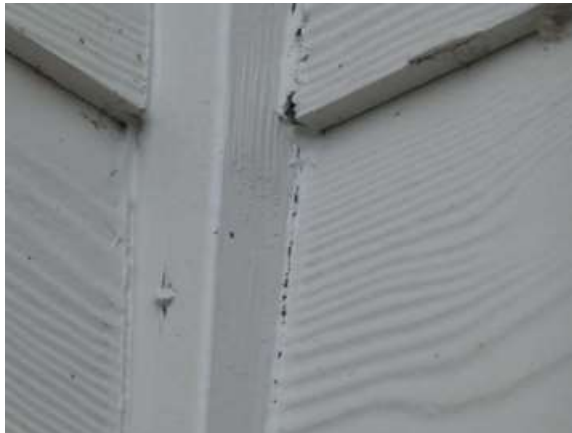
4.7 Exterior Wall Trim Condition:

Sealant installed between siding materials and exterior trim had shrunk, exposing the area between the materials. Recommend replacement of the sealant in all areas where existing sealant had failed.

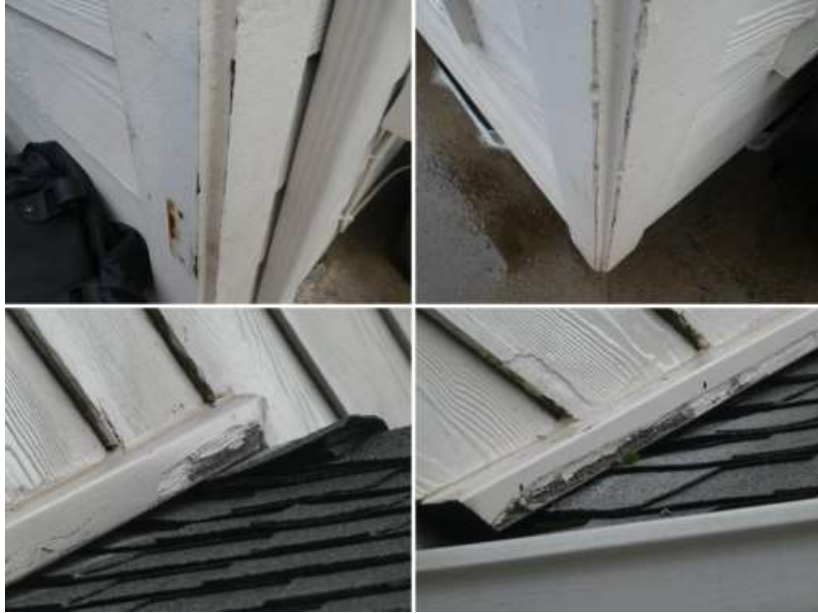
4.8 Exterior Wall Trim Condition:

Paint was worn in the trim materials. Recommend scraping and repainting worn areas.

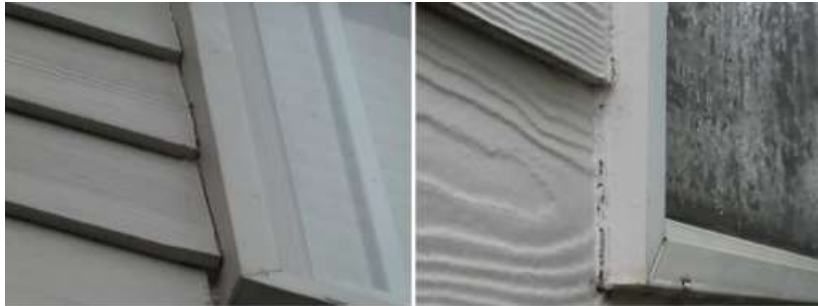
4.9 Window Trim Condition:

Sealant materials at window(s) appeared aged/shrunk, revealing an opening between the window frame and the structure. Recommend applying new weather resistant sealant around the window frame. Preferably a product rated for longevity and advertised to not shrink.

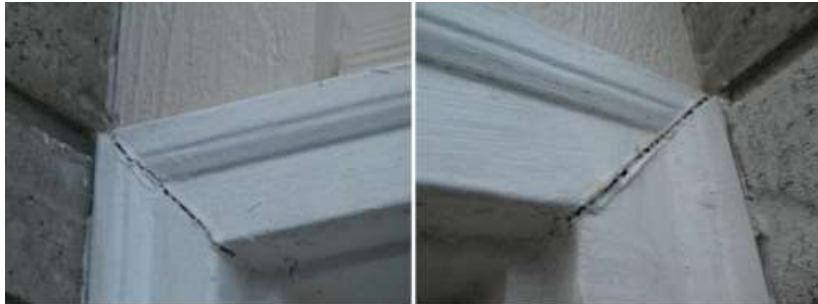
4.10 Exterior Door Trim Condition:

Caulking materials at exterior door were aged/shrunk, revealing an opening between the exterior door frame and the structure. Recommend applying new weather resistant caulking or equivalent flexible sealing compound around the door frame. Preferably a product rated for longevity and advertised to not shrink over time.

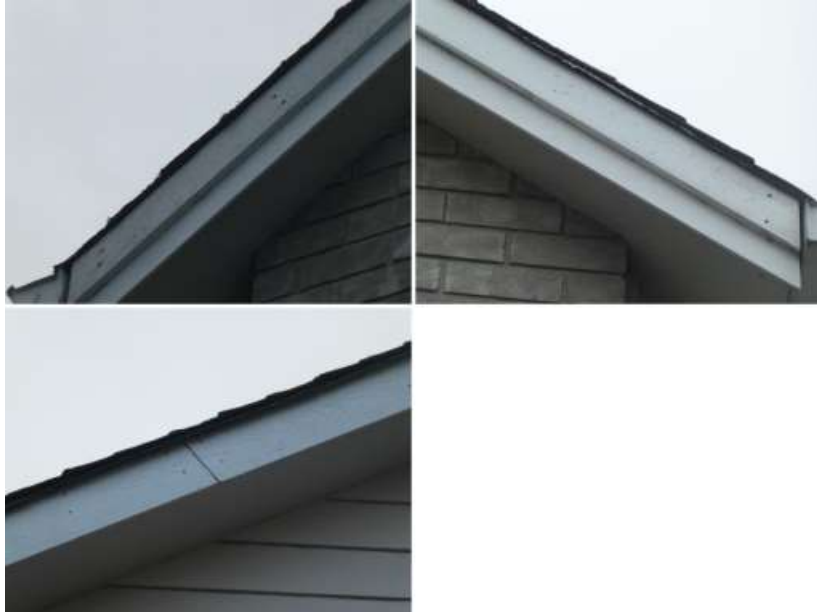
4.12 Fascia Condition:

Fasteners had been sunk too deeply into the fascia materials, exposing unprotected portions of the materials, increasing the risk of rot growth. Sealing over the countersunk fasteners to prevent water buildup in these areas is recommended.

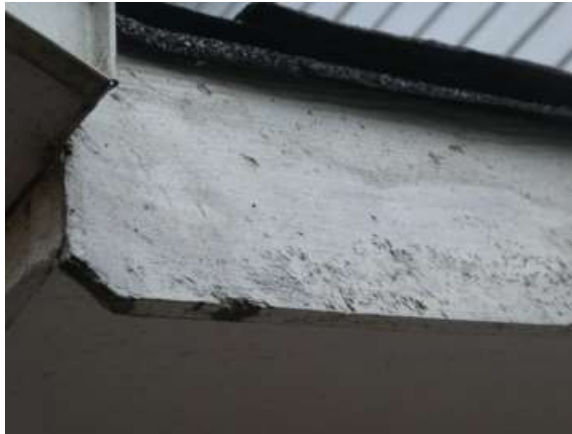
4.13 Fascia Condition:

Fascia board paint was showing signs of wear. Recommend scraping and repainting over any areas where the paint has worn away to expose the materials underneath. Monitor for future deterioration of painted wood and paint as needed.

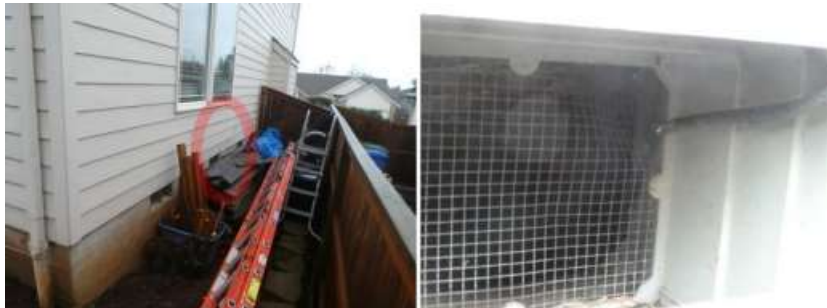
4.16 Crawlspace Vent Condition:

Penetration through the vent screen was not properly sealed. Properly sealing the penetration in the screen system to prevent future pest infestation is recommended.

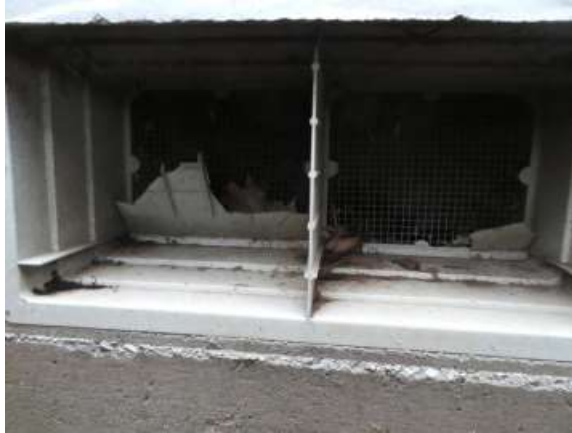
4.17 Crawlspace Vent Condition:

Damaged vent flap materials were observed.

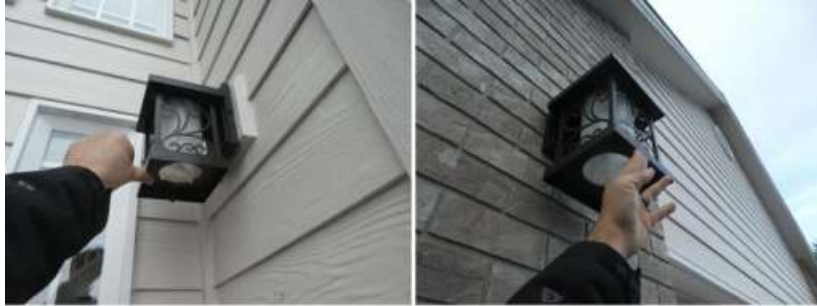
Hardware for exterior electrical fixture did not appear to be properly secured/sealed to the structure. Recommend repair/replacement of the fixture.

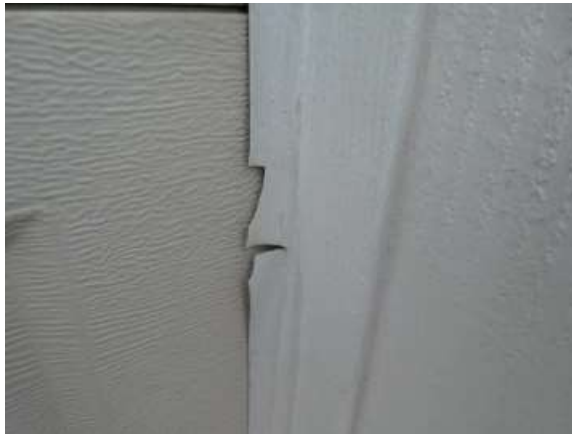
Garage door weather seal hardware appeared to have been damaged. Repair/replacement of the damaged weather seal hardware for proper garage door functionality is recommended.

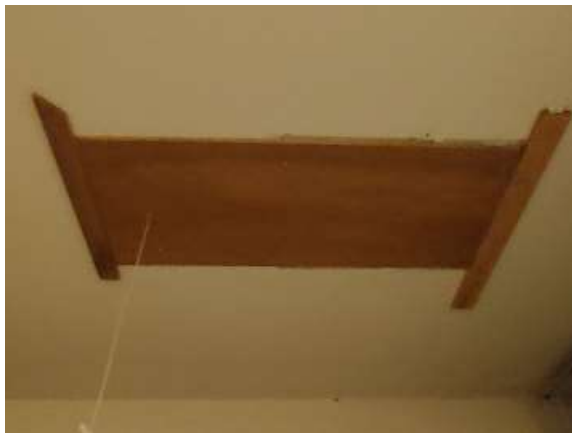
☐ ☐ ☒ Attic access panel did not appear to be fire rated. Replacing the access panel with a fire rated panel or modifying the panel to be fire rated is recommended.

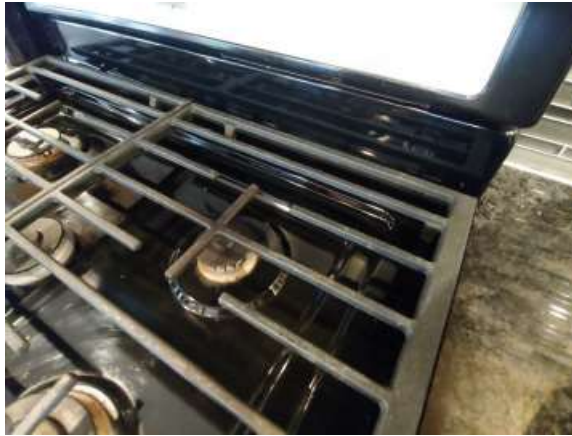
OK	MM	RR	
12.1 Counters & Cabinets Condition:	<input checked="" type="checkbox"/>	<input type="checkbox"/>	<input type="checkbox"/>	Counters appeared to be granite, Counters and cabinets appeared to be serviceable, Stored items prevented full inspection of the counter materials.
12.2 Garbage Disposal:	<input checked="" type="checkbox"/>	<input type="checkbox"/>	<input type="checkbox"/>	
12.3 Cooktop/Range Condition:	<input type="checkbox"/>	<input type="checkbox"/>	<input checked="" type="checkbox"/>	Gas, Ignition hardware for the top burners did not appear to function correctly. Proper repair/replacement of the inoperable hardware is recommended.

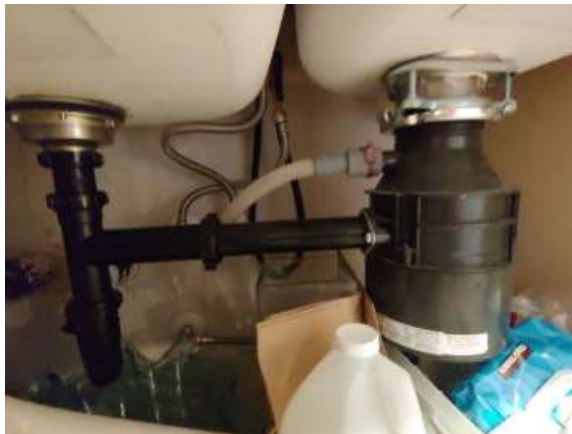
12.4 Ventilation:	<input checked="" type="checkbox"/>	<input type="checkbox"/>	<input type="checkbox"/>	Fan/Hood operational.
12.5 Refrigerator:	<input checked="" type="checkbox"/>	<input type="checkbox"/>	<input type="checkbox"/>	Appeared serviceable. Basic functionality of the unit was inspected.
12.6 Dishwasher:	<input type="checkbox"/>	<input type="checkbox"/>	<input checked="" type="checkbox"/>	A proper rise in the waste line was not observed in the dishwasher drain line. Proper adjustment/repair of the dishwasher drain line is recommended.

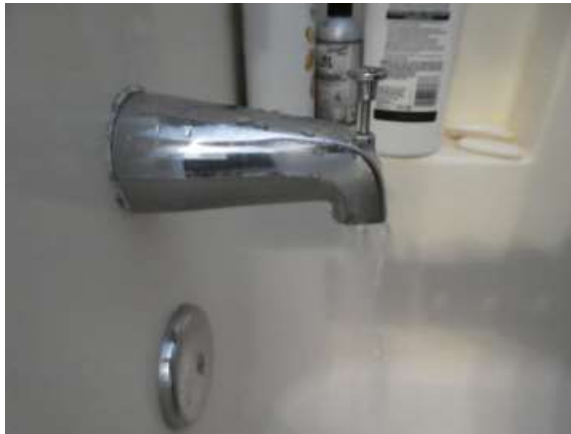
13.6 Hall Bath:	<input type="checkbox"/>	<input type="checkbox"/>	<input checked="" type="checkbox"/>	Fixture appeared to leak water at the wall when the shower diverter was engaged. This condition is a concern at water could be splashing into the wall system through the plumbing penetration hidden by the fixture. Repair/replacement of the fixture to prevent water from flowing behind the faucet into the wall cavity.
-----------------	--------------------------	--------------------------	-------------------------------------	---

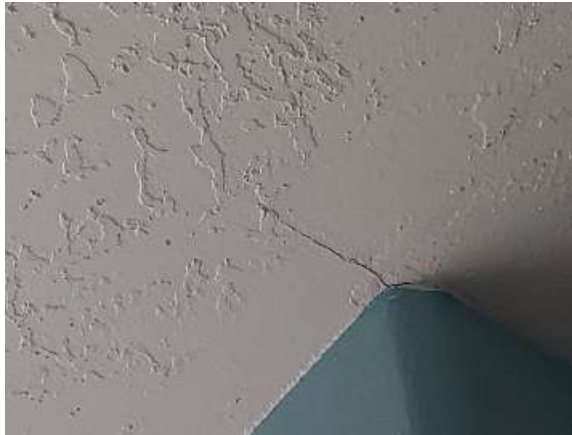
Cracks in the interior materials were observed. Most likely this was due to slight settlement, shrinkage or improper installation techniques. Observing the cracks over time for widening or lengthening of the cracks is recommended.

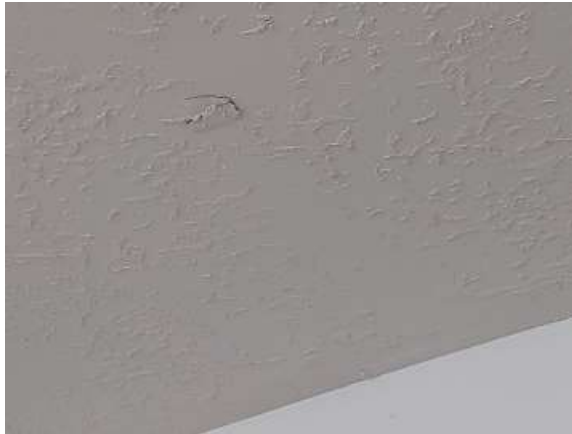
Damaged materials were observed. Proper repair of the damaged ceiling materials is recommended.

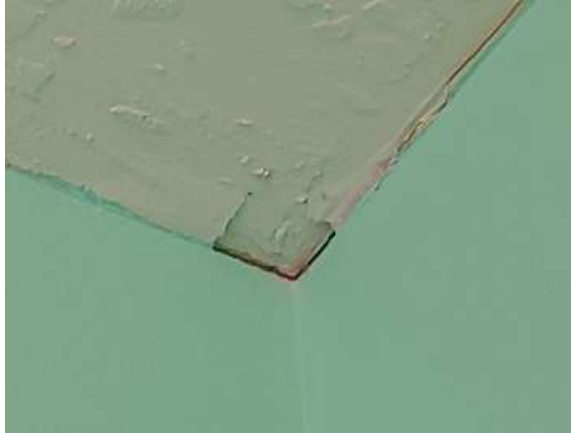
Cracks in the interior materials were observed. Most likely this was due to slight settlement, shrinkage or improper installation techniques. Observing the cracks over time for widening or lengthening of the cracks is recommended.

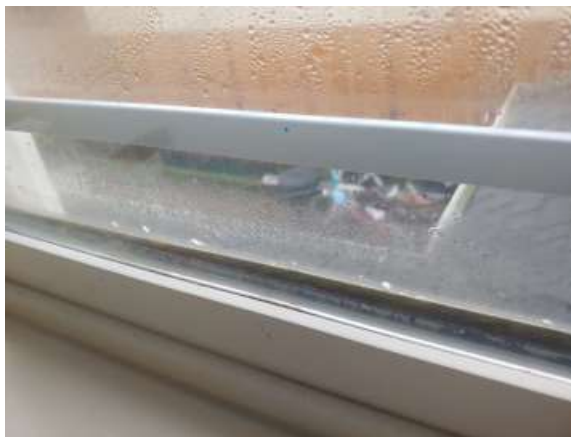
14.67 Bedroom #04:	<input type="checkbox"/>	<input type="checkbox"/>	<input checked="" type="checkbox"/>	Type: Vinyl, double pane. Window Hardware Condition: The weather seal appeared to be broken at the time of the inspection. Although it was keeping the elements out, it had a clouded appearance. This condition likely will worsen. The appearance of moisture between the window panes is not always apparent and will vary throughout the day. Repair/replacement of all windows with failed seals is recommended. Corrosion noted in the frame hardware between the window panes. This is an indication of a failed thermal seal. Consulting a window installation professional to determine the extent of the damage and the estimated remaining lifespan of the window system is recommended.

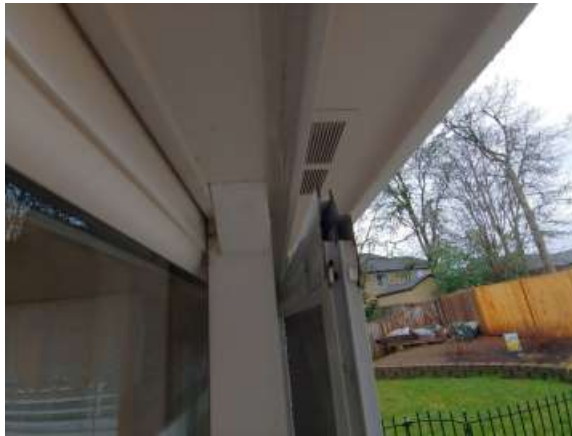
14.79 Hallway #01:	<input checked="" type="checkbox"/>	<input type="checkbox"/>	<input type="checkbox"/>	Hardware appeared to be operational.
14.80 Dining Room #01:	<input type="checkbox"/>	<input type="checkbox"/>	<input checked="" type="checkbox"/>	Sliding glass. Screen door system did not align with the screen frame.
