# Analysis Report

**Test name:** GUILDFORD Upgrade

**Test date:** 2019-09-20

**Test author:** Óscar González - Victor Barberán

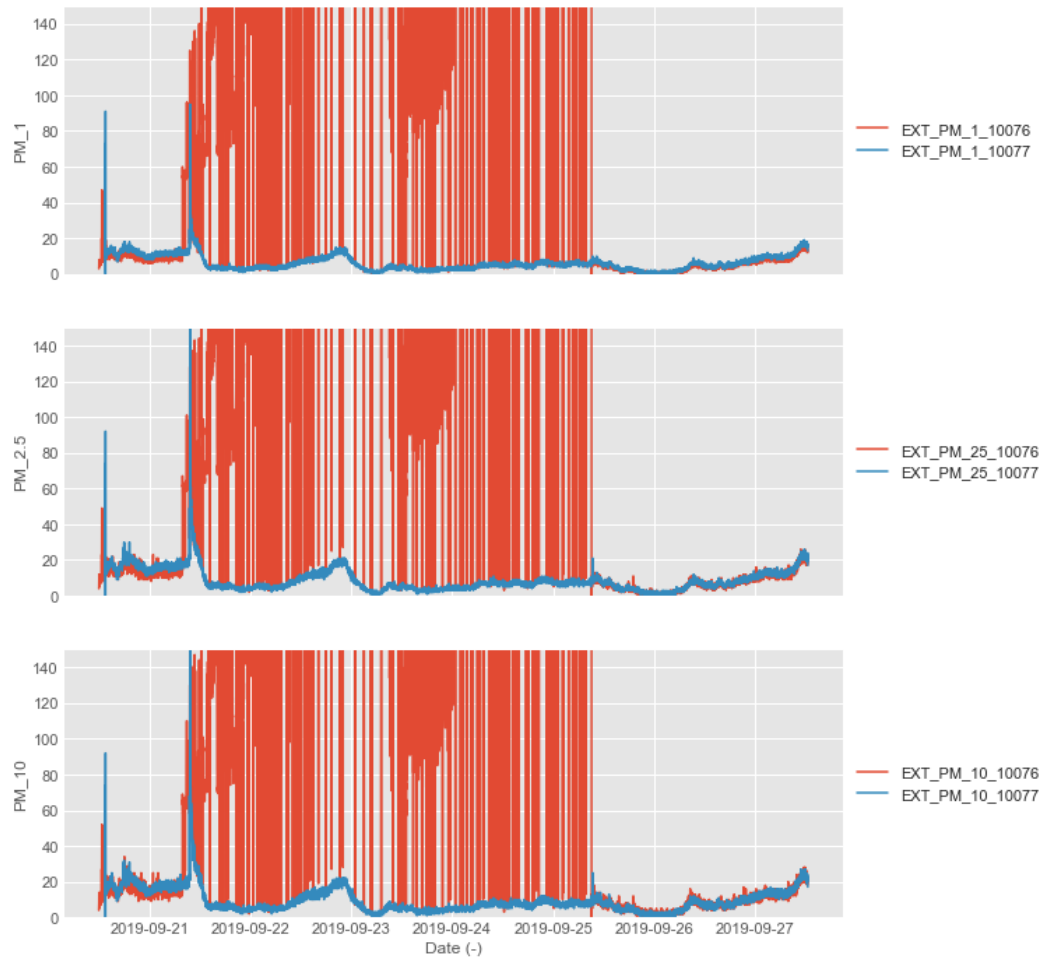
PM\_Check

The PM sensor shows improvement after change on 25-09-2019

1. Upgrade firmware. New channels for PM\_A, PM\_B and PN\_XX\_A, PN\_XX\_B
2. Change both PM sensors - 25/09
3. Change Urban board for Noise issue

1. Upgrade firmware. New channels for PM\_A, PM\_B and PN\_XX\_A, PN\_XX\_B
2. Change both PM sensors and cables- 25/09
3. Changed NO2 EC sensor - new device ID

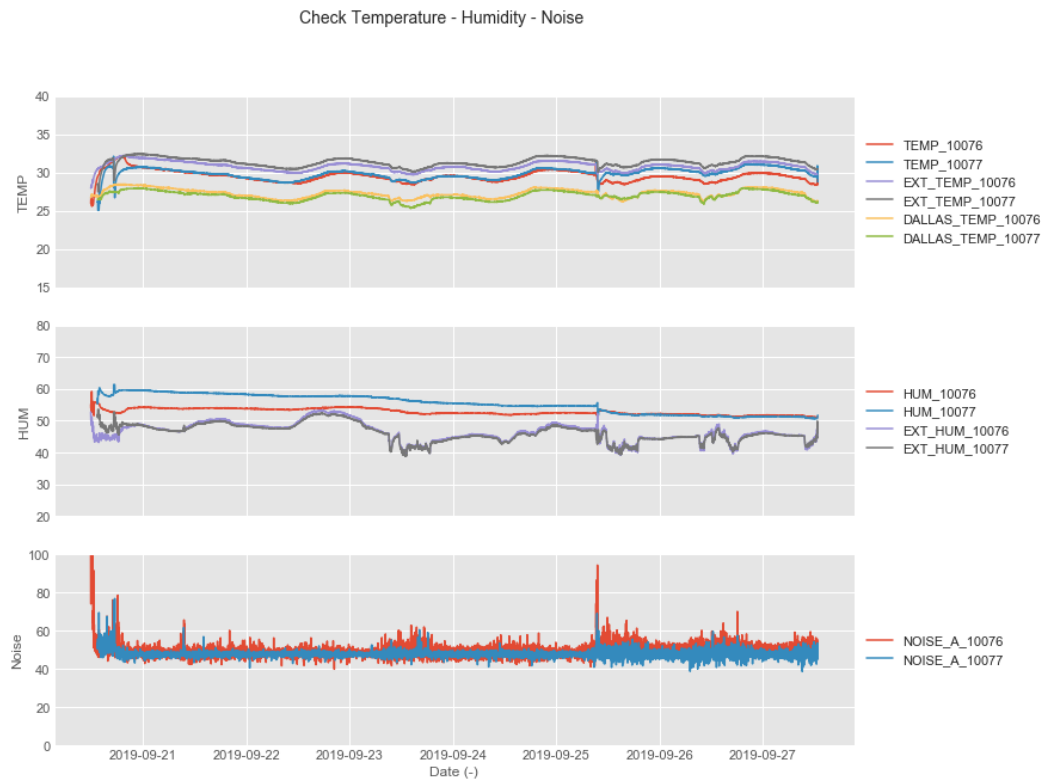
Sensors show normal behaviour

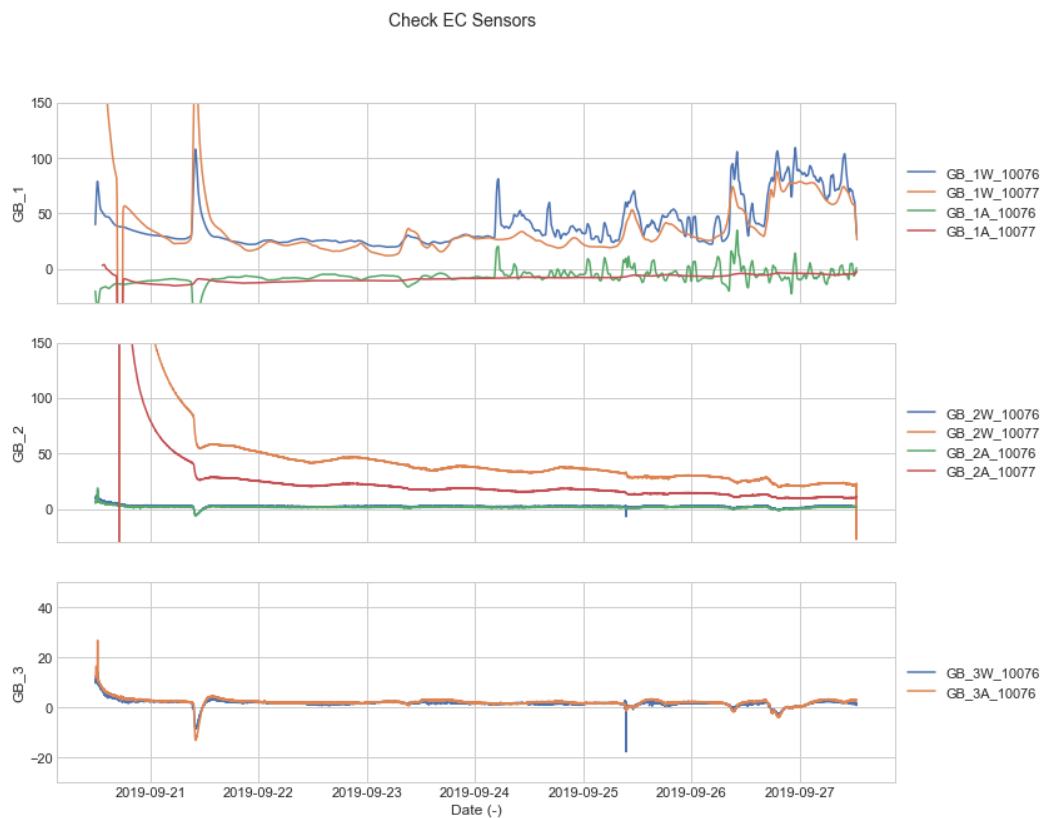
Sensors show normal behaviour after replacement of NO<sub>2</sub> sensor on device F9FF. Indoor environment with air conditioning for both, which affects on GB\_1 on 10076.
