W7500P Errata Sheet

Document History

Ver 1.0.0 (July.11, 2016)	First release (erratum 1) - I2C
Ver 1.0.1 (Dec.08, 2016)	Correct SCL speed
Ver 1.1.0 (Jun.18, 2018)	erratum 2 - Transmission Delay

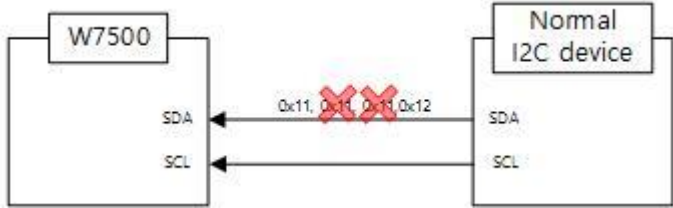
Phenomenon	Receiving repeating data in continuative data transmission causes I2C communication problem.
Condition

<p>W7500 receives the first repeating data but starts to discards from the 2nd repeating data to next different data in continuative data transmission. It causes data loss.</p>
Solution & Recommendation	<p>To avoid this issue, W7500 uses GPIO instead of I2C. In this case, SCL has limited speed, 100KHz.</p> <p>Example pseudo code:</p> <pre> Function Initialize_I2C () { ... scl_port_num = I2C_PORT(conf->scl); scl_pin_index = I2C_PIN_INDEX(conf->scl); sda_port_num = I2C_PORT(conf->sda); sda_pin_index = I2C_PIN_INDEX(conf->sda); //SCL setting GPIO_InitDef.GPIO_Pin = scl_pin_index; GPIO_InitDef.GPIO_Mode = GPIO_Mode_OUT; if(scl_port_num == 0) { GPIO_Init(GPIOA, &GPIO_InitDef); GPIO_SetBits(GPIOA, scl_pin_index); } ... //SDA setting </pre>

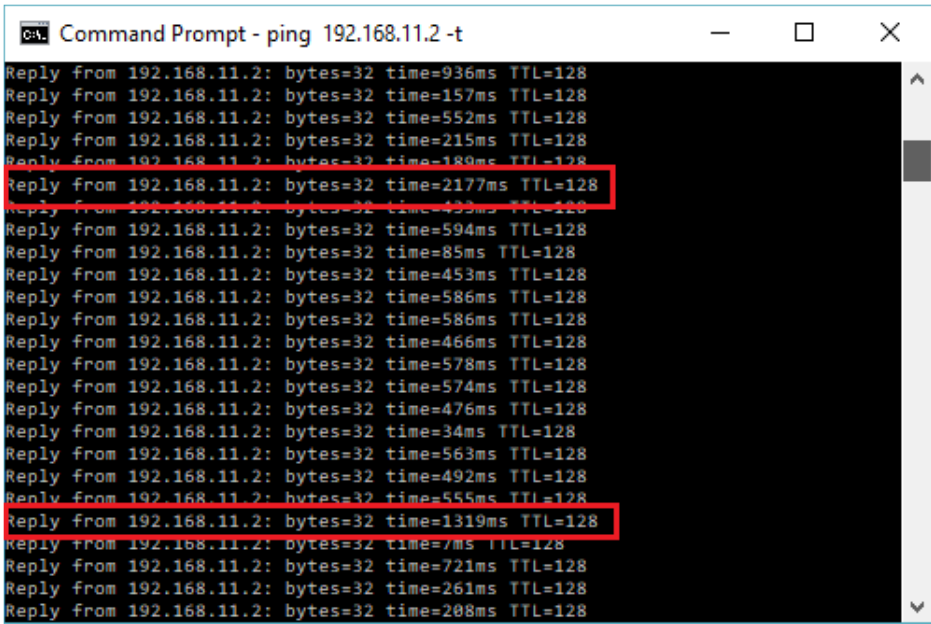
Phenomenon	<p>There are some cases of data transmission delay when W7500P is connected to a particular switch or router. (The router that was used for the below test is "TP_LINK AC750")</p>

<p>As shown above, there are random cases where the ping reply is delayed over 3 seconds and occurs irregularly.</p>
Condition	<p>The cause of this phenomenon is due to NC (Not Connected) pads & the connection problems related to PHY MII signals inside the chip (W7500P is silicon-in-package product and it includes W7500 and Ethernet PHY circuit inside.); By Collision handling due to wrong detection of duplex mode, the transmission packets are delayed.</p>
Solution & Recommendation	<p>In order to resolve this phenomenon, users MUST add the following initialization code.</p> <pre data-bbox="430 1702 1364 1982"> void PHY_Init(void) { #ifdef __W7500P__ // W7500P only // PB_12 *(volatile uint32_t *) (0x41003070) = 0x61; // RXDV: set pull down // PB_05 </pre>
