### **CONDITION REPORT**

**Job No:** 16/0388

**Address of Property:** No. 103 Ranelagh Village, Ranelagh, Dublin 6.

**Property Type & Age:** A mid-terraced 2 storey commercial building built circa in the 1800's.

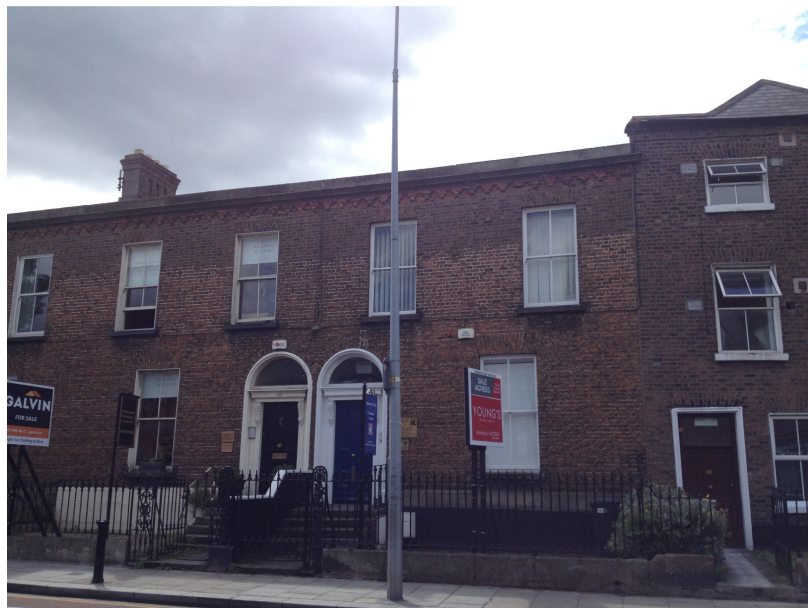
**Figure 1: Front elevation of the property.**

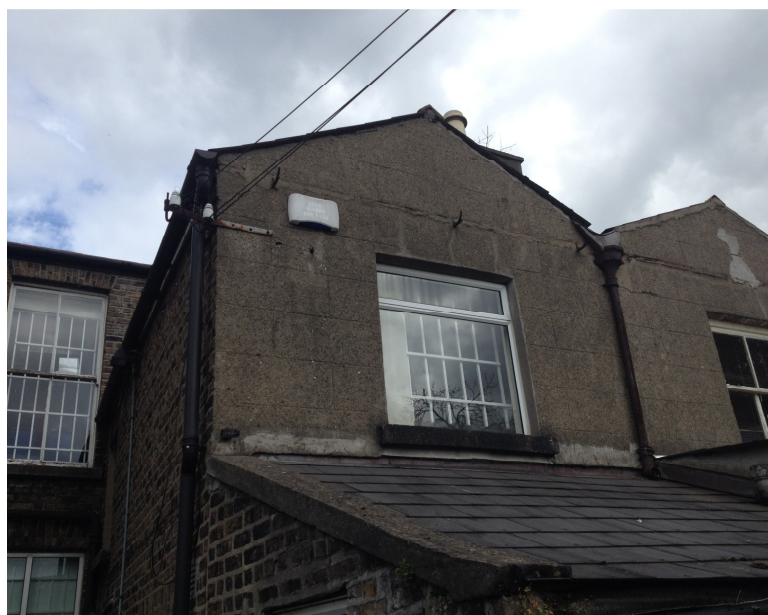
**Figure 2: Part rear elevation of the property.**

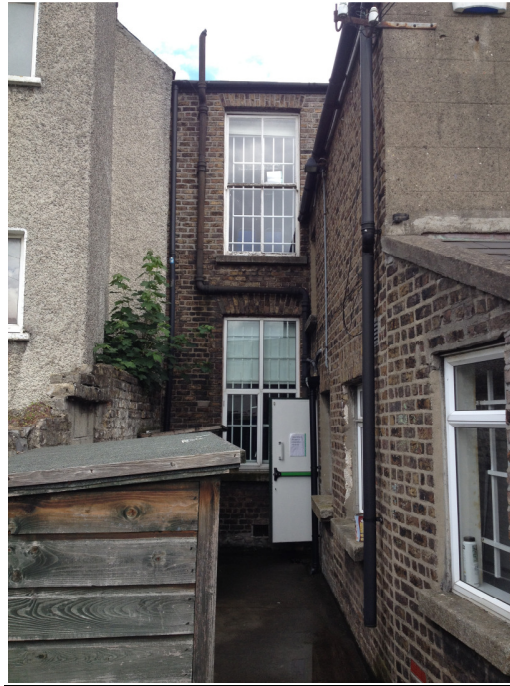
**Figure 3: Part rear elevation of the property.**

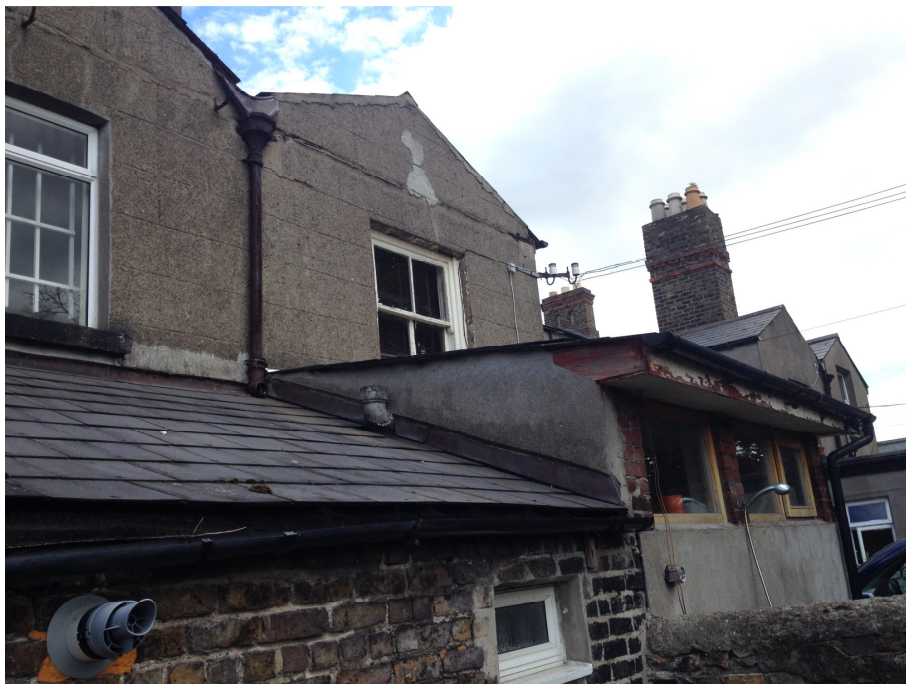
**Figure 4: Part rear elevation of the property.**
