Technical Bulletin

Subject
Possible Water Entry Areas
on Targa Vehicles

Number
9601

Models Affected: **911 Targa, Model Year 1996**

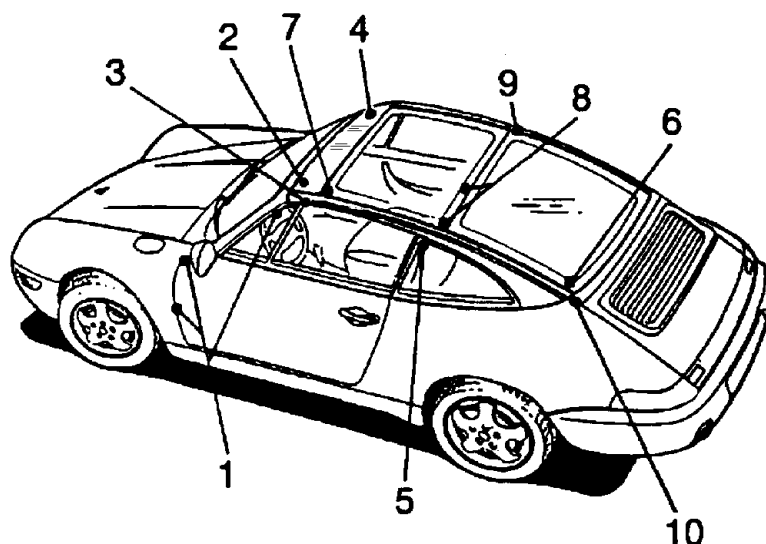
Possible water entry areas include:

- 1 - Water entry on the left and right door seal.
- 2 - Water entry above the left and right "A" pillar - windshield frame/ roof module.
- 3 - Water entry on the formed seal piece of the left and right top door seal / "A" pillar.
- 4 - Water entry on the air deflector.
- 5 - Water entry on the left and right "B" pillar.
- 6 - Water entry on the rear / "C" pillar, left and right sides.
- 7 - Water entry on the left and right side glass roof seals.
- 8 - Water entry on the top of the rear window, left and right sides.
- 9 - Water entry at the transition ramp rear window inside bracket.
- 10 - Water entry on the rear body center piece, left and right sides.

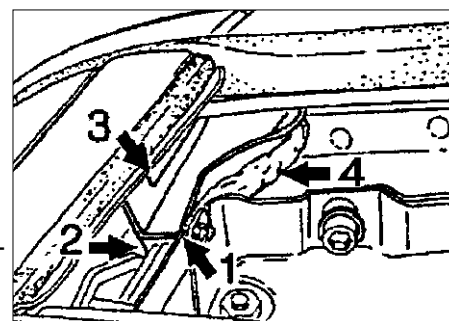
Figure 1

Area #2 Water entry above the left and right "A" pillar - windshield frame / roof module water channel on the windshield frame seal.

- Incorrect position of the water channel in the windshield frame seal.

- The complete water channel must enter into the guide rail and be slightly bent to the outside. It must not protrude on the side (arrow 1, figure 1). The sides must be bent without kinks slightly to the top.

The end piece (arrow 2, figure 1) must point straight to the bottom into the guide. The drip pan which is located below the side wind deflector (sheet metal strip, arrow 3, figure 1) must go into the water channel and lay on the side of the channel. The water channel can be adjusted by installing butyl sealing strips or similar material (arrow 4, figure 1). All areas of the channel must be even without any kinks. The rear end of the butyl sealing strip must connect with the guide rail on the inside of the side wall (arrow 1, figure 1)

A space of approximately 2 mm must be present between the butyl sealing strip and the sun screen rolling shaft. If the distance is too small, butyl material may wrap around the rolling shaft and affect its operation.

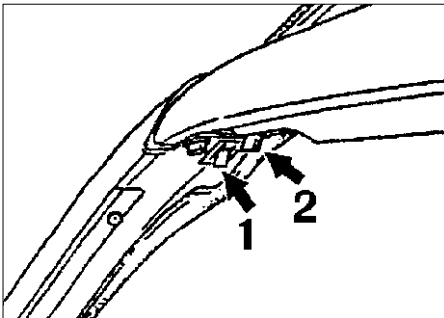
Figure 2

Area #3 **Water entry on the formed seal piece of the left and right top door seal / "A" pillar transition of the water drainage pipes of the windshield frame seal and the roof frame to the formed piece on the door seal.**

- The transition of the water drain pipes of the seal and the roof frame to the formed piece on the door seal (area of "A" pillar) does not exist.

- Remove the holding bracket for the door seal formed piece on the inside (if installed).
- Remove the 4 bolts from the door seal bracket on the roof frame.
Pull the seal off in the area of the "A" pillar.
- Remove the sealing material from the bottom of the seal and seal base.
- Install a clamp (part number 999 507 542 01, arrow 1, figure 2) onto the plastic hose of the windshield frame seal. This prevents the plastic drain hose from moving to the top when installing the door seal.
- Install a 2 mm wide strip of sealing butyl around the metal drain pipe (arrow 2, figure 2) of the roof frame.
- Lay butyl material on top of the formed piece on the door seal (arrows A and B, figure 3).

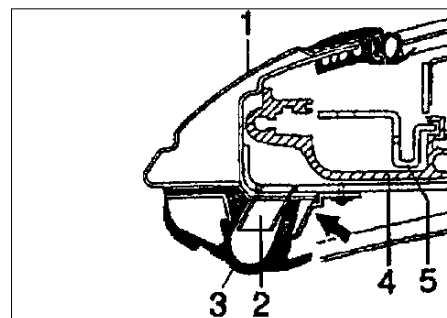
Figure 5

- 1 - Roof frame
- 2 - Water drainage pipe
- 3 - Door seal
- 4 - Guide rail
- 5 - Carrier bracket in the guide rail

- Reinstall the door seal. Ensure that the water drain pipe is properly installed in the opening of the door seal and the butyl seals are not moved.
- Secure the door seal onto the roof frame with the bracket.
- Reinstall the holding bracket (part number 993 562 571 00, arrow, figure 4) for the door seal on the inside.
- The holding bracket (part number 993 562 571 00) must be service installed since it was not done in production. This bracket should be installed as shown (arrow figure 5) to a 3 mm hole drilled into the roof frame.

- Fill the hole with body sealer and install the bracket with a sheet metal screw (4 mm dia. by 6 mm long). Install the door seal into the correct position and set the bracket into place. Bend the bracket to the outside until the teeth of the bracket contact and hold the door seal rubber.

Position the holding bracket to the center of the drain pipe of roof frame and flush with the bottom edge of the roof frame.

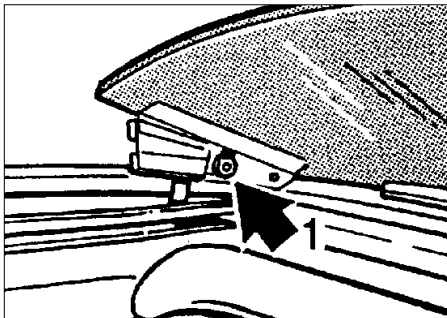
Figure 7

Area #4 Water entry on the air deflector

Insufficient pressure on the air deflector seal by the air deflector. The lip of the side seals (left and right) touches the bracket ends of the air deflector.

With the air deflector open, loosen the left and right holding nut (arrow 1, figure 7). Adjust the air deflector within the elongated slots so that in the closed position the deflector places a light preload on the seals.

The air deflector must be even with the glass roof and the side trim after adjustments. Tighten the left and right holding nuts to 5.5 Nm (4 ftlb).

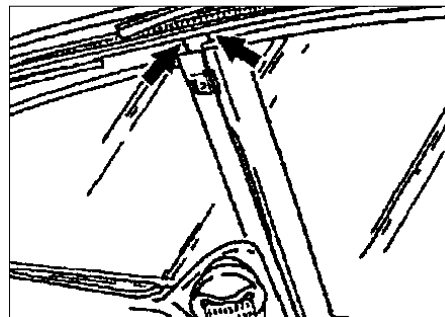
Figure 9

Area #5 Water entry on the top of the left and right "B" pillar.

A gap in the upper corner of the "B" pillar and roof frame.

- Close the gap on the "B" pillar (arrows, figure 9) to the roof frame in the area above the coat hook using body sealer.

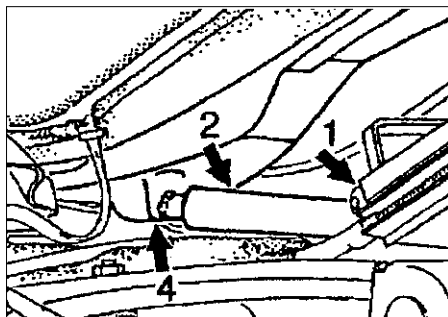
Figure 10

Area #6 **Water entry in the rear "C" pillar area on the left and right sides.**

- The guide rail leaks at the lower end (arrow 1, figure 10).
- The water drainage pipes (arrows 2 and 3, figure 10 and 11) maybe damaged or incorrectly installed.
- The water drainage connector (arrow 4, figure 10 - drainage from the rear window) may be leaking.

- Seal the area of the guide rail unit with body sealer (arrow 1, figure 10).
- Correct the installation or if needed, replace the drain pipes (arrows 2 and 3, figure 10 and 11).
- Seal the drainage connector with body sealer (arrow 4, figure 10).

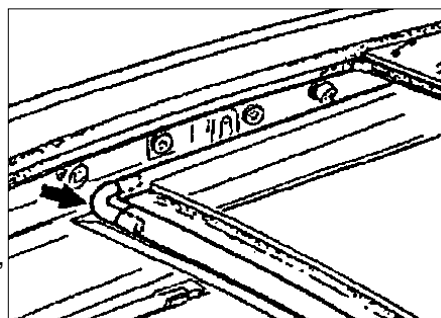
Figure 12

Area #7 **Water entry on the left and right side glass roof seal.**

- Possible openings on the corners of the glass roof seal. Water can run through the seal toward the rear and enter the passenger compartment.

- Close the open ends of the glass roof seal using rubber cord (part number 999 911 088 50) 7mm dia., 45 mm in length (arrow, figure 12).

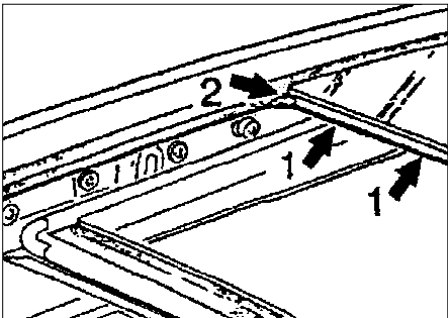
Figure 13

Area #8 **Water entry on top of the rear window on the left and right sides.**

- Improper sealing of the rear window frame at the front upper area (arrow 1, figure 13).
- Possible openings on the front corners and / or the transition between the rear window and side seals (arrow 2, figure 13).

- Close any gaps using body sealer.

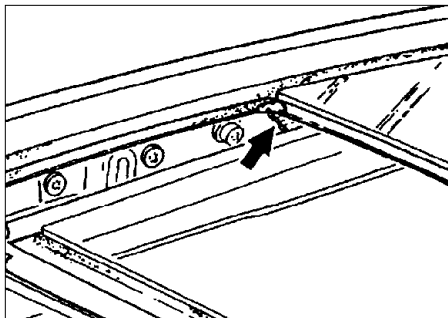
Figure 14

Area #9 **Water entry at the transition ramp rear window inside bracket above the roof frame left and right sides.**

Insufficient sealing of the transition ramp.

- Press sealing material between the roof frame and the rear window inside bracket (arrow figure 14).

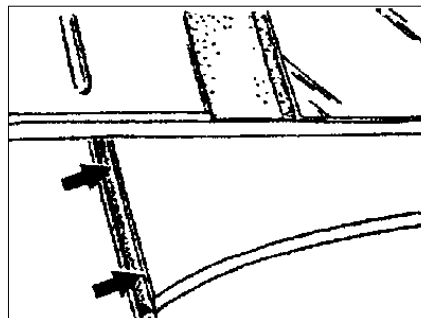
Figure 1

Area #10 **Water entry on the rear body center panel at the side seam connections to the left and right side members.**

- Inadequate sealing.

- Seal the gap between the rear body center panel (arrows, figure 14) and side members from the outside using silicone free body sealer. Depending on the body color, a light or dark sealer should be used which can be painted.

- Angle the tip of the sealer cartridge.
Start at the bottom of the seam and apply the sealer.
Remove any excessive sealer.
- After approximately 30 minutes drying time, paint over the sealer in the vehicle exterior color.
