<b>Technical Bulletin</b>		<b>Model</b> <b>6 Cyl.</b>	<b>Group</b> <b>6</b>
<b>Subject</b>  <b>Cabriolet Top Damage</b>		<b>Part Identifier</b> <b>6101</b>	<b>Number</b> <b>9505</b>

**911 Carrera Model Year 1995**

<b>Technical Bulletin</b>		<b>Model</b> <b>6 Cyl.</b>	<b>Group</b> <b>6</b>
<b>Subject</b>	<b>Replacing Folding Bow Tension Straps</b>	<b>Part Identifier</b> <b>6101</b>	<b>Number</b> <b>9505</b>

**Models Affected:** **911 Carrera Cabriolet, 1995 Models**

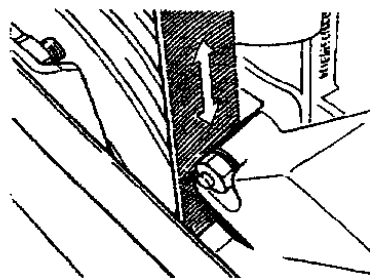
**Figure 1**

If the Cabrio top canvas is punctured or chafed by the locating pins when the Cabrio top is opened fully, the top folding bow must be checked for sufficient operating clearance to the top frame side rails. The folding bow must move freely and the elastic straps that pull the folding bow rearward must have sufficient tension. As a preventative measure, 911 Carrera Cabrios which are in the workshop for regular service or other repairs should also be checked.

1. Check for proper clearance of the top folding bow to the side rails of the Cabrio top frame (Figure 1 dimension "B"). Dimension "B" should be 5 to 7 mm. If dimension "B" is not 5 to 7 mm, it may be necessary to rework the side rails of the Cabrio top frame in the area "B" (Figure 1) to gain sufficient clearance for the folding bow.
2. Remove the plastic clamps near the folding bow on the right side that are holding the Cabrio top wiring harness to the Cabrio top frame. Use electrical tape to resecure the harness to the top frame. Be sure the harness does not interfere with movement of the folding bow.
3. Shorten the length of the folding bow elastic straps on both sides by approximately 25 mm (one inch). This can be done easily by folding the elastic material (Figure 2) where it is attached to the cabrio top folding bow. Staple the fold three times using a common stapler.

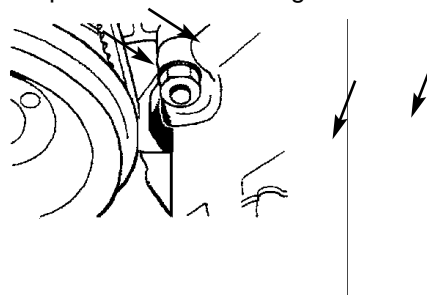
**Figure 1**

**Concern:** The folding bow elastic tensioning straps (arrows Figure 1) should be reworked on vehicles produced prior to February, 1995 in order to ensure correct operation of the folding bow.

**General Information:** The folding bow tensioning straps should be reworked in order to ensure correct operation of the folding bow. If the folding bow tension straps do not have enough tension, the Cabrio top material may not fold correctly and can be consequently damaged by the locating pins that stabilize the top frame when in the fully open position. Whenever the vehicle is in the workshop for regular service or other repairs, be certain to rework the folding bow tension straps as described in the following text.
