Technical Bulletin

Center Stoplight Bulb Replacement

Number
9601

Models Affected: **911 Carrera and 911 Turbo, as of Model Year 1995**

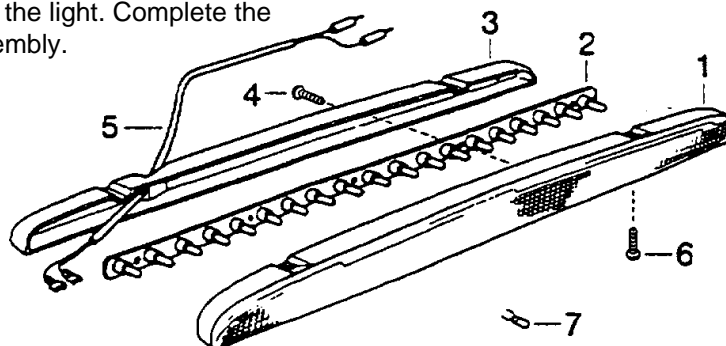
Figure 1

Concern: Replacement bulbs for the center stoplight are now available as spare parts.

- Lift off the cover for the center stoplight and remove the rubber strip.
- Remove the light bracket from the locating pins and remove the (2) screws that hold the light strip in the lens assembly (# 6 in figure below).
- Disconnect the wiring for the center stoplight and the phillips screws from the light strip cover (# 3).
- Unplug the wire harness from the bulb strip (# 5).
- Using a fine tip soldering iron, unsolder the defective bulb and solder in a new bulb. **Be very careful not to let any excess solder run across the bulb connecting strip (short circuit!).**
- Reassemble the center stoplight far enough to test for proper operation of the light. Complete the reassembly.

- Remove light bracket from the engine lid.
- Remove the (2) screws that hold the light strip in the lens assembly (# 6 in figure 1).
- Disconnect the wiring for the center stoplight and remove the phillips screws from the light strip cover (# 3).
- Unplug the wire harness from the bulb strip (# 5).
- Using a fine tip soldering iron, unsolder the defective bulb and solder in a new bulb. **Be very careful not to let any excess solder run across the bulb connecting strip (short circuit!).**
- Reassemble the center stoplight far enough to test for proper operation of the light. Complete the reassembly.
