# Technical Bulletin

**ATF Flow Noises  
on Cold Tiptronic Transmission**

**Number**  
**9402**

***911 Carrera Model Year 1995  
with Tiptronic Transmission***

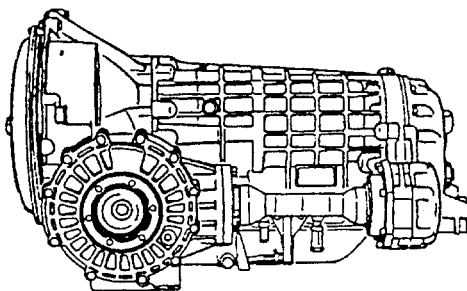
In isolated cases, ATF flow noises may occur on cars with Tiptronic Transmissions in a cold condition or, when driving, a scraping noise might be noticeable.

Increase the ATF level in the transmission. This means at 80°C (176°F ATF temp) the ATF quantity has to be increased to 15mm above the 80°C maximum mark on the inspection glass on the side of the transmission.

In addition, the ATF lines near the transmission must have a minimum clearance of 20mm to the body. If not, the lines should be slightly bent outward.
