Inspection Report

Property Address:
xxxxxx xxxL AVE, WHITE ROCK

ANTECH HOME SOLUTIONS

**LEO ZHANG BC HOME INSPECTOR#51809
6055 NELSON AVE
BURNABY, BC V5H 4L4
778-8559588**

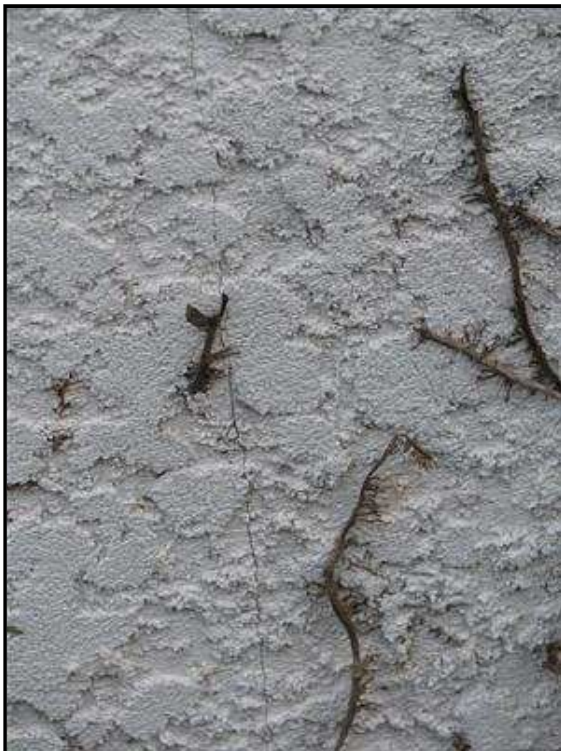
1.0 Picture 1

(1) Common cracking noted. Seal any openings to prevent moisture damage to exterior/interiors walls. the left side(facing front)stucco was replaced recently but no paint on it noted, paint is desired.

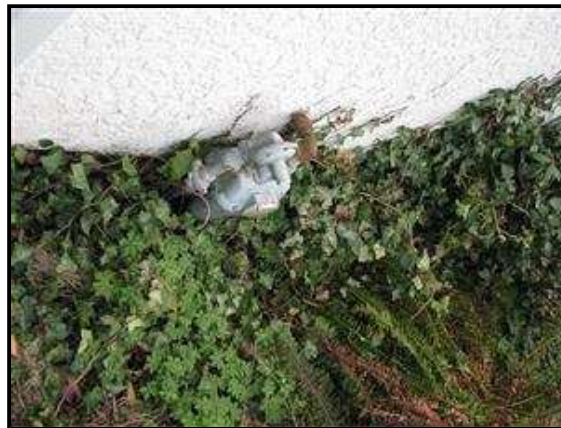
1.0 Picture 3

(3) Siding in contact with ground at right side (facing front). Because the siding is in contact with ground it is possible for framing to be deteriorated. We did not inspect behind this siding. Recommend a ground clearance of six to eight inches where possible.

EFIS siding should terminate 6" to 12" above grade level so it does not draw water up into wall. Water in the wall can lead to algae buildup on EFIS siding, mold buildup behind EFIS siding, and rot in wood siding and structural components. A lower trim piece called a drip screen is missing. The drip screen provides a finished edge, allows drainage and prevents water from being drawn up into wall. Evaluation and repair recommended by a qualified EFIS siding contractor.

Siding below grade level will remain moist and be a path for the entrance of Wood Destroying Insects (WDI).

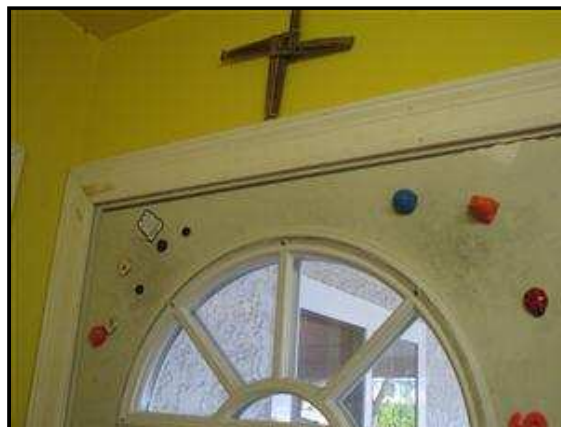
1.1 Picture 1

(1) no door closer noted.

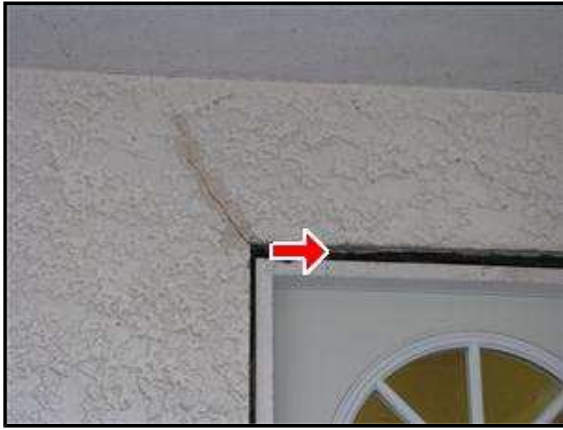
1.1 Picture 2

(2) the new installed door at the left front entrance door, has a gap between the frame and siding, exposed wood noted. Seal the gap and repair are needed.

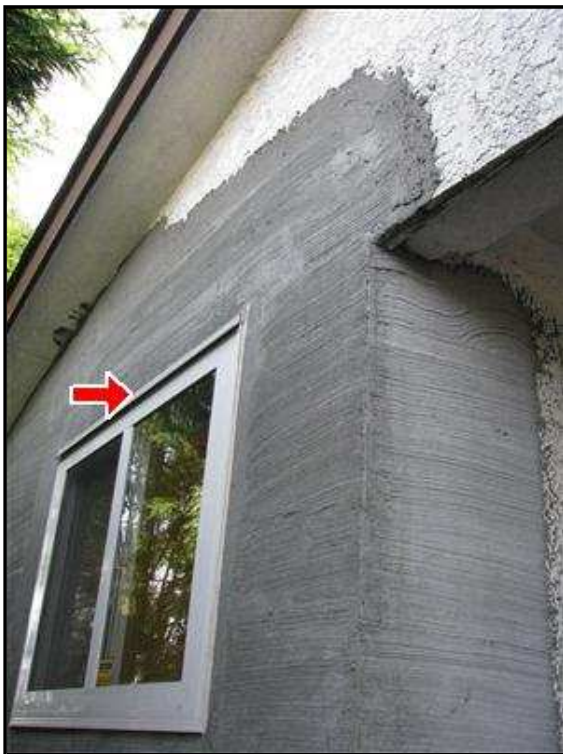
1.2 Picture 1

new windows were replaced but No drip flashings installed. This may allow moisture ingress if exposed to wind driven rain.

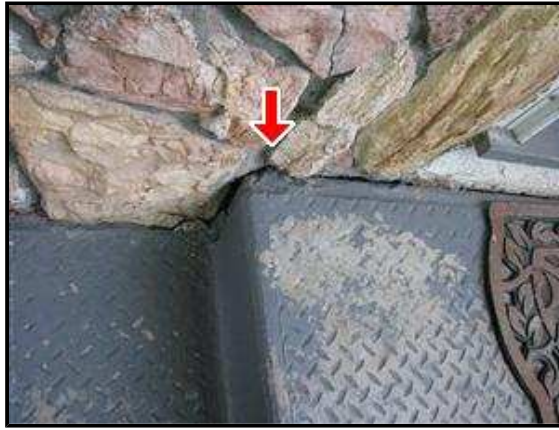
1.3 Picture 1

cracks noted between front door stoop and wall, re-seal is desired.

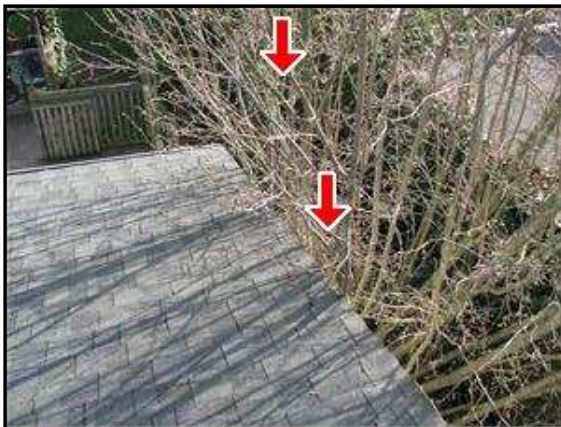
1.4 Picture 1

There are tree limbs overgrowing the residence that should be trimmed or monitored, to insure that they do not impact or damage the wall or roof or its components

✍️Vegetation is encroaching on the structure, and should be kept a minimum of twelve inches away for the general welfare of the walls and foundation

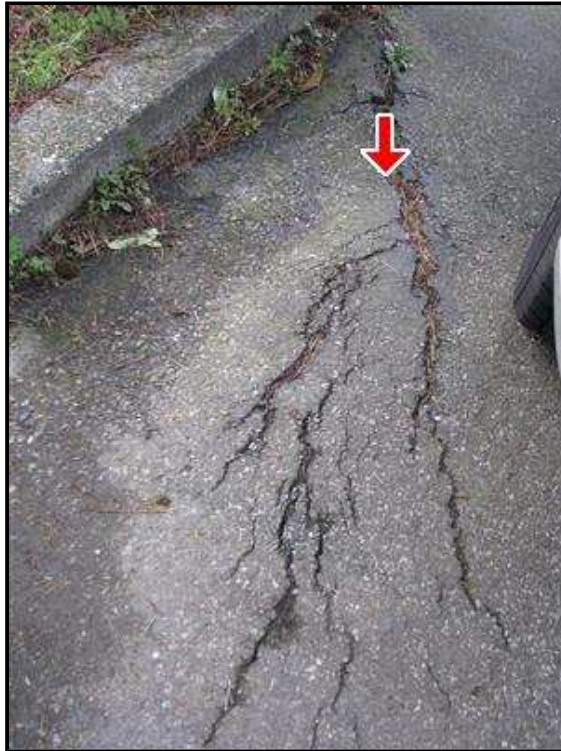
1.4 Picture 3

(2) the driveway is damaged by the roots, a trip hazard is noted.

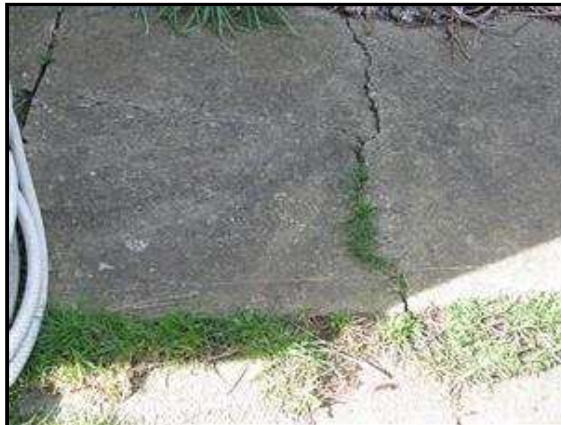
1.4 Picture 4

(3) The walk has cracks and is uneven. Tripping hazard present. I recommend repair by a qualified contractor

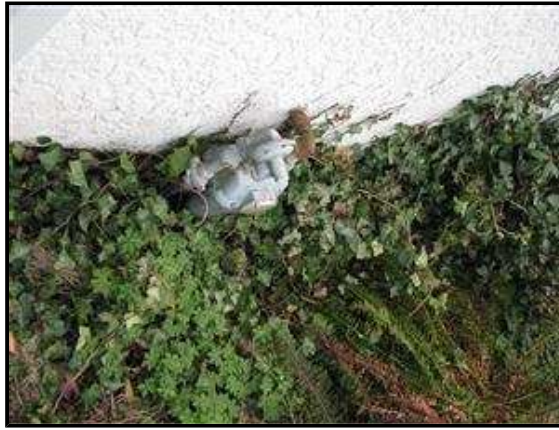
1.4 Picture 5

(4) There are various plants and or bushes next to the exterior wall(s). Trim or prune all vegetation in such a way as to allow a minimum of 12 inches of clearance between the plant and the exterior wall. This is necessary in order to prevent damage to the exterior and to inhibit the ability of insects to migrate into the building structure.

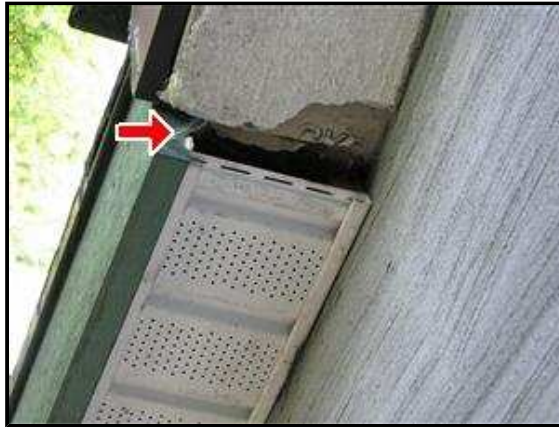
1.5 Picture 1

between the old soffit and new added room soffit, a gap is noted; the front side soffit has a missing parts. This gaps/hole exists which allows insects or bees to enter attic.

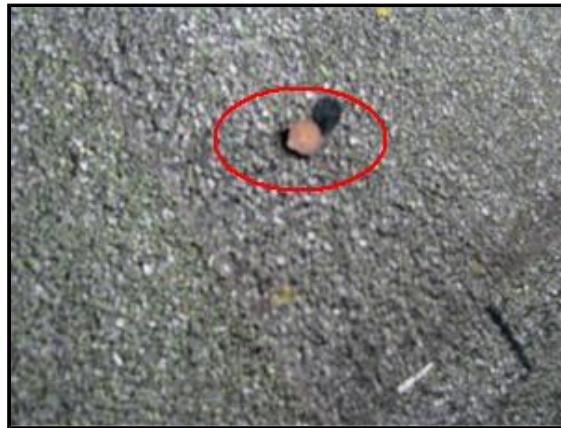
2.0 Picture 1

(1) popped out nail noted, re-seal is desired.

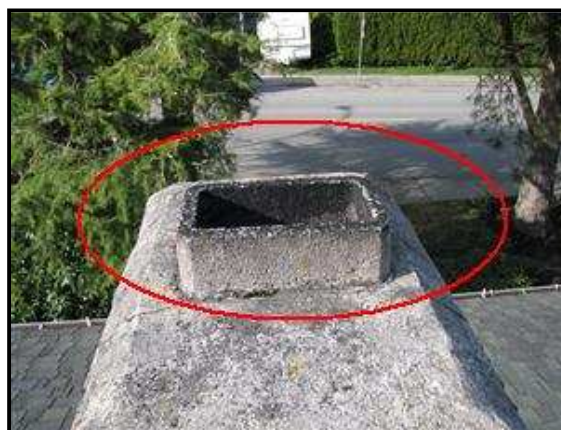
2.2 Picture 1

a chimney cap and screen was recommended to install

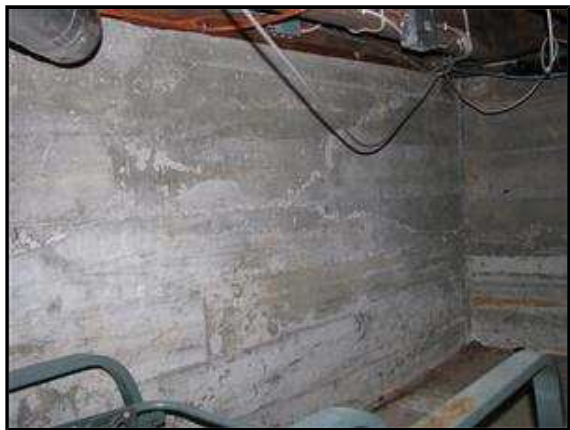
3.0 Picture 1

cold poured concrete noted in the crawl space, the entrance well looks liked added later than the foundation made, cracks and sister sills were installed not properly noted. repair are needed.

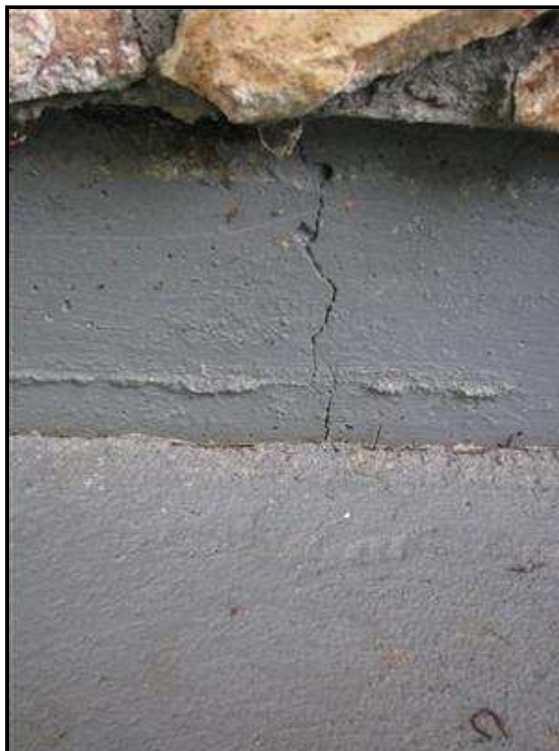
3.1 Picture 1

✍ There are hairline cracks on the concrete foundation at rear side of the house which could be caused by concrete cure & should be normal. We suggest owner monitor & caulk the crack including the possibility of moisture intrusion into the crawlspace. Re-grade service needed if necessary

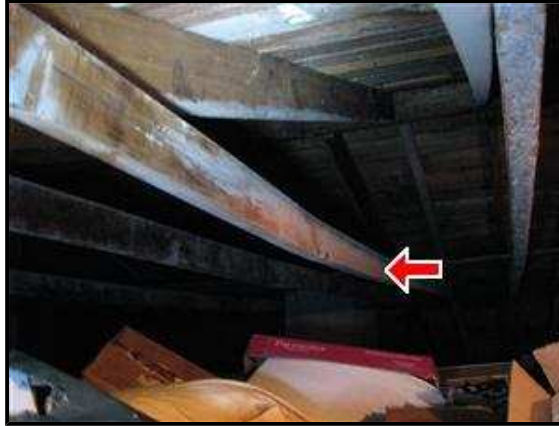
3.4 Picture 1

sagging joist noted the attic

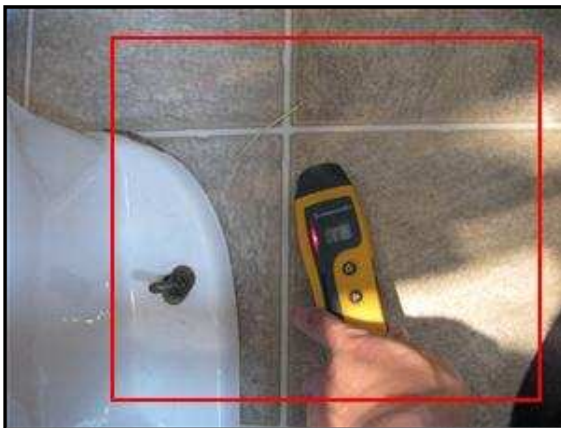
4.2 Picture 1

I found indications of water beneath the floor covering around the toilet. And the toilet bowl is loose. I checked underneath the bath in the crawl space, no current leak noted but old water stains noted.

I recommend further investigation and repairs as necessary.

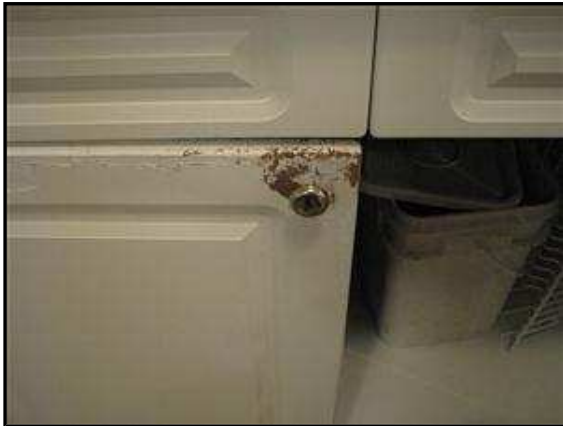
4.4 Picture 1

aged and peeled out paint noted on the kitchen cabinet, also some doors hardware need to be adjusted.

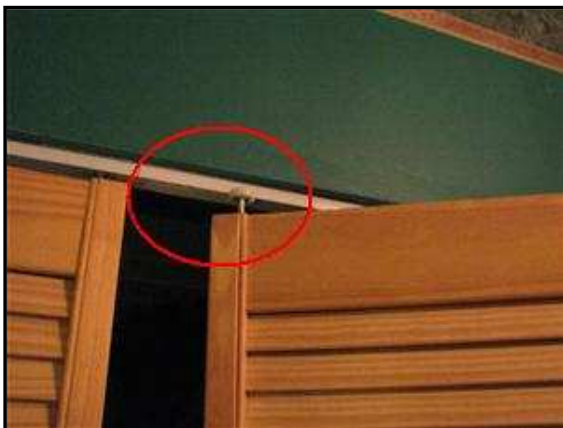
4.5 Picture 1

some closets doors are out of track or missing parts, repair is needed.

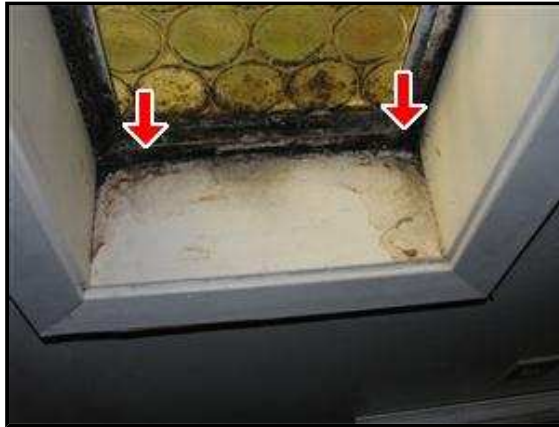
4.6 Picture 1

single pane original window noted by the main entrance, high moisture damaged frame and sill noted. repair is desired.

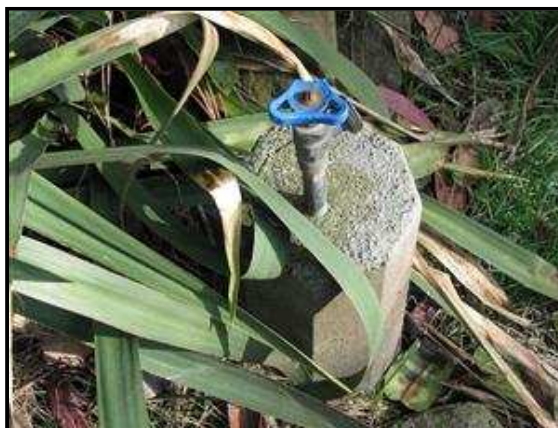
5.1 Picture 1

back yard the water valve no water noted.

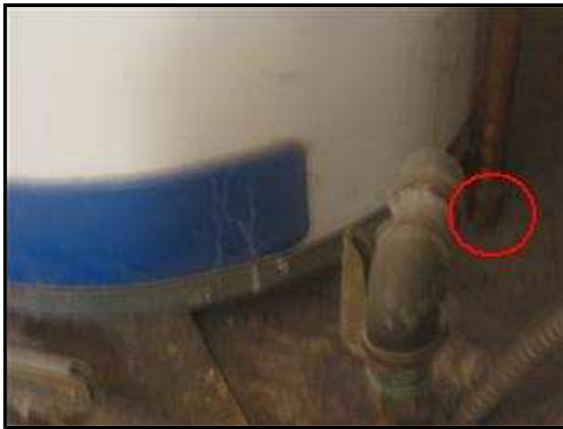
5.2 Picture 1

Pressure & temperature relief valve installed as a safety feature. A discharge pipe on pressure & temperature relief valve is installed BUT the valve is not close properly, the water dripping directly on to the duck in the crawl space and will rust the duck and add extra moisture to the space.

Recommend repair immediately. Recommend strapping the hot water tank securely to prevent tipping or moving excessively during an earthquake. This may help prevent gas or water lines from cracking or breaking during

a significant earthquake.

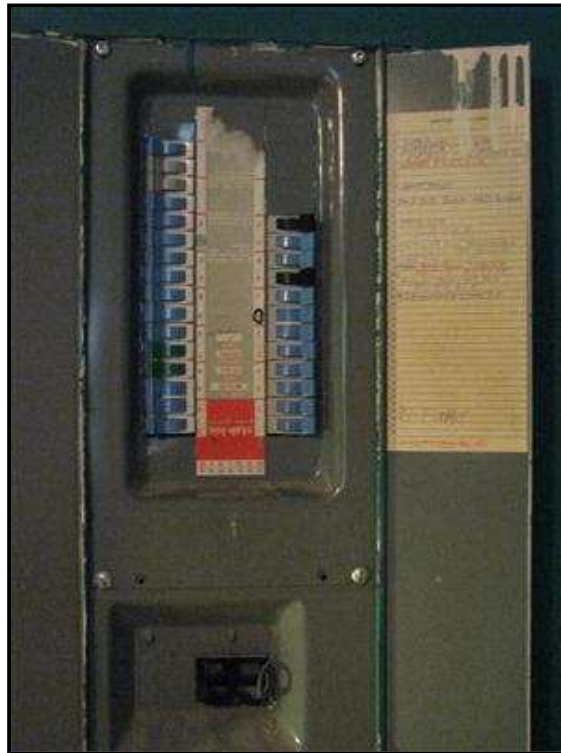
6.1 Picture 1

We recommend that residential FPE Stab-Lok electrical panels be replaced entirely or the entire panel bus assembly be replaced entirely, regardless of model number or year of manufacture. We recommend against replacing individual FPE Stab-lok circuit breakers. We do not sell circuit breakers nor any other products. Our site offers impartial, unbiased advice without conflicts of interest. We will block advertisements which we discover or readers inform us are associated with bad business practices, false-advertising, or junk science. Our contact info is at InspectAPedia.com/Contact.htm.

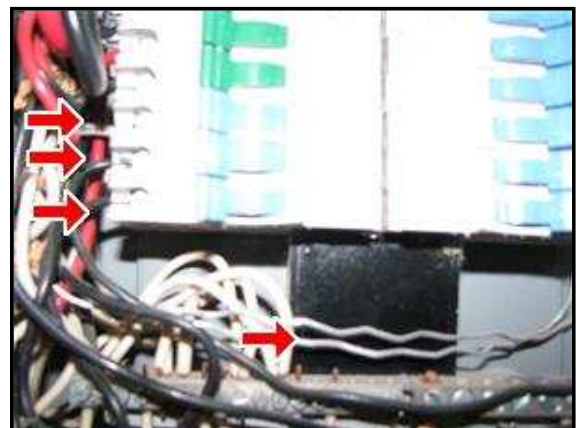
6.2 Picture 2

Aluminum wire is installed on 120 VAC branch electrical circuits in the subject house. These single strand, branch circuit aluminum wires were used widely in houses during the mid 1960s and 1970s. According to the U.S. Consumer Product Safety Commission, problems due to expansion can cause overheating at connections between the wire and devices (switches and outlets) or at splices, which has resulted in fires. For further information on aluminum wiring contact the U.S. Consumer Product Safety Commission via the Internet at <http://www.cpsc.gov/> . It is recommended that the electrical system be evaluated by a licensed electrical contractor.

. This type of wiring was standard at the time of construction. Client should consult with a qualified electrician to ensure proper and safe installation. Some home insurance require that aluminium wiring be checked and/or upgraded as a condition to granting fire insurance.

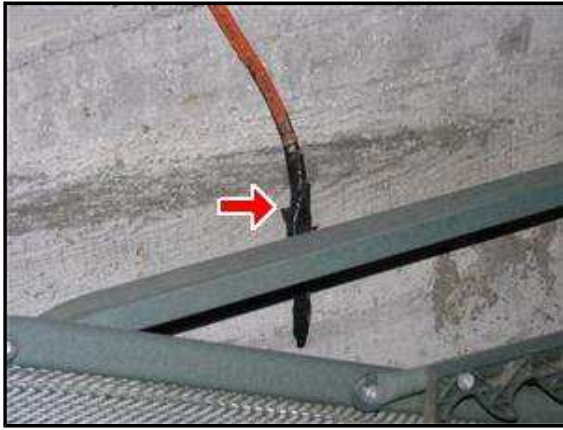
6.3 Picture 1

exposed wires and junction box noted in crawl space, the old wire need to be removed or covered properly.

the light is too close to the sheathing wood in the attic,contact an electrician make sure the clearance is enough.

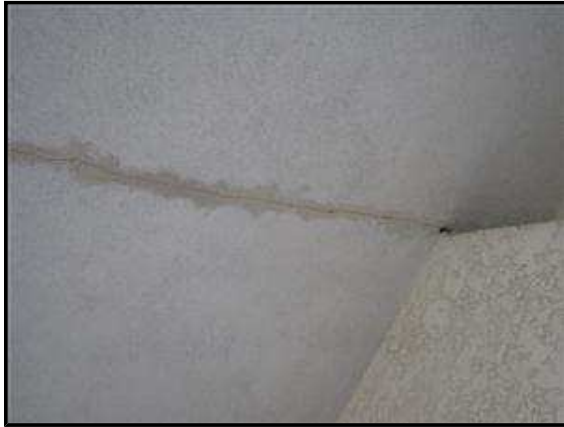
10.0 Picture 1

cracks and patching noted in the car porch
