**Annex Survey Report No. 8638/2025**

In accordance with the authorization of **Mohandes Insurance co**, we proceeded on 27 Aug 2025 to “

**Cairo three A for Agricultural & Animal Production (Al-Naeem 2 Farm)** located at West of Wadi El-Natrun City, behind Diplomats' Farm, Beheira Governorate, Egypt, in order to assess and categorize the hazards under evaluation for insurance coverage.

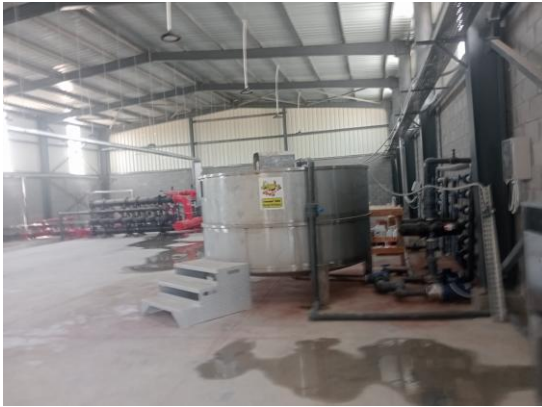
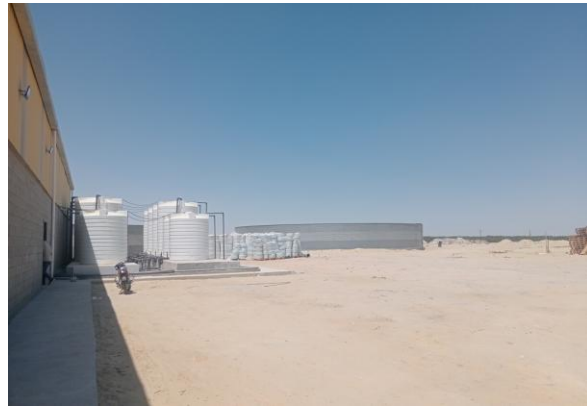
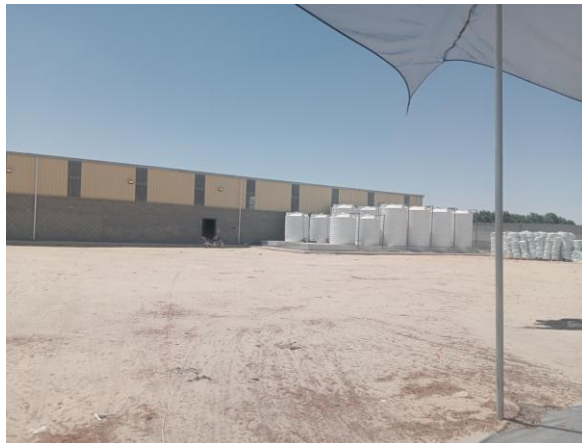
- **Automatic Irrigation and Fertilization Station Building**

- Constructed over 1000 m<sup>2</sup>, it consists of ground level and is constructed of (walls constructed of bricks and completed with truss, floors constructed of reinforced concrete and ceilings are constructed of truss)and including the following

- Fertilizer Mixing Unit

- Automatic Irrigation System
- Electric room and administrative offices: It is constructed of (walls constructed of bricks, floors and ceilings constructed of reinforced concrete)
- 8 tanks capacity of 20 m<sup>3</sup>
- 4 tanks capacity of 10 m<sup>3</sup>

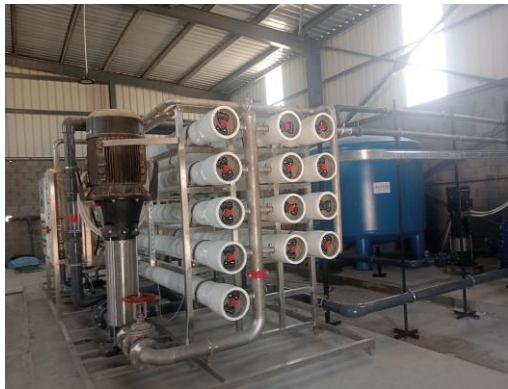
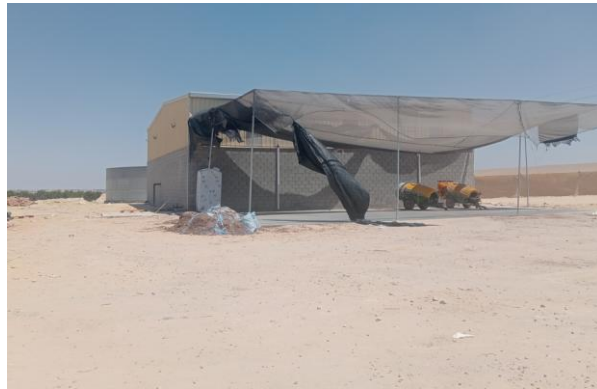
#### ○ **Water treatment station**

- Constructed over 400 m<sup>2</sup>, it consists of ground level and is constructed of (walls constructed of bricks and completed with truss, floors constructed of reinforced concrete and ceilings are constructed of truss) and the building houses a water treatment plant owned by another company

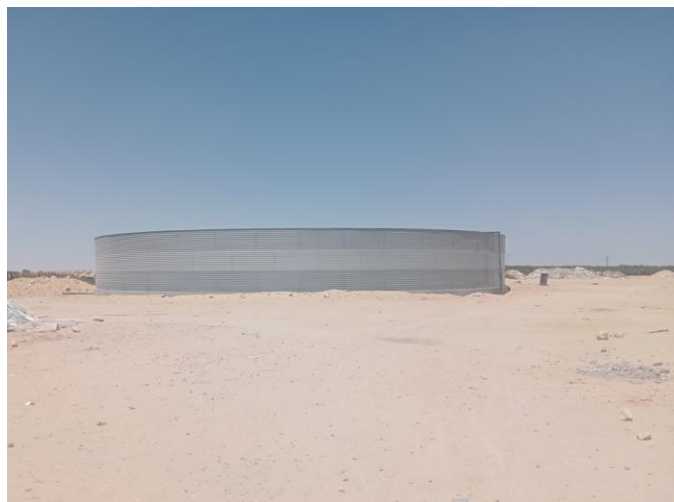
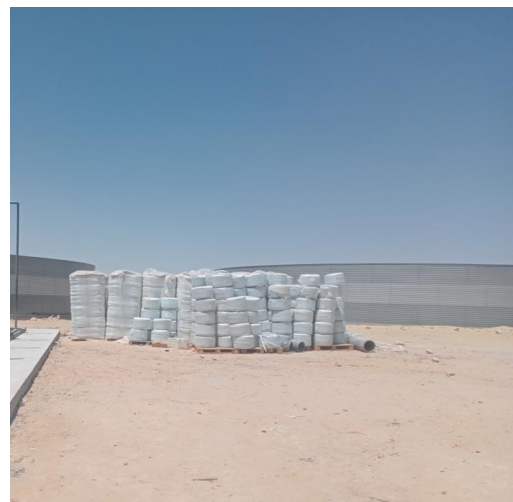
- 
- **3 treated water tanks:** Three steel storage tanks erected on reinforced concrete foundations as the following:
  - 2 tanks capacity of 2500 m<sup>3</sup> / per each
  - 1 tanks capacity of 1100 m<sup>3</sup>

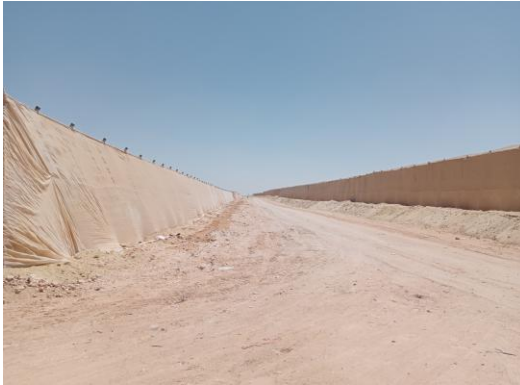
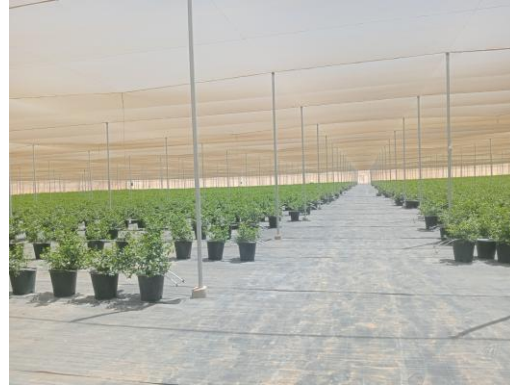
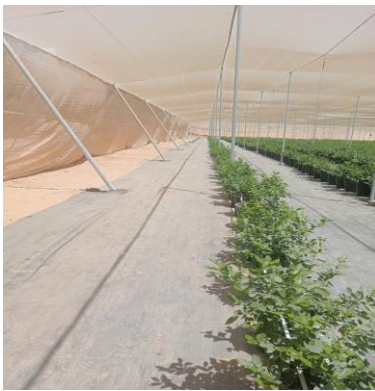
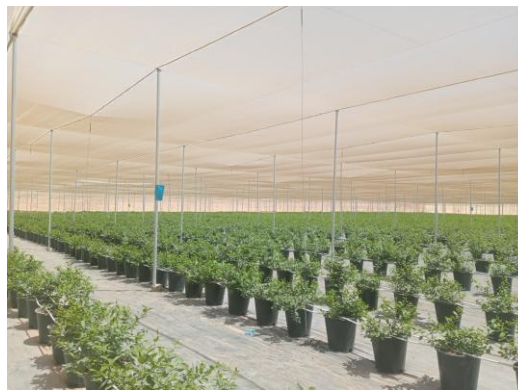
- **Greenhouses and Agricultural Seedlings**
  - Comprising 16 agricultural greenhouses (each greenhouse with an area of 6.4 acre), with a total of 320,000 trees. The first-phase greenhouses are located approximately 100 meters from the industrial complex and are divided on both sides of the road, with 8 greenhouses on each side.
  - Each agricultural greenhouse is a plot of land covered with plastic sheeting and containing groups of plastic containers (planting baskets) filled with imported agricultural soil, within which blueberry trees are cultivated. These trees are irrigated through an automatic irrigation system designed to determine the precise amount of water required by the plants as well as the necessary quantity of fertilizers."

- Construction is in progress for the second phase, which will consist of 42 additional greenhouses accommodating approximately 480,000 trees, with the total project target amounting to 800,000 trees.

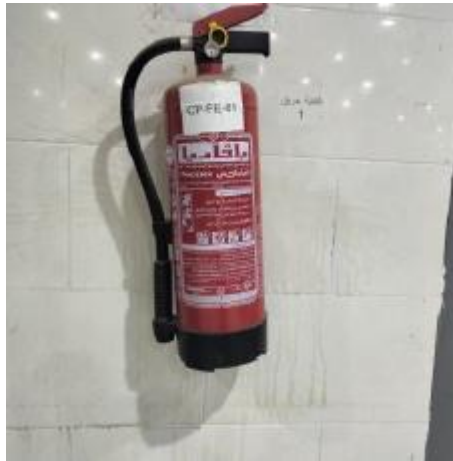
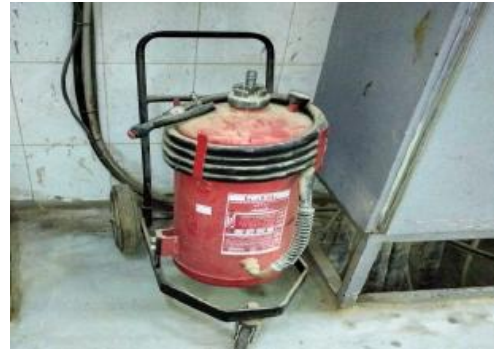
- **Hand- held Extinguishers:** distributed adequately on the entire site
  - Fire extinguishers dry powder
