# **Green Watts (Private) Limited 10 MW Bio Mass Power Plant – Cooling System Inspection Report**

ASANKA WIMALARATHNE  
AREA MANAGER – TECHNICAL SALES  
WASSER KRAFT TECH LANKA (PVT) LTD

25<sup>TH</sup> MARCH 2019

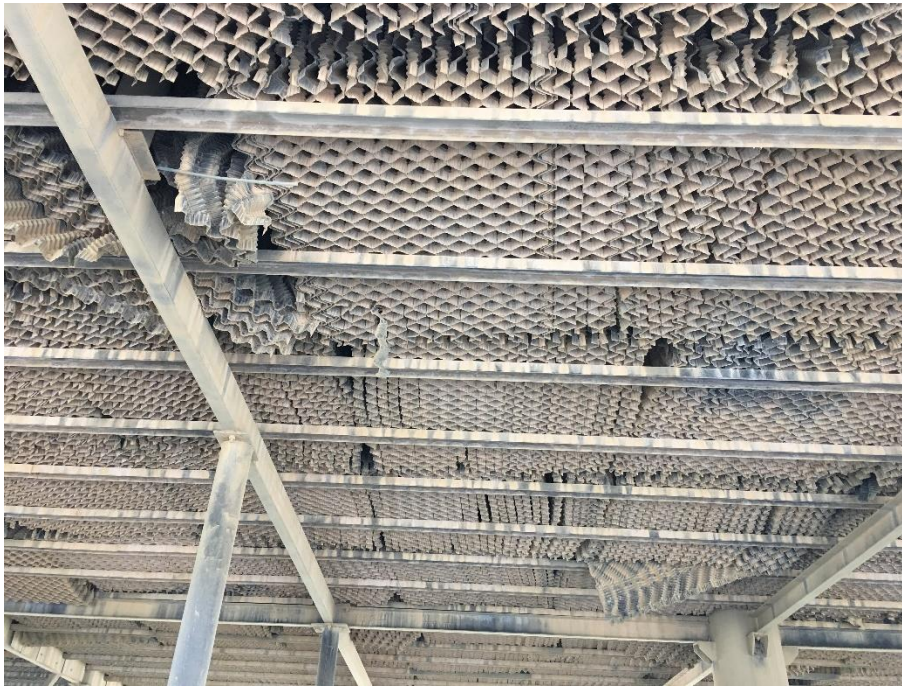
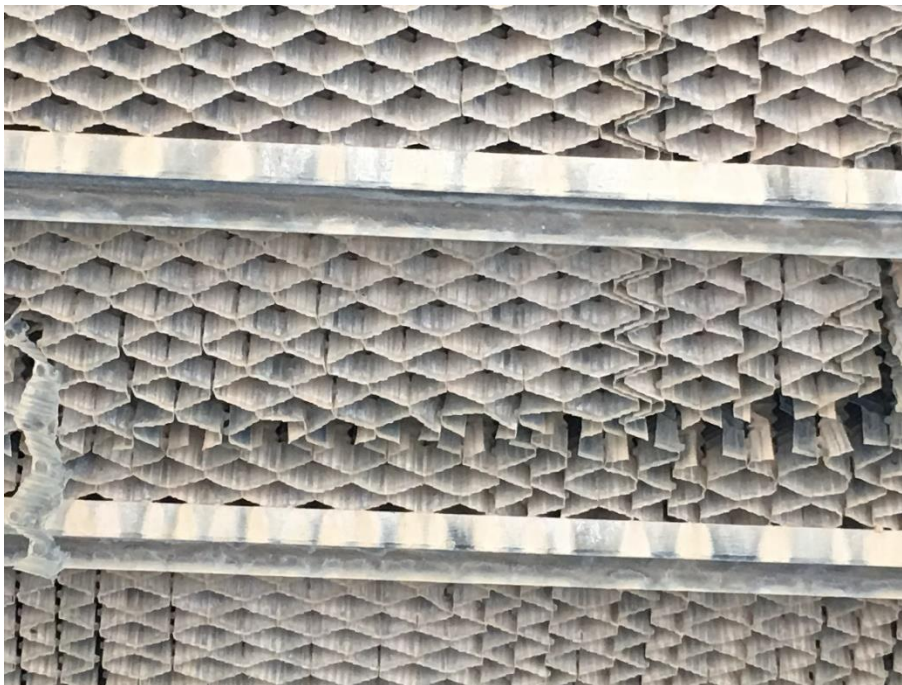
- Some fills were unmounted and broken.
- Slight deposit was formed inside the Cooling Tower Fills surfaces.

- Perform the system Pre-Cleaning & Passivation 2 – 3 times to remove the existing deposit and re-build the system passivation layer (Good passivation layer will help you to avoid any corrosion of the system).
- Make sure to maintain a good chemical and physical treatment for the system (Recommend to follow SUEZ guideline for the better performance of the system)
- Make sure to maintain a continuous monitoring for the cooling system chemistry.
- Install strainers to cooling tower recirculation pump suction to avoid, entering any suspended partials to the condenser.
- We wish to recommend to obtain expert services of Suez/WKT Chemical to assure overall plant chemistry, preferably on permanent basis or if not minimum once a week

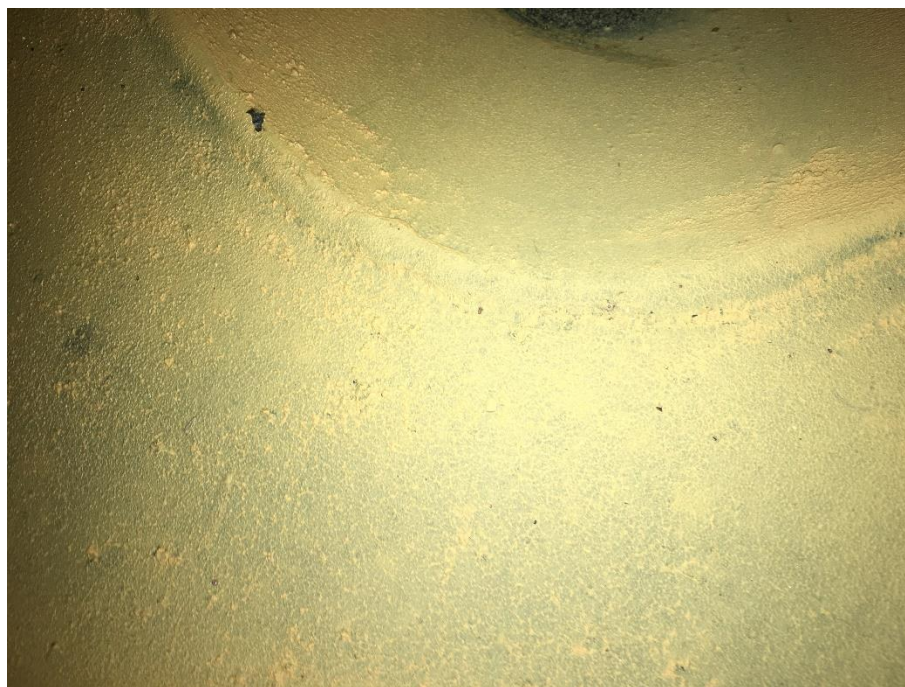
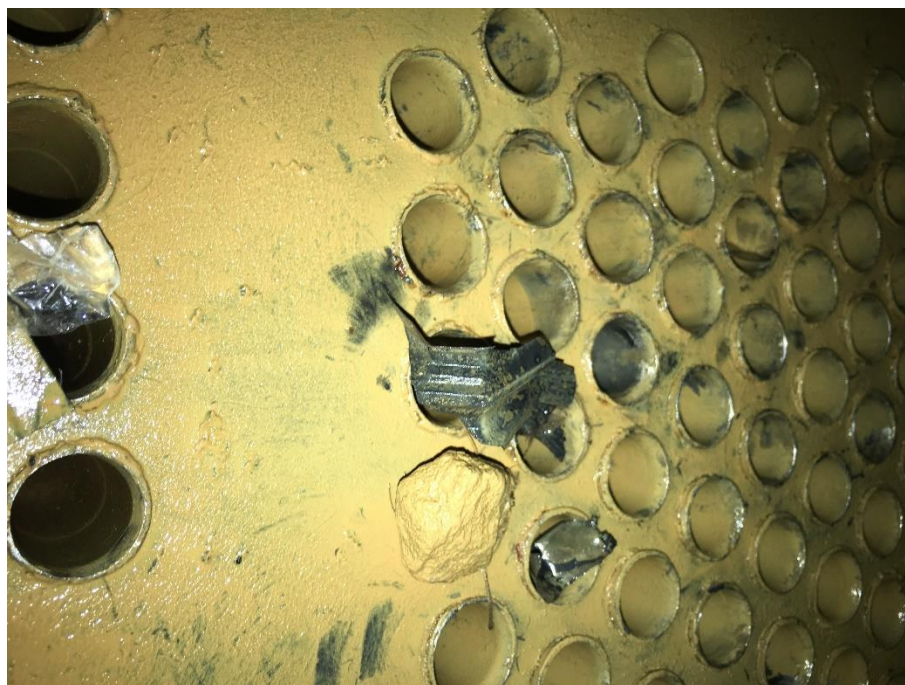
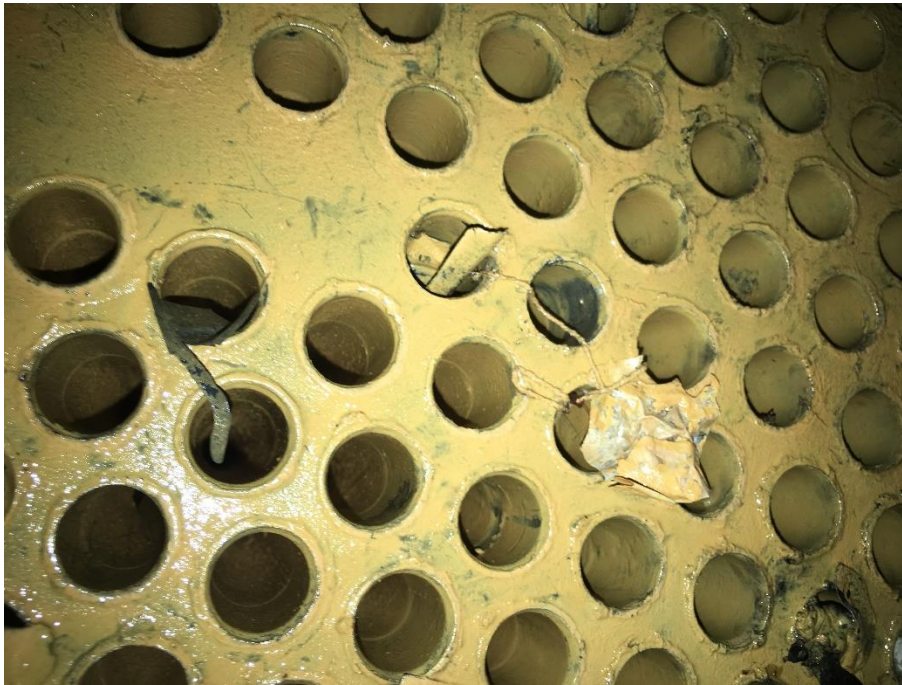
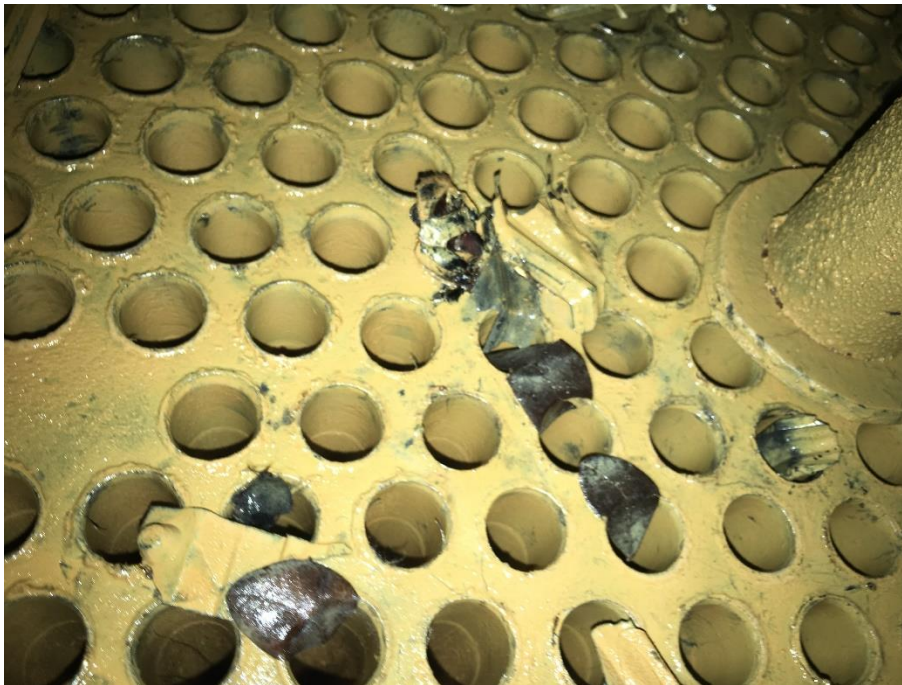
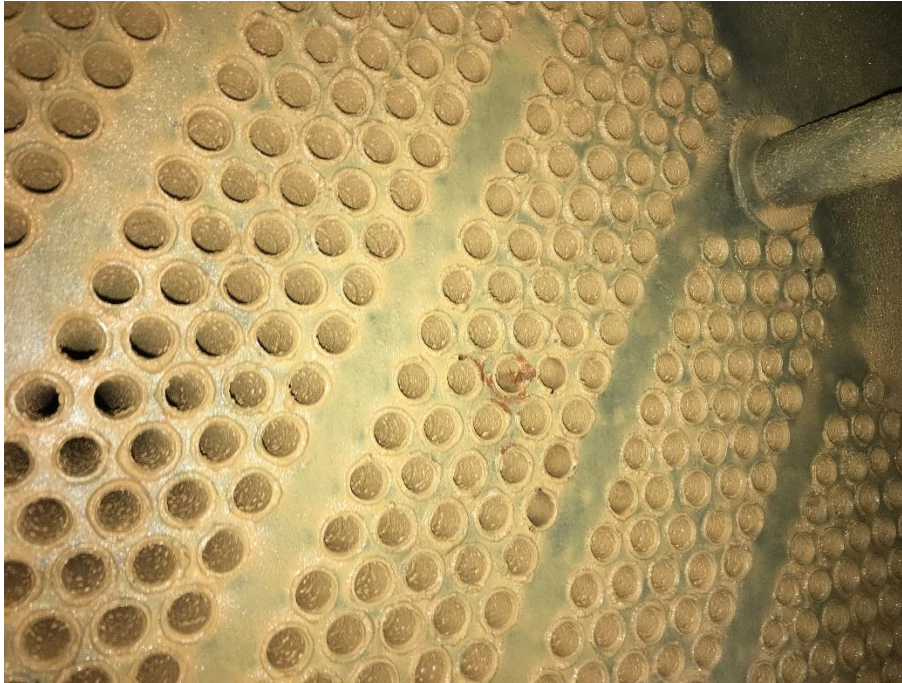
- Lot of suspended partials were accumulated inside the bottom pass of the condenser.
- Thin kind of slurry layer was formed inside the condenser including condenser tubs and shell walls.

- About 0.4 - 1.0 mm thick deposit layer was formed under above mentioned slurry layer. (In the site we did a simple magnetic test and observed this deposit layer has iron contamination also – Figure CD09)

- System pre-cleaning & passivation were not completed properly before start the system (While the system commissioning). – When proper pre-cleaning & passivation was not done at initial commissioning stage, there is a possibility of causing solid deposition as fouling due to the mill rust, corrosion products, dirt & oil and grease which had deposited during transportation, storage & installation stages. Also once the fouling occurs, the possibility of scaling & under-deposit corrosion increases.
- Overall cooling system treatment program and the monitoring were also not up to the standard in terms of maintaining water chemistry, addition of chemicals & interpretation of test results as per our limited observations.
- Also we believe that the Cooling tower blowdown was not done as per the requirement (12.6 m<sup>3</sup>/hr)
