Failure Analysis of Stainless-Steel Rifle Barrel

416R Material Case Study

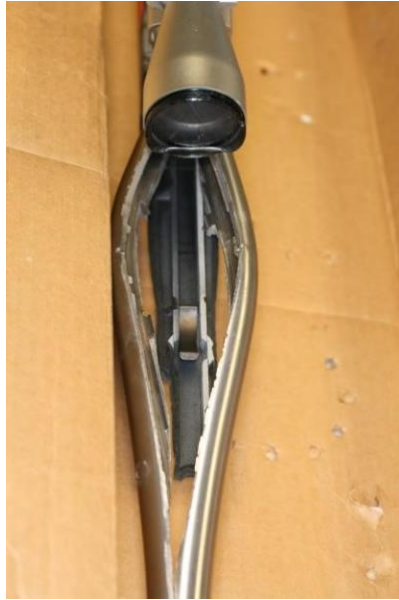
The user of the rifle was severely injured because the barrel on the firearm split during firing (Figure 1). The rifle was said to have a 416R steel barrel. Upon questioning, it was found that the rifle was “fairly new” and had only been used 20-30 times prior to the failure. Additionally, before leaving the manufacturing facility, the rifle was proof tested with a double load of the powder.

Figure 1: Barrel split during the accident on the failed rifle

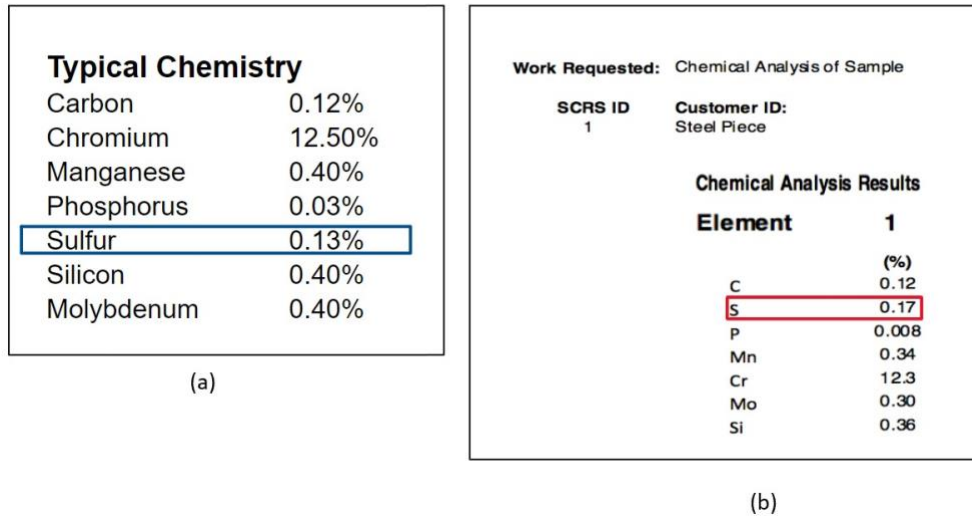
Figure 2: Comparison of (a) Typical chemistry of 416R Stainless Steel [10] to the (b) chemical analysis testing of the 416R stainless steel part from the barrel of the rifle Notice the highlighted (a) blue and (b) red boxes. They show the difference in Sulfur(S) percentage

The maximum concentration of sulfur in 416R stainless steel is given as 0.13% (Figure 2, (a)). In this muzzleloader's case, the chemical analysis of the barrel showed that the concentration of sulfur in the sample was 0.17% (Figure 2, (b)). Hence, there is a 0.04% difference between 416R stainless steel used in the rifle in question and the 416R stainless steel in the market.

Additionally, by simply keeping the hole depth and barrel chemistry within design specifications, this gruesome mistake may very well have been avoided and can be prevented in the future.

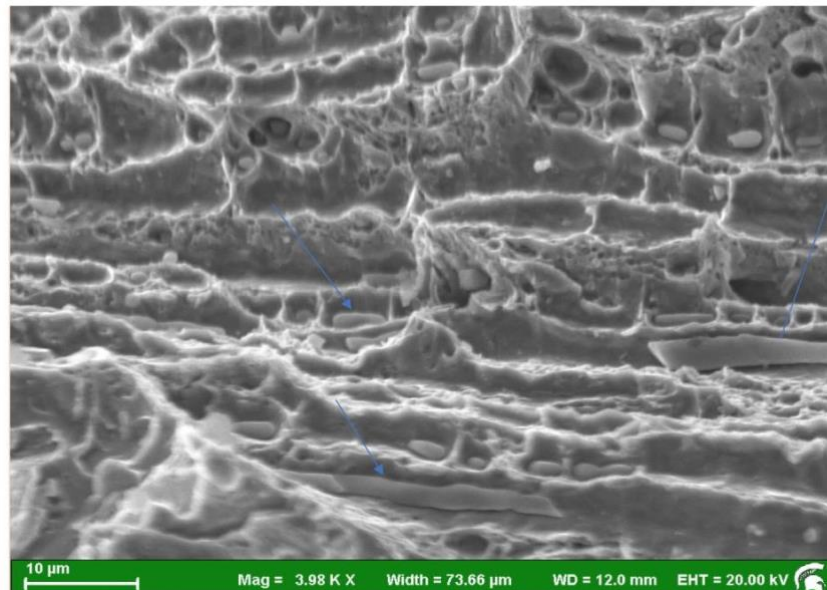
Figure 3: SEM image that shows the segregation of the MnS particles from the stainless-steel matrix. The arrows point to the MnS particles.

Because of the high concentration of sulfur, the barrel contained a high amount of MnS particles. The MnS inclusions were segregated from the steel matrix (Figure 3). These inclusions increase the softness of the steel, which, ultimately, results in easy breakage of the part. Moreover, the sulfide particles cause 416R stainless steel to be anisotropic (Figures 4 & 5). The difference in the concentration of sulfide particles in the right side of the barrel versus the left side of the barrel further confirms the anisotropy (Figures 4 & 5).

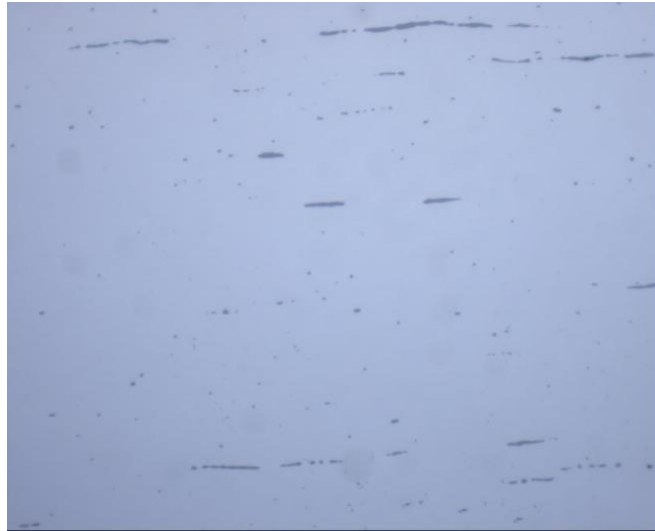
Figure 4: Optical micrograph of the right side of the barrel. The black “stretched out lines” or “strings” represent the MnS elongation in the direction of the stress. (50x magnification)

The MnS inclusions that can be found in the SEM images also relate to the cause of fracture. These MnS “stringers” can be seen in Figures 4 & 5. A common observation in steels is fracture that is initiated by sulfide stringers [13].

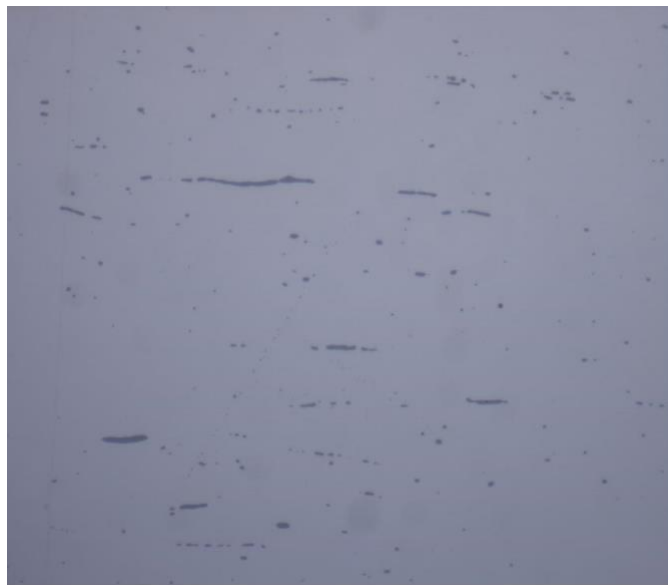
Figure 5: Optical micrograph of the right side of the barrel. The black “stretched out lines” or “strings” represent the MnS elongation in the direction of the stress. (50x magnification)

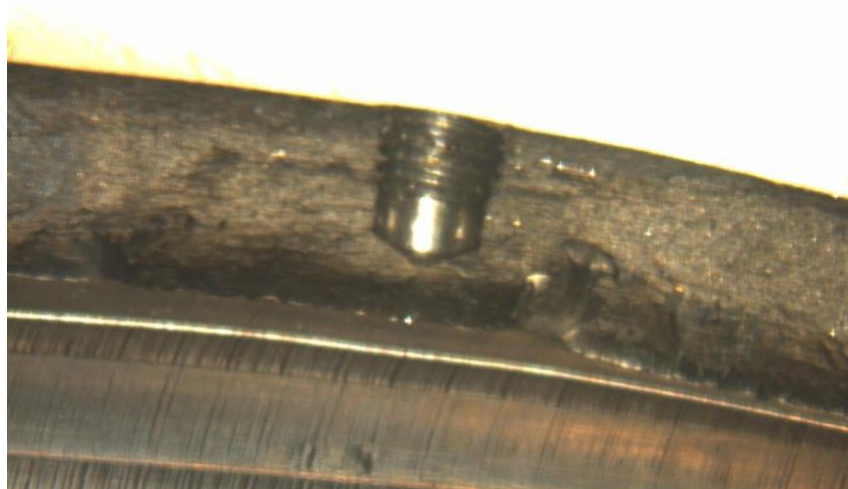
One reason that the rifle is believed to have failed is the improperly sized threaded hole in the barrel. While the presence of a threaded hole on rifle barrels for the purpose of mounting attachments is common, the depth of the hole in question is detrimental to the rifle's safety. The design specification for this particular hole called for a maximum depth of .161in, and measurements have shown this hole to have an actual depth of .168in, which is .007in deeper than should be allowable per the specifications. This increased depth lowers the toughness of the area and creates an area of increased stress.

Furthermore, the hole extends past the threaded portion, increasing the depth of the hole significantly (Figure 6). While the threaded portion of the hole is used for mounting sights and various accessories, the unthreaded portion seemingly serves no purpose. With that being said, the unthreaded portion of the hole could easily be removed, which would greatly reduce the depth of the hole and increase the safety of the rifle without sacrificing any functionality.

Figure 6: The hole, as seen here, extends past the threaded portion. In doing so, the depth of the hole is increased significantly.

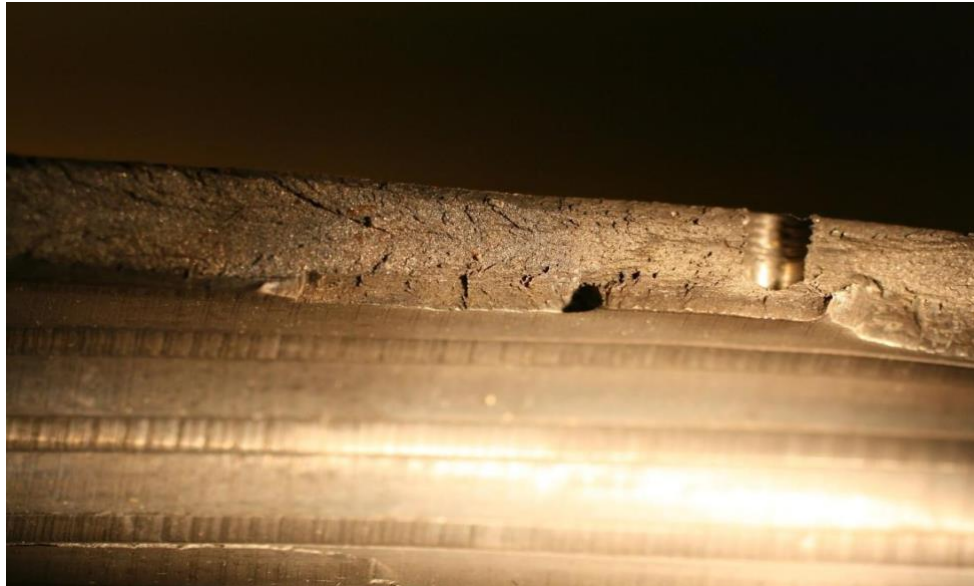
Figure 7: Chevron markings can be seen here as they point towards the origin of the fracture i.e. the mounting hole.

The chevron marks running from the hole further reinforce the idea of the hole being a major contributor to the failure. Chevrons are a pattern that is formed on a fracture surface that shows the direction of crack propagation, while pointing back towards the crack origin. The fracture surface displays these chevron markings (Figure 7). The figure also points to the fracture origin: the mounting hole. This further suggests that the incorrectly manufactured mounting hole is a factor in this failure.

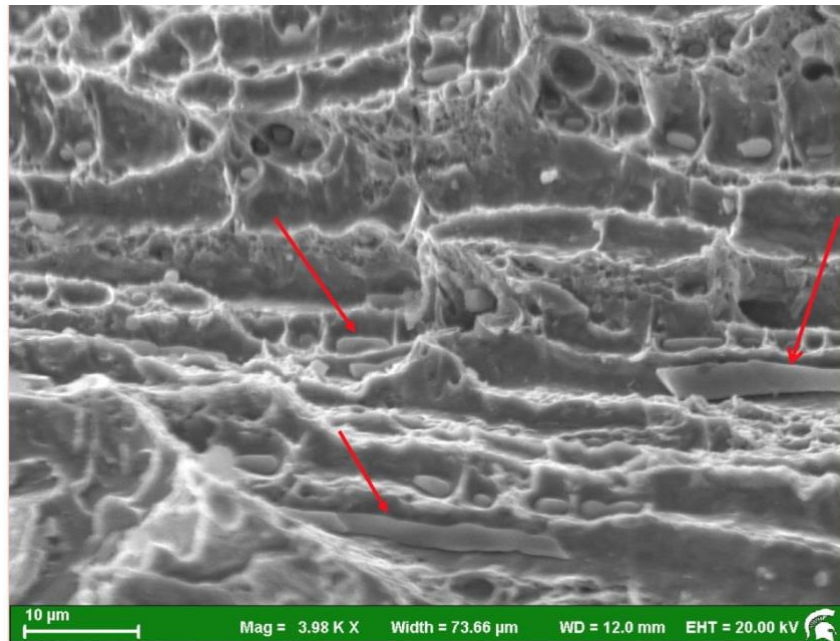
The evaluation of the ductile existence in the SEM images suggest that particle spacing as well as size contributed to crack nucleation.

Figure 8: SEM image showing ductile dimples along with MnS inclusions. The dimples are elongated in the direction of the x-axis. This illustrates that the mode of failure is either mode II or III. These types of modes deal with shear or tearing.

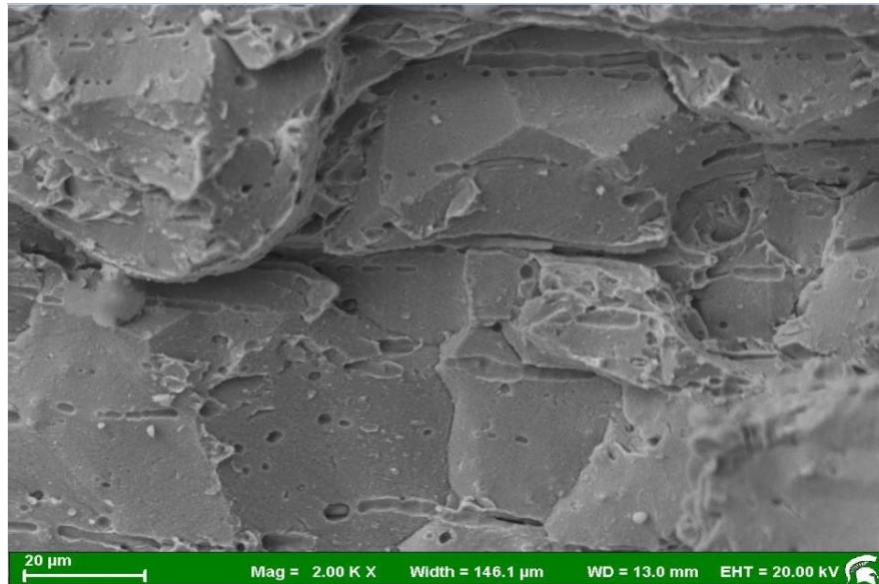
Another source of brittle fracture comes from the 416R steel phases. The steel used in the gun barrel is heat treated and later goes through temper embrittlement to form martensitic phases, where martensitic phases are known to be brittle. An error during heat treatment could be a culprit in the steel used in the barrel to not meet the required characteristics for the application it was intended for. If this is the reason the responsibility of the failure falls upon the manufacturer and not the user.

Figure 9: SEM image displaying the rock candy topography. This supports the theory that MnS inclusions as well as faulty temper embrittlement processes are likely the reasons the gun barrel fractured and failed.
