CONSTRUCTION ISSUES

A total of 101 issues were identified during the commissioning efforts for the project. As of August 21, 2022, 99 issues were closed. The two remaining open issues are listed below.

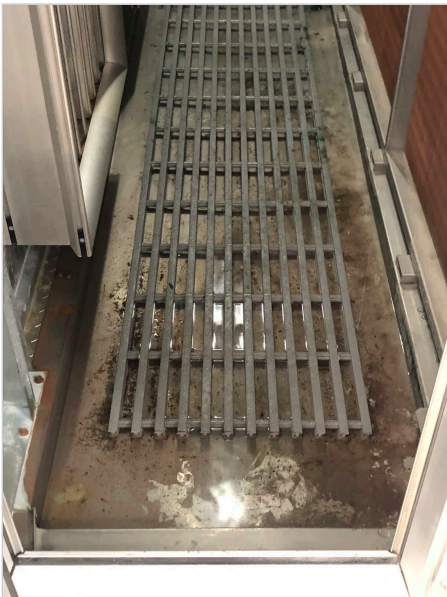
09E02278-A787-4D21-A7CF-5AC5A56461F5.jpeg

Compartment between CHW coil and supply fan not draining.

Light for Compartment out
Kelley Dugosh on 02/25/2022 at 09:29 AM
Commissioning Authority, NV5

Not corrected as of Feb 25 field visit
Kelley Dugosh on 02/25/2022 at 09:20 AM
Commissioning Authority, NV5

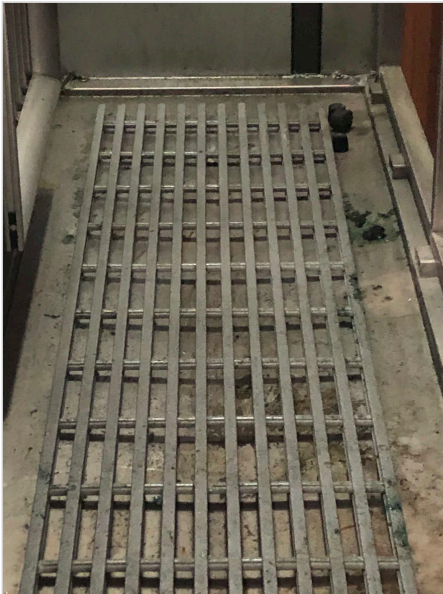
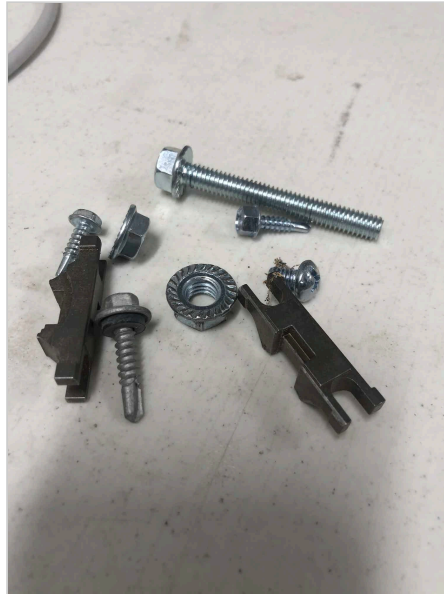
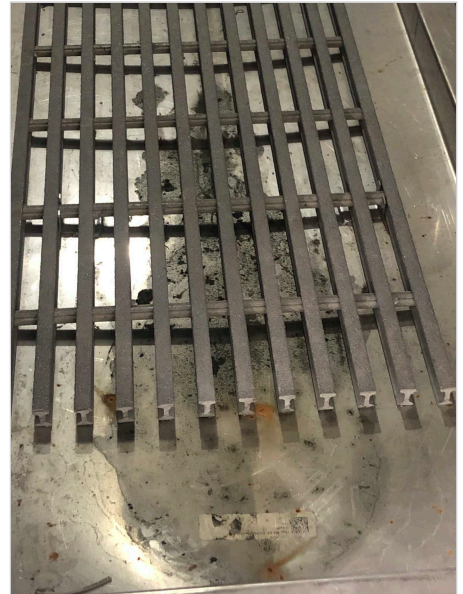
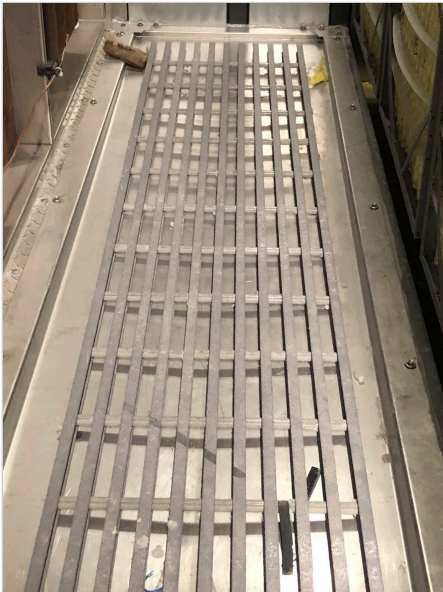
AHU-4 interior needs a final cleanout and clean. Metal, plastic, and other construction materials on floor of multiple sections. I removed all the metal (included in final picture) but did not remove all debris. Photos attached.

Clean out verified Feb 25. Gilbert reported a vacuum/mopping after our Feb 25 walk. Issue closed.

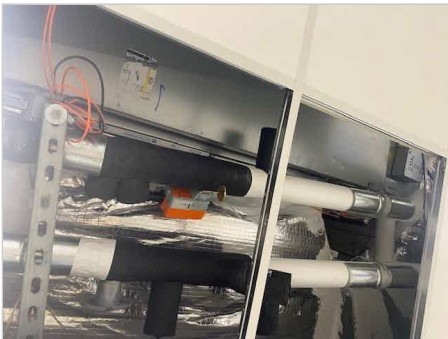
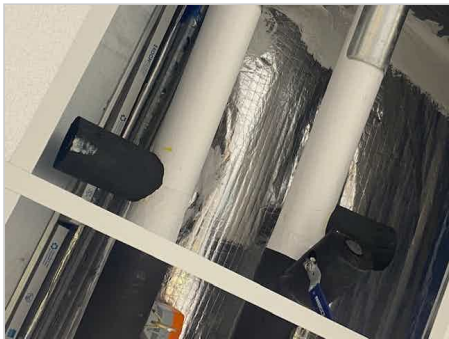
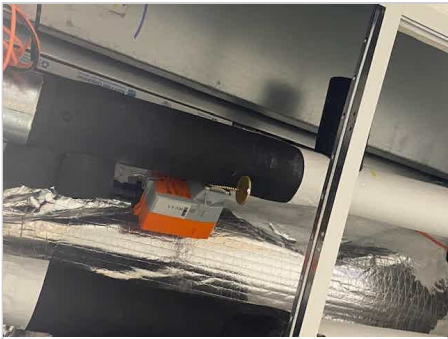
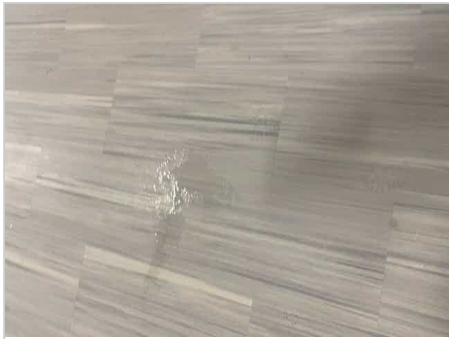
Piping at FCU-3-1 is dripping.

This appears to be corrected, though no one has commented on it. I will recheck the next time I am on site to confirm the leak is fixed.

Verified multiple times, closed.

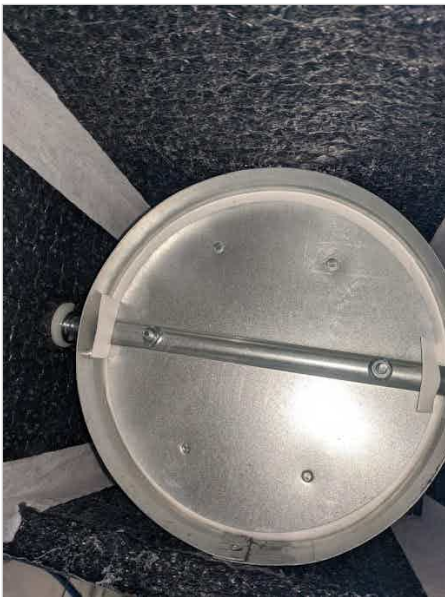
unnamed.jpg

Damper commanded and visibly closed with no airflow. Looks to be the airflow sensor.

Mechanical replaced sensor, VAV working correctly. Issue closed.

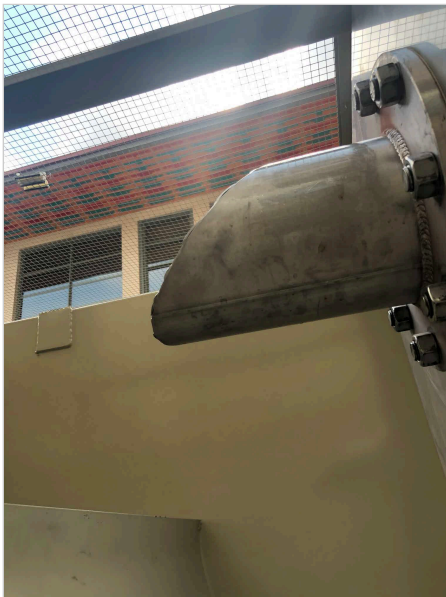
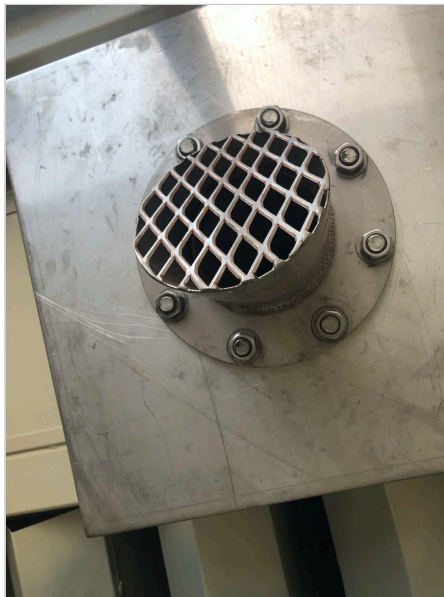
Missing Catalyst installed on generator exhaust and the insulation installed to prevent the exhaust pipe from heating the enclosure has melted two sensor cables that need to be replaced and system checked out for proper function and operations.

The missing catalyst on the generator exhaust and insulation have been installed and the two sensors have been replaced and all is functioning. 11/17/2021

Replace the melted two sensor cables that need to be replaced and system checked out for proper function and operations.

Belden wire replaced, generator has been tested.
