## CASE STUDY

OISD/CS/2024-25/P&E/12

Title: Explosion in furnace.

Location: Process (Crude Distillation) unit in refinery.

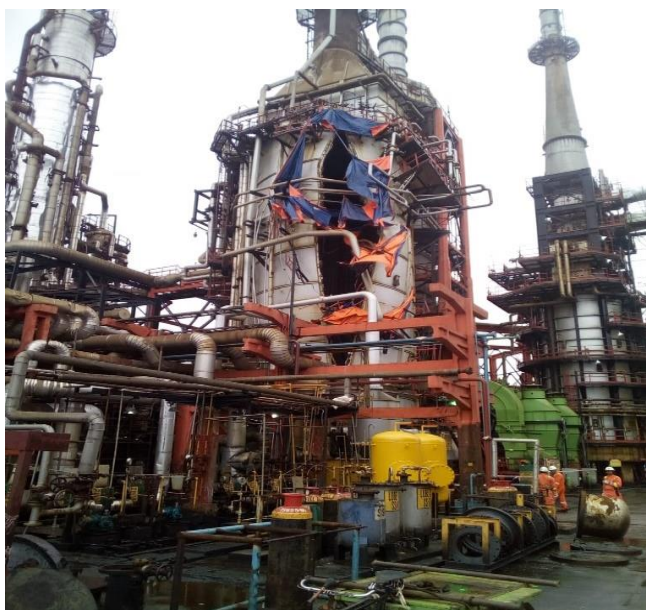
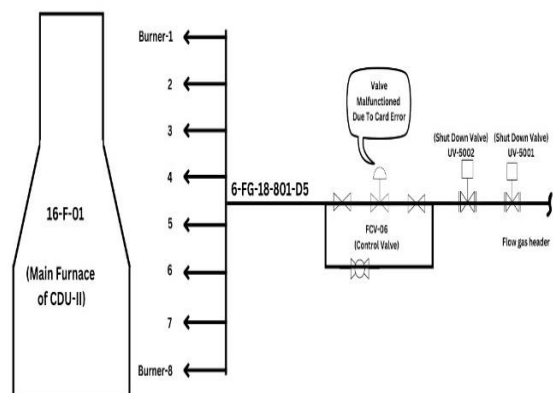
The panel operator re-opened the fuel gas control valve manually from Distributed Control System (DCS) panel. Around 3 minutes later, explosion occurred in the furnace with momentary fire. Consequently, the shell of the furnace burst open.

- The furnace shell had split from around 1 m about the burner floor to the furnace arch level. Furnace tubes were also uprooted from hangers. Some piping, electrical cables & trays, instrument & cables and insulation lining (blanket) inside furnace were damaged.

The resetting of the fuel gas supply to furnace control valve analogue control card resulted in closure of the valve. Hence, the flame of the burners must have extinguished. Subsequently, when the panel operator opened the fuel gas controller manually, without following the procedure of purging the furnace before relighting it, the un-combusted gas got ignited on coming in contact with the already hot tubes and detonated.

- In case of flame failure/ failure of Fuel Gas/ Fuel Oil, furnace light up procedure i.e., box purging, pilot burner light up, main burner light up etc. shall be followed in line with Cl. 11.3 of OISD-STD-111.

- Installation of Burner Management system (BMS) in furnaces should be reviewed.
- Organization should reinforce the system of reporting of unsafe act emphasising acts of procedural bypasses, not following SOP, etc. followed by appropriate rectification measure and dissemination of learnings in endeavour to enhance the safety culture in line with OISD-GDN-206 cl no 5.1.4.

- Position of stack damper, while in operation shall be distinctly visible from ground as per clause no.5.4 of OISD-STD-111.
- A position based ‘Three-Dimensional Competency Grid’ including basic requirements, technical competencies and behavioral competencies to be developed to have a structured mechanism for tracking competency requirement, availability, interventions required and outcomes. Organization to ensure compliance of Cl. 7.2 of “Report of the Working Group on Safety in Indian Petroleum Sector”. Structured training in functional safety shall be provided to all employees in line with Cl. 6.1.3 of OISD-STD-154.
