CASE STUDY

OISD/CS/2025-26/PL/03

Title: Oil Pipeline leakage Incident in an Offshore Pipeline.

Location: Offshore.

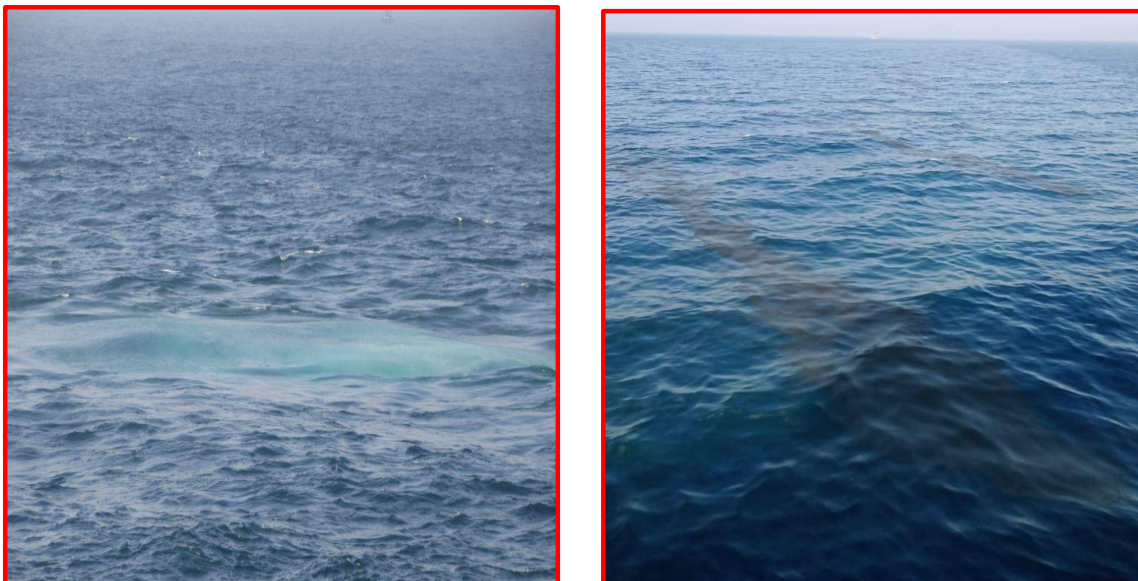
Figure No. 1

During leak survey, one of the vessels located oil slick and bubbles at four locations. Remote operated vehicle (ROV) launched by the vessel located bubbles emanating from the pipeline at one subsea location. The coordinates of leak point were recorded and chainage of this leak location along pipeline from process platforms was found 18.955 KM.
