CASE STUDY

OISD/CS/2025-26/P&E/02

Title: Fire in compressor house.

Location: Off Gas compressor in Gas Processing Plant.

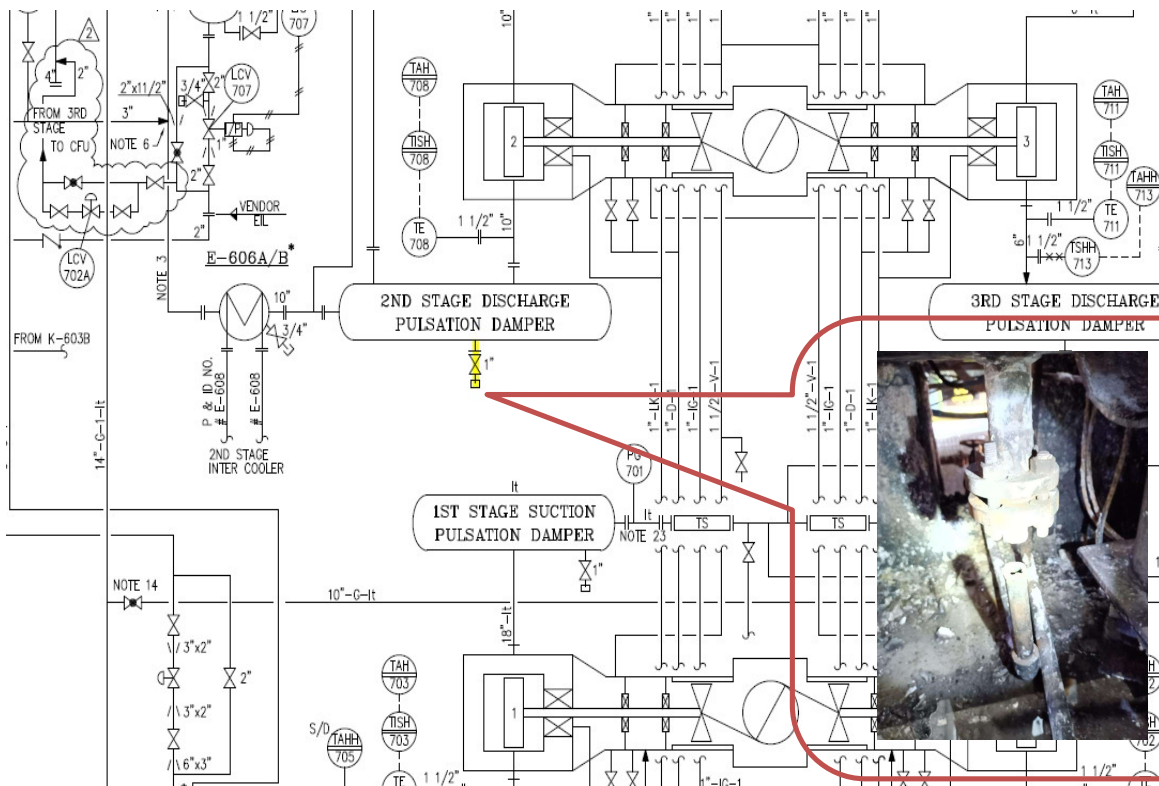
1" drain line from the weld joint connected to the 2nd stage discharge volume bottle of the compressor snapped at the weld joint

- c. In the drain line, no piping support existed for the modified line, unlike the standby compressor, where support for the original 1" line was present.

- k. There was no inspection practise in place for small-bore piping.
- l. Failure analysis report revealed heavy internal corrosion at a butt-welded joint of the high-pressure line. Crevice was observed in butt weld area with thickness locally reduced to 1 mm from 5 mm. Sludge had accumulated near the butt-welded. The Energy Dispersive Spectroscopic (EDS) analysis revealed presence of Sulphur, oxygen and waterborne contaminants on inner surface.

The 1" drain line from the weld joint connected to the 2nd stage discharge volume bottle of the NP-B compressor snapped at the weld joint, weakened by internal corrosion and erosion. The failure was aggravated by mechanical stress due to absence of proper pipe support coupled with high vibration in the equipment.

- a. Pulsation and vibration study shall be conducted for compressors. Based on the findings, necessary design modifications, as required, shall be carried out.

- b. Pipeline supports shall be provided based on detailed load calculations.
- c. The material of construction of piping should be evaluated and revisited based on its exposure to corrosive operating environment.
