## CASE STUDY

OISD/CS/2024-25/E&P/08

Title: Fire in a Battery Room

Location: Offshore wellhead platform.

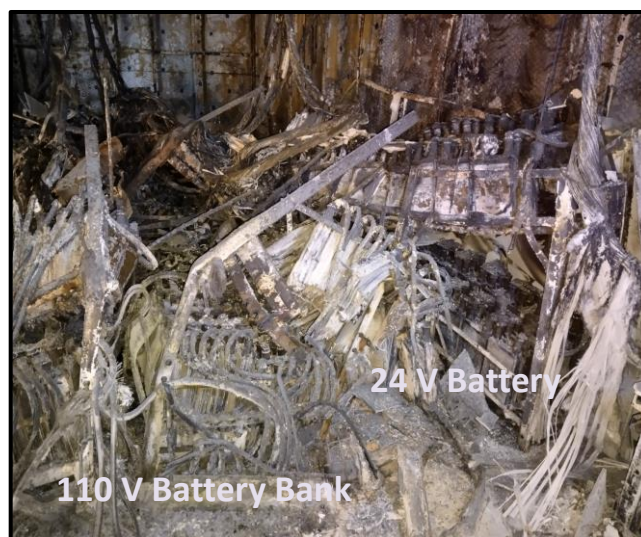
1. The fire incident was due to the continuous overheating and overcharging of the Ni-Cadmium battery banks supplied by OEM which led to a thermal runaway condition within the battery banks.
2. Organization's over-reliance on OEM for resolving battery issues without seeking alternative solutions or taking independent actions led to significant delays in addressing critical battery problems.
3. The absence of continuous battery room monitoring when batteries were heating allowed critical parameters like voltage and temperature to escalate without detection. SCADA system for well-head platforms was not monitored at night, and alarms were in an inhibited state. There was no action for about 11 hours.

Photograph of burned battery room at the well platform post fire incident

1. **Preventing Runaway reaction in Nickel-Cadmium batteries:**
  - a) Battery temperatures should be maintained within optimal ranges as specified by the OEM. [Refer clause 6.2.1.3 of IEEE Std 1635-2012/ASHRAE Guideline 21-2012].

- b) Battery management system (BMS) should be used to control the amount of charge and output of battery systems. BMS are meant to shut down or control the battery before thermal run-away may occur. [Refer to clause 52.3.2 of NFPA-1].

- c) A system to disconnect batteries in case of ventilation failure should be ensured. [Refer to clause 10.3.4.3.7.2 of API 7F-2018]
2. **Competency building:**

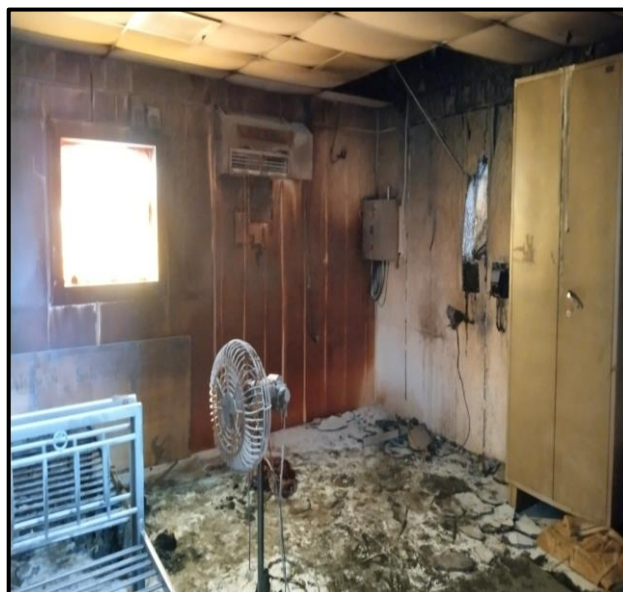
A fire broke out in the battery room of an offshore wellhead platform of an organization. Smoke was noticed by crew members on a nearby manned platform almost 10 hours after the fire had started. The power supply to the wellhead platform from the FPSO, where well fluids from wells of the platform were processed and which supplied power to the well platform, was cut off and all the wells of the wellhead platform were closed. The fire, triggered by a thermal runaway reaction in the Nickel-Cadmium (Ni-Cad) batteries, resulted in the burning out of 352 batteries. It also caused significant fire damage to the electrical infrastructure and inflicted heat-related damage to the adjacent shelter room.

Photograph of shelter room at the well platform post fire incident
