CASE STUDY

OISD/CS/2024-25/P&E/04

Title: Fatal accident by hook-loaded FARANA crane.

Location: Battery area of a Refinery.

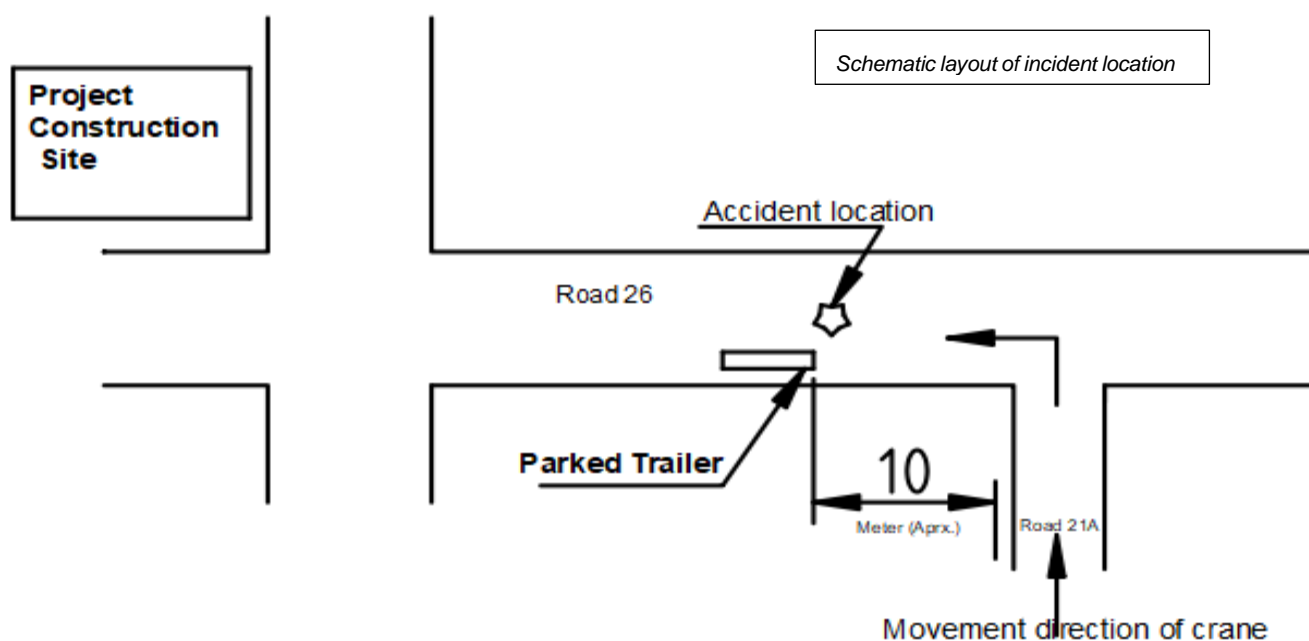
Construction of a new process unit was going on in a vacant plot in a refinery. Due to space constraint, construction material (pipe spool, structure module/ members, etc.) were kept beside a road around 200m away from the construction site. The incident occurred when a Farana crane was transporting members (C-sections of around 300kg and length of 2m max.) from the storage location to the construction site. The material was being transported hook-loaded through the battery area road. A flagman and only one rigger were assisting the crane operator in the transportation.

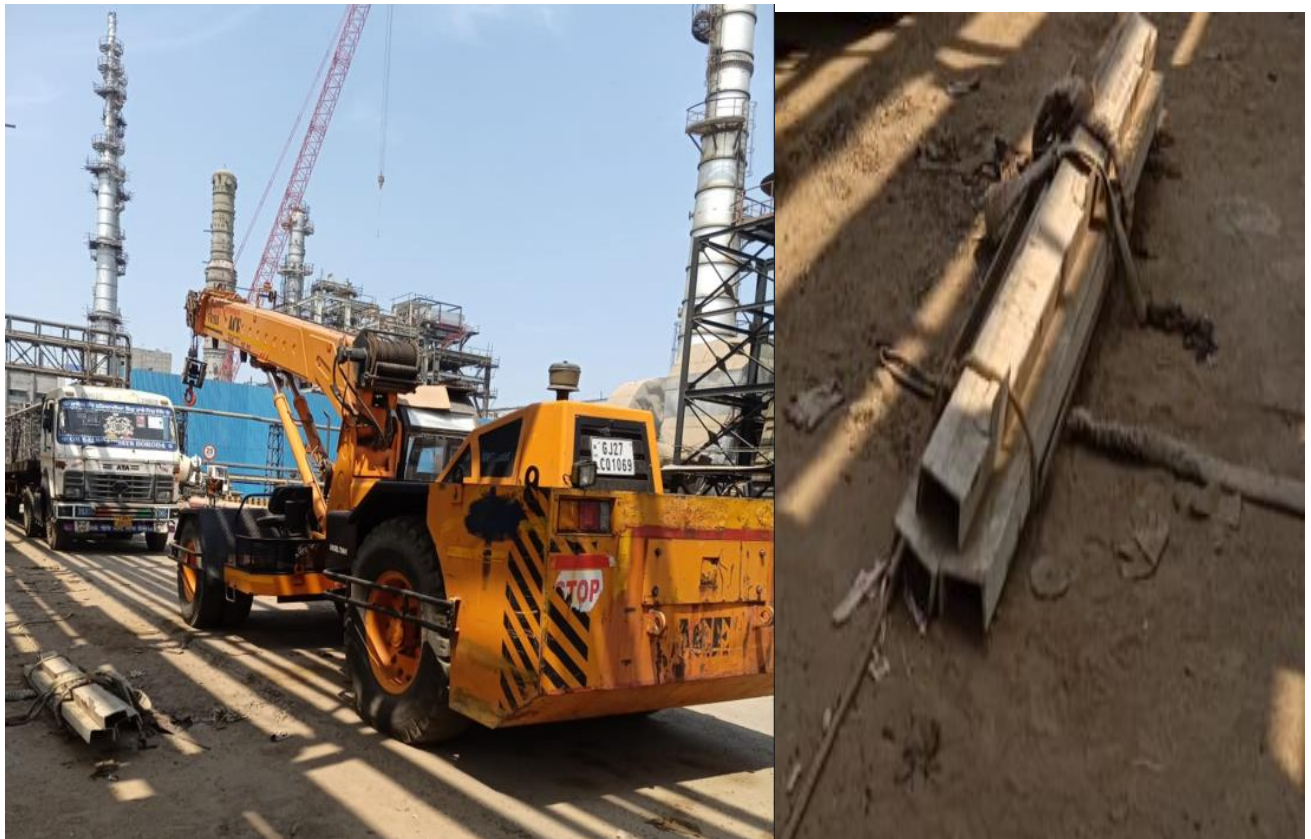
At a road junction, the rigger was hit by the Farana crane. The flagman, who was marching forwards, guiding the crane operator, shouted for help. The people working in nearby area rushed to the incident site. The fire station was also informed, and ambulance reached the site. The rigger, hereinafter called as Injured Person (IP), was shifted to refinery hospital by ambulance at 13:20hrs. After IV infusion and wound dressing, IP could not survive due to profuse bleeding.

- The incident site was around 10 m from the junction of 2 roads. A truck-trailer was parked on the left side of the road at the incident site. The Farana had turned left and then must have swerved slightly right due to parked truck-trailer.

- Vehicles/ trailers shall be parked in designated locations to prevent obstruction of other vehicle movement/ emergency vehicle movement.
- Crane (inclusive of Farana/ Hydra) should not be used for transportation of hook loaded materials in line with Cl. 5.1.9 of OISD-GDN-192.
