## CASE STUDY

OISD/CS/2025-26/MOPOL/01

Title : **HSD overflow from underground tank**  
Location: **POL Depot**  
Loss/ Outcome: **The overflown HSD reached the internal stormwater drain and the municipal drain outside the depot premises.**

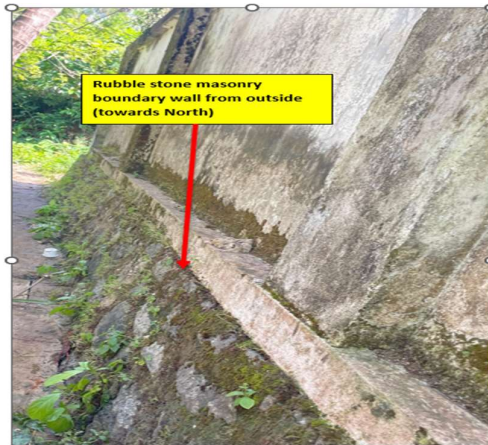
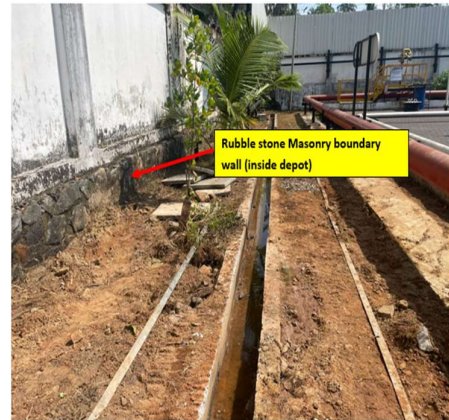
- I. The kerb wall of the UG tank farm had three holes towards storm water drain. It was observed that the overflowed product seeped out of the kerb wall thru the holes. Location officials didn't notice the same during daily safety inspections and didn't record the same under unsafe conditions.
- II. On the north side, the basement of the boundary wall was constructed with random rubble masonry. The overflowed product would have percolated through the loose sand, crossing the boundary wall via the RR masonry foundation, and reached the outside drain running parallel to the boundary wall. Oil-soaked soil was observed between the kerb wall and the boundary wall.

- The location shall strengthen the inspection and maintenance of the underground tanks (UG) kerb wall area. The kerb walls around UG tanks shall be inspected to ensure there are no holes. Drains shall be provided in the UG tank kerb wall area so that in case of any spillage, the overspilled product is directed to the ETP/OWS.
- Depot shall be provided with boundary wall with gates and sluice gates on drain to meet the objective of tertiary containment in accordance with cl. 6.4.2 (f) of OISD-STD-244). Inspection and maintenance of the drain valves shall be strengthened.

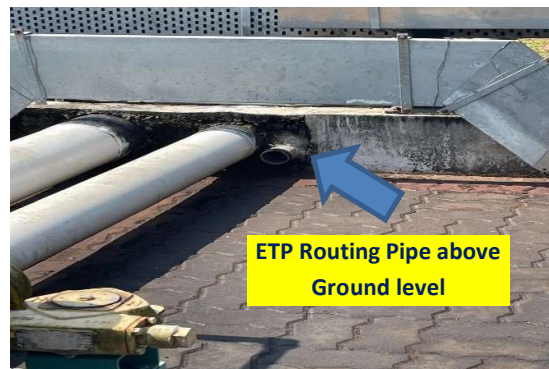
- III. The drain in the UG tank kerb wall area was provided. However, the slope of UG tank farm was towards north side whereas the existing drain was provided at southwest side and was directed towards ETP. The inlet of the drainpipe was approx. 80 mm above the dyke floor. The provided drainage was not effective, and this deviation was not recorded by location during routine inspection and maintenance and during the internal audits.

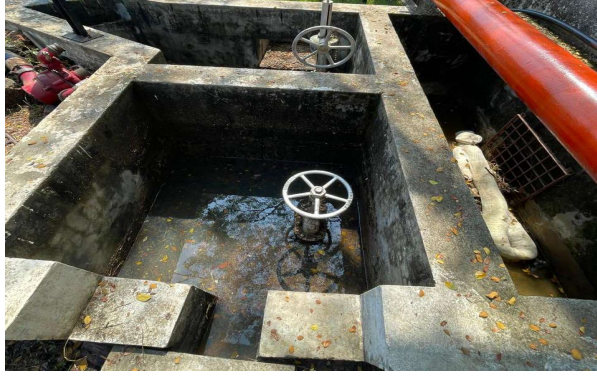
- IV. There was a stormwater drain within the location that leads outside through the tertiary containment valves. A sluice gate was not provided in the stormwater drain at the tertiary containment, only gate valves inside the pit were installed. The storm water drain was connected to the outside drain through these gate valves. During investigation, it was observed that one of the gate valves was leaking even when in the closed position. Non availability of sluice gate on tertiary containment is a violation of cl. 6.4.2 (f) of OISD-STD-244.
