CASE STUDY

OISD/CS/2024-25/P&E/16

Dt.: 31/01/2025

Title: Naphtha Splitter Reboiler Furnace Fire Incident.
Location: Refinery
Loss/ Outcome: Property Damage

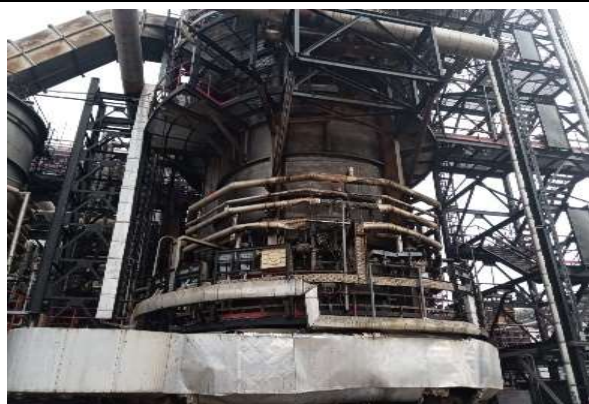
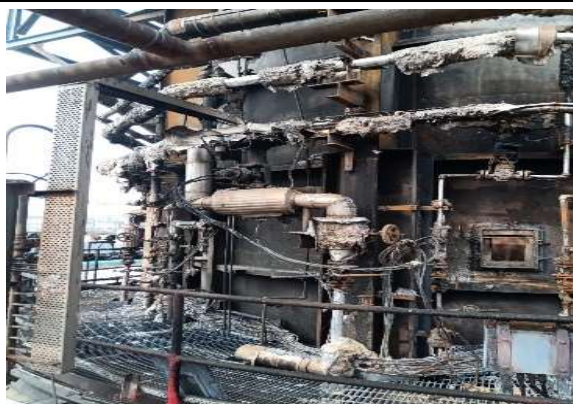
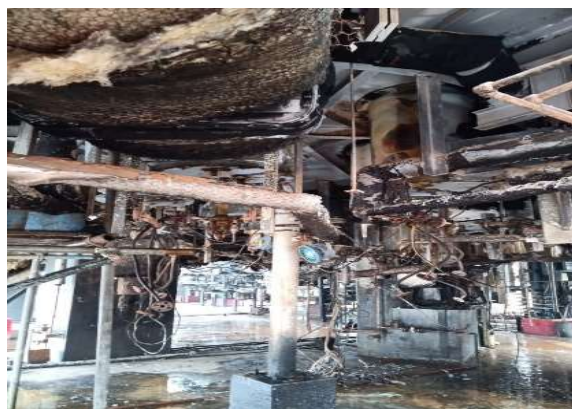
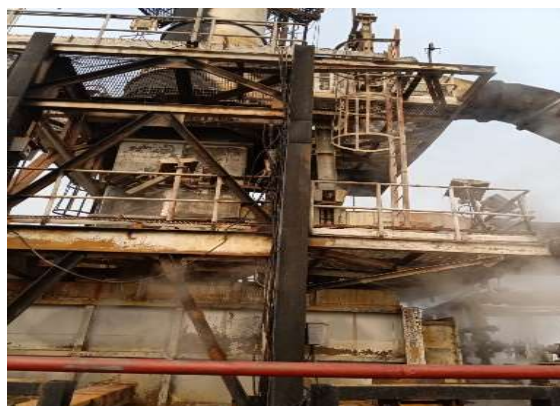
Site Photographs

Fire incident occurred in the furnace of Naphtha Splitter (Part of Isomerization Unit). The Refinery's operating team and fire personnel responded immediately, and the fire was extinguished in about 22 minutes. There were no injuries/casualties due to the incident.

10. Fire was extinguished at 17:39 hrs, after extinguishing the fire, cooling operation was continued till 17:53 hrs.
11. Later Naphtha leakage was noticed from convection section tube. The concerned tube thickness was not checked in year 2021 shutdown.

Fire in the furnace was result of naphtha leakage from the Naphtha Splitter reboiler convection bank tube. Failure of tube in convection section led to leakage of naphtha and resultant fire in reboiler furnace. The naphtha (class-A hydrocarbon) caught fire due to the high temperature (around 720°C in arch) in the furnace. Tube failure can be attributed to high rate of corrosion.

2. Inspection report shall include all the observations in details like thickness reading, observation, thickness measurement techniques/ tool used, measuring equipment details with calibration date, recommendations, exclusions (areas not covered), etc. Studded tubes shall also be inspected in line with OISD-STD-133.

3. The monitoring of critical parameters, feed quality, etc. should be strengthened/ frequency increased for known failure cases.
4. API standard 530 shall be used to calculate remaining life of heater tubes as stipulated in clause no 10.2.4 of OISD-STD-133. Corrosion rate shall be determined separately for each pass and accordingly remaining life shall be calculated.
