## CASE STUDY

OISD/CS/2025-26/E&P/04

Title: Fatal accident during the laying down of Drill Pipe on Catwalk through V-door

Location: Offshore Drilling Rig.

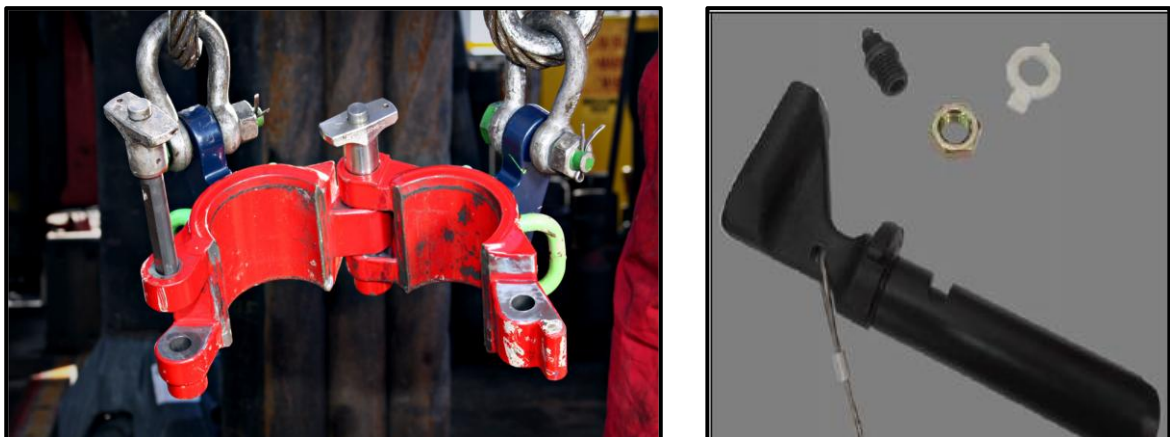
**Picture 1: Safety Lock Pin Remains Fixed to tool body**

- Locking pins designed to remain fixed within the tool's body should be used, eliminating the need for additional retention methods such as chains, thereby enhancing reliability and safety.

- Locking pins with a positive latch mechanism should be used that includes visual confirmation, ensuring that when the activator pin is fully extended, the pins are securely engaged and locked, providing a clear and reliable indicator of proper securing.

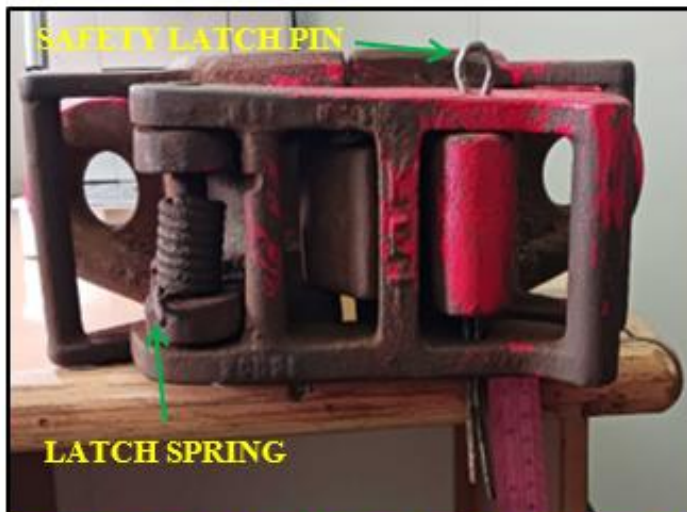
1. The use of the cotter pin in place of the OEM-supplied safety latch pin, which was undersized and loosely fitted, causing it to dislodge from the designated hole due to sudden impact on the V-door incline ramp.

2. The broken latch spring contributed to the unlatching of the elevator.
3. Failure to conduct Category II Inspection, which could have identified the critical deficiencies, such as broken latch spring and an undersized cotter pin in place of the safety latch pin. Inaccurate and incomplete Category III Inspections, where safety latch pin and bore diameter inspections were not documented or done inadequately.

**Picture 2: BROKEN LATCH PIN AND SPRING**

1. Daily Category II inspections must be conducted as per OEM Recommendations /API RP 8B. Inspection parties should be selected with due diligence and reports must be cross verified by competent rig officials to ensure quality and accuracy.
2. Maintenance activities, including lubrication and greasing of critical components, must adhere to OEM manuals. Equipment storage should follow OEM procedures to maintain integrity during non-use.
3. Rig materials must be positioned to avoid obstructing the tugger or driller's line of sight. CCTV coverage should provide a 360-degree view for enhanced situational awareness.

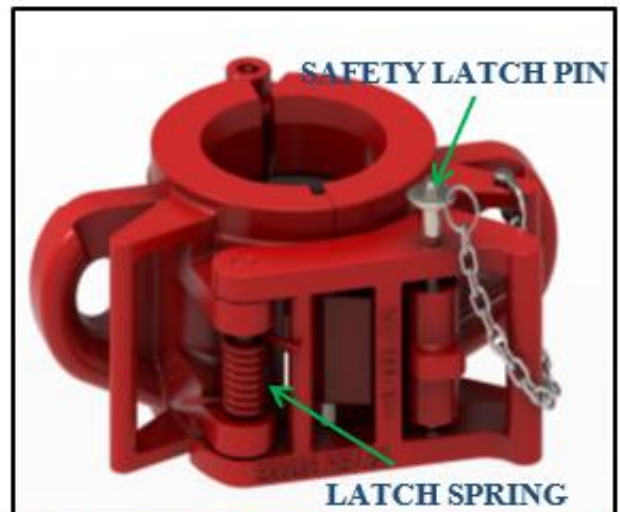
**Picture 3: OEM LATCH PIN AND SPRING**

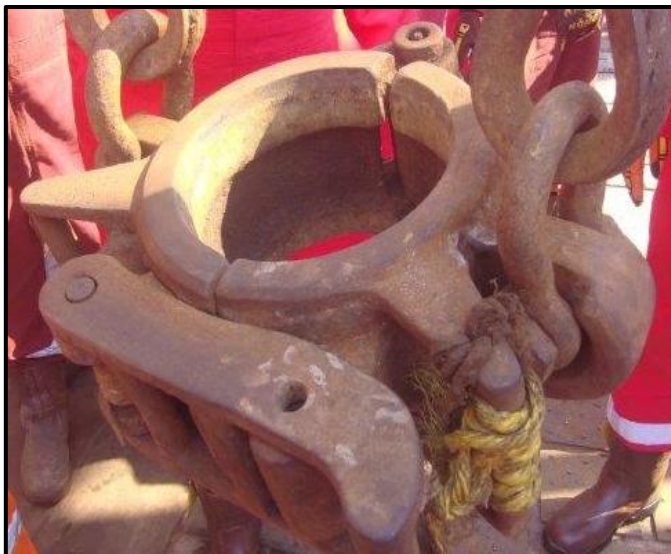
1. There was no evidence that Category II inspection was conducted, which was also recommended by OEM. As a result, critical deficiencies in the elevator went undetected:
  - Replacement of the OEM-supplied safety latch pin with a cotter pin. The latch spring was rusted and broken.
  - Undersized cotter pin (6 mm vs. OEM-recommended 14 mm) used.Though preventive maintenance records were provided, the elevator's condition indicated that OEM maintenance and storage guidelines were not followed.
2. The Category III inspection reports had several critical deficiencies:
  - Failed to document dimensional checks and condition assessment of the safety latch pin.

**Picture 4: USED AT THE OFFSHORE DRILLING RIG**

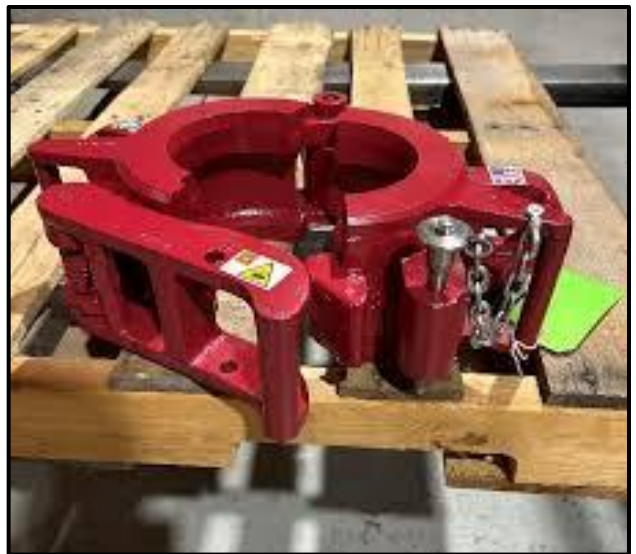
**Picture 5: ORIGINAL ELEVATOR CONDITION**
