CASE STUDY

OISD/CS/2024-25/P&E/13

Title: Fire in Atmospheric Vacuum Unit (AVU).

Location: Process (Crude Distillation Section) unit in refinery.

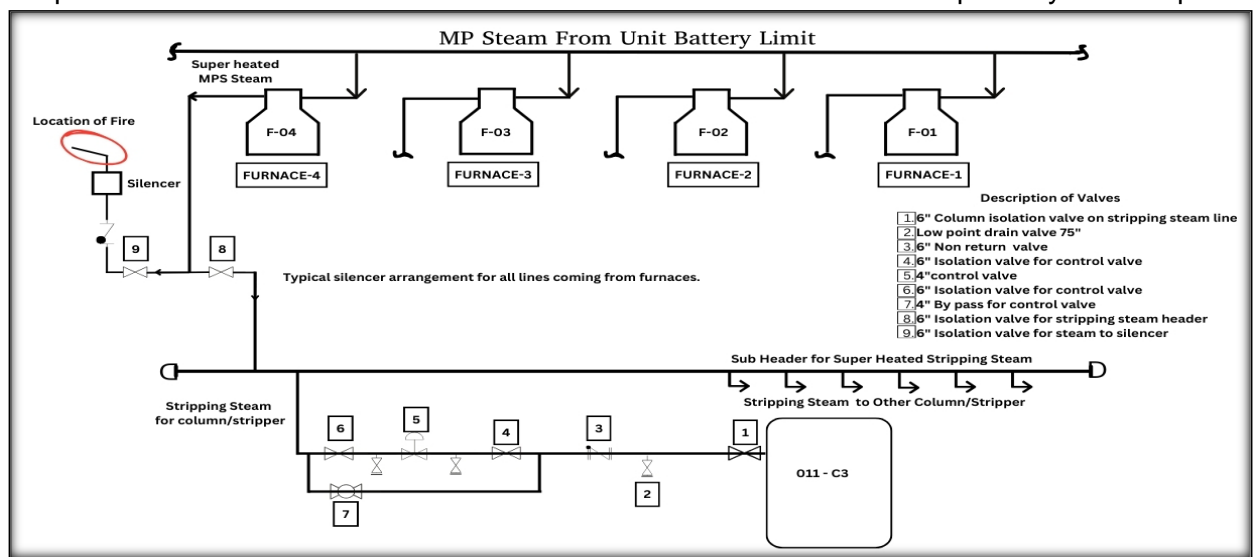
Fig 1: Schematic of MP Stripping Steam to Columns/ Strippers

Accordingly, the field operator was re-routing the steam from vent to the stripping steam header by closing the vent valve (V9- Refer FIG:1) and at the same time opening the main steam header valve (V8- Refer FIG:1), both located on the operating platform at approx.8.5m from grade. Upon diverting super-heated steam to steam header, a flash fire occurred at the vent of the crude furnace. One fire tender was already available in standby at CDU as per unit startup protocol. Fire fighting started immediately. A nearby remote operated "high-volume long-range monitor (HVLRM)" was used. Fire was extinguished within 12 minutes. Nine persons, who were involved in various startup activities in nearby area, sustained burn injuries. They were taken to refinery hospital and then were referred to other speciality hospitals.

1. The pipe length from the valve (V8- Refer FIG:1), from where steam was being diverted to the stripping steam header that led to the stripping columns steam inlet control valves, was around 20M implying a hold up capacity of approximately 1.4 m³. Instead of first preparing the header and heating by means of venting/ draining till the point (V2- Refer FIG:1) nearest to location of process mixing, the diversion was attempted from distant location (V8- Refer FIG:1).

4. Post incident, sample from drain points (V2- Refer FIG:1) of the stripping steam header was collected and sent to QC lab for testing. The reported density of hydrocarbon sample was 731.5 kg/m³ and the sample also contained 10% of free water.

7. After the incident, it was reported that heavy naphtha was observed in drain points of the stripping steam header at multiple locations. Reportedly, the 4" control valve bypass valve (V7- Refer FIG:1), 6" non-return valve (V3- Refer FIG:1), and 6" block valve (V1- Refer FIG:1) in the stripping steam line to heavy naphtha stripper were passing.

8. It was informed that the non-return valves (i.e. V3- Refer FIG:1) in the stripping steam line to the columns had been replaced during the turnaround. The non-return valves had been tested prior to installation.

Naphtha backed up from heavy naphtha stripper (11-C-3) due to passing of isolation valves and NRV in stripping steam circuit (V1, V3, V7- Refer FIG:1), possibly aided by high liquid level in the HN stripper. Hence, the stripping steam line up to the 6" diversion valve (V8- Refer FIG:1) located at silencer platform was already full of Naphtha before the 6" diversion valve for routing steam from vent to the stripping steam header was crack opened. The liquid naphtha, when came in contact with superheated steam (320°C) vaporized and discharged through the steam silencer (V9- Refer FIG:1) as in the downstream side, there was a blocked outlet condition.

- f) Industry shall ensure minimal manpower is deployed in process area during critical activities such as unit startup, shutdown, etc.
- g) Method to check such critical NRVs should be developed. Means should be explored for online checking of such NRVs. Installation of double NRV shall be reviewed in utility/ process interface circuit for enhancing system integrity.
