CASE STUDY

OISD/CS/2024-25/P&E/14

Dt.: 15/1/25

Title: Explosion and major fire in benzene storage tanks.

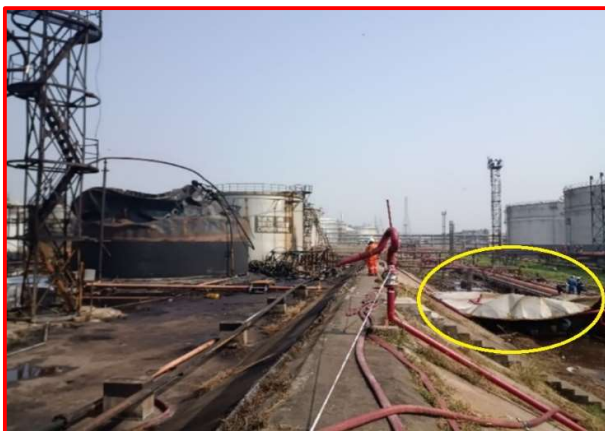
The first explosion was caused by the confined vapor cloud explosion between the floating roof deck and the fixed roof ignited most likely by spark emanating from the dip hatch lid (non-spark proof) or the discharge of static charge of benzene liquid (accumulated during the receipt of material) at the time of sampling activity.

Figure 1: Dome of the first exploded tank, outside the dyke.

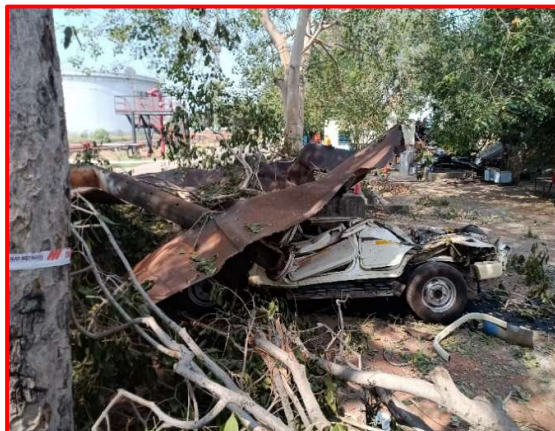
The second explosion occurred due to boiling of material in the second tank, aggravated during the foam application interruption at the incident site.

Figure 2: Dome of the second exploded tank.

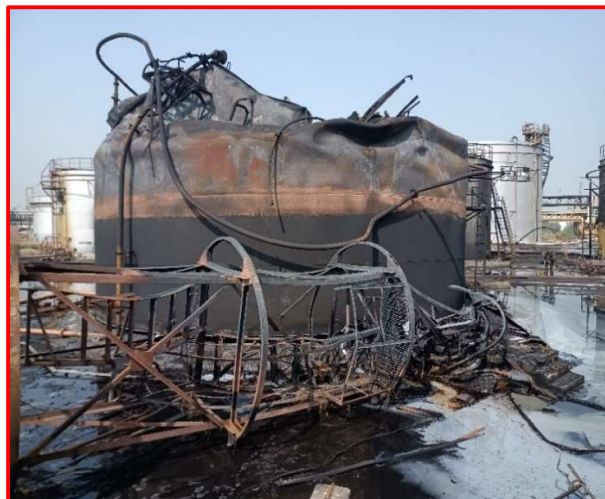
Figure 3: Image of the first exploded tank.

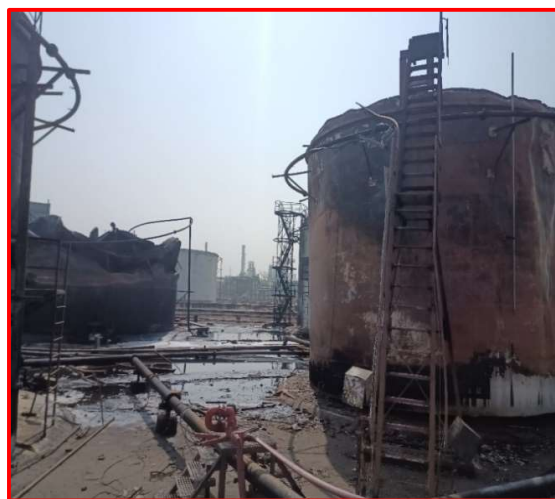
Figure 4: Image of the second exploded tank.
