CASE STUDY

OISD/CS/2024-25/P&E/09

Dated: 23/09/24

Title: Fire incident during maintenance activity.
Location: Refinery
Loss/ Outcome: INR 85 lacs

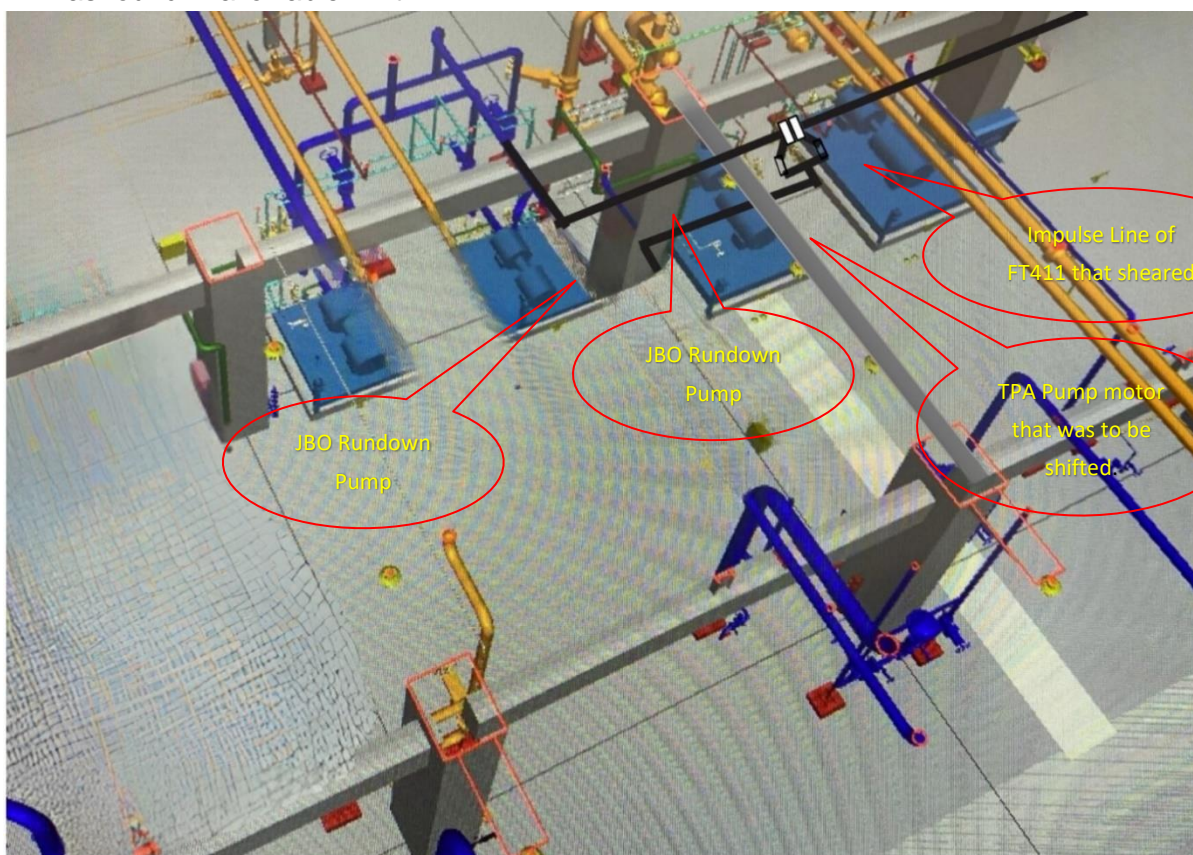
3D Schematic of incident area

1. One of the impulse line HP tapping of flow transmitter of JBO rundown pumps' common discharge line, was found sheared from the orifice flange (upstream of root valve).

2. The flow transmitter connection piping upto root valve was found bent implying being hit and dragged.
3. The impulse line was just above the TPA pump whose motor was attempted to be lifted.

4. The height of the tapping was 3350mm. The forklift mast height was 2250mm. On lifting the forklift, the height can reach upto 3500mm.
5. There was a scaffolding immediately in front of motor of TPA pump that was hindering free movement of both man and vehicle. This was built in two month ago for completing the post turn around insulation jobs in pipe alley.

6. Minimum height at lowest point of the bottom most pipe-rack should be stencilled in units for information to all concerned.

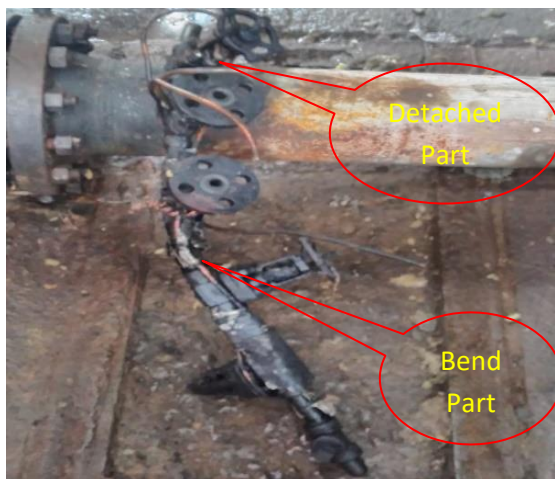
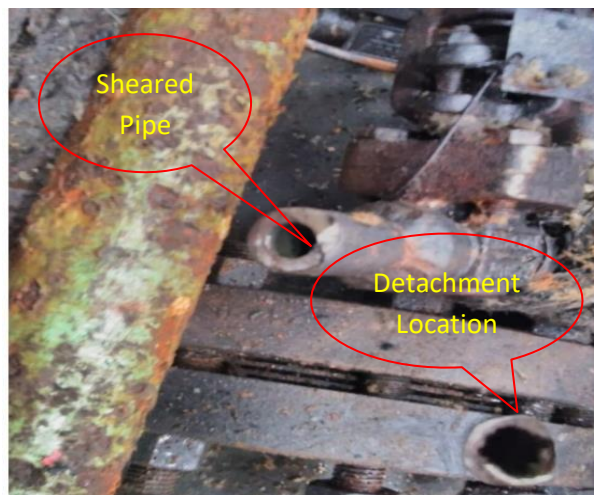
Pictures of damaged equipment taken after the incident

15. No CCTV was installed in the unit.
16. Major damage occurred to electrical/instrument cables, cable tray, light fittings, pipes, flanges, etc. All the six tiers of pipe rack were found affected by fire. Total 22 lines were affected. Six number utility lines (2" and below) were observed sagged and bowed. No sagging was observed in any structure. Total damage (Static + Electrical + Instrumentation) was evaluated around INR85 lacs as per the detailed submitted by the entity.

Based on the site conditions, statements and incident scene recreation, it was concluded that forklift hit the flow transmitter impulse piping during the backing of the forklift after abandoning the lift operation (without fully lowering the fork) resulting in shearing of the impulse line piping from the root.

The JBO in the pipeline, which was above auto ignition temperature (i.e. 310°C), gushed out and self-ignited, resulting in the fire.

1. Operators of mobile lifting equipment (inclusive of crane/forklift/Farhana) shall have minimum training in line with procedure given in IS13583. A robust mechanism should be developed for competency assessment before deploying the person. As per High Level Committee recommendations (Ref. recommendation 14 of HLC on Baghjan incident)- Competency criteria of key operating personnel shall be explicitly included in tender and to be ensured.

4. Entity shall review the delayed shutdown initiation.
5. Accessibility to the job site and working space should be assessed and ensured before executing/ conducting the job.
