CASE STUDY

OISD/CS/2024-25/P&E/02

Title: Fatal accident during hydrostatic testing of fin-fan cooler.

Location: Refinery

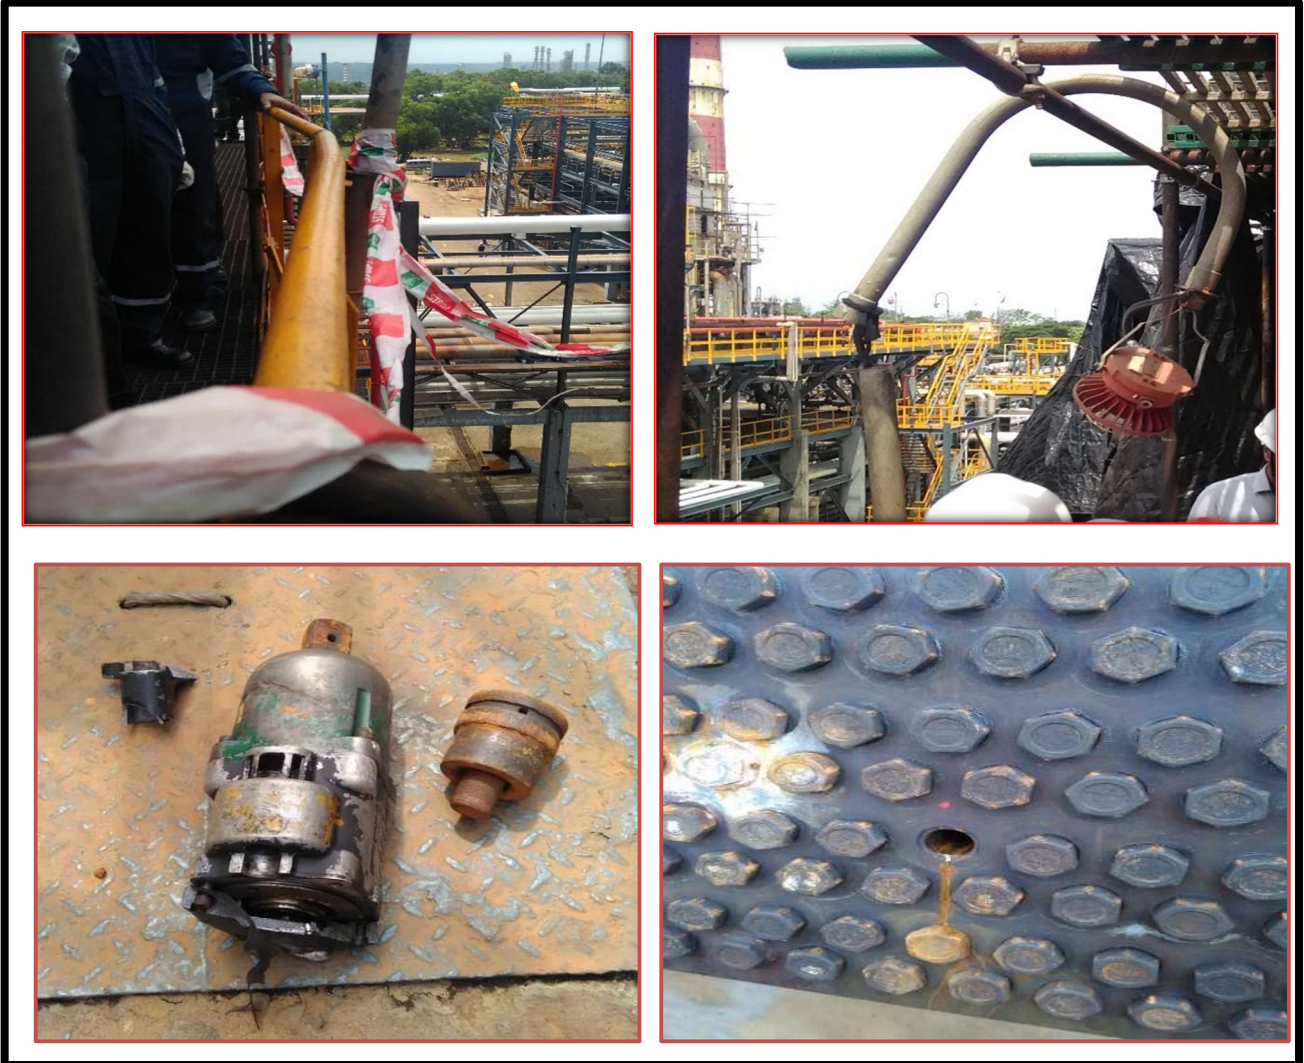
1. At the time of site visit by the investigation team, the following were observed:
 - The plug (bolt) of the cooler tube was found stuck in the chuck of the pneumatic torque wrench and its thread was intact without any perceptible sign of shearing. The broken wrench (which could be used for both ways, i.e. tightening as well as loosening based on a provided switch) was found at the grade level a few meters away from IP. The pneumatic hose of the torque wrench was still hanging on the air fin cooler platform.

- The tube threads, whose bolt was stuck in the chuck of the wrench, were found intact, and no sign of shearing was evident implying that it had been opened.

- Hand railing at the south side of the fin-fan cooler was bent implying that the railing was hit by an object (probably by pneumatic torque wrench) with force.

- The lighting post facing the fin-fan cooler was distorted, detached and leaning over. The post was probably hit by the IP.
 - Pipeline near the feed filter area at grade level, where the IP fell, were damaged at several places.

Pictures of damaged structures/ equipment taken after the incident

From the fact that the plug was stuck inside the chuck of torque wrench machine, it is conceived that IP attempted to tighten the plug to arrest the sweating (leak) and might have accidentally loosened it (The thread of the plug and the tube were intact and there was no sign of shearing) while the equipment was still in pressurised condition for hydrotesting.

1. No repair activity shall be carried out while the equipment is pressurised for hydrotest. During hydrotest activity, area around the equipment subject to testing shall be barricaded and unauthorised entry shall be restricted.
