## CASE STUDY

OISD/CS/2024-25/P&E/11

Title: Fatal accident at maintenance fabrication yard during cleaning & stacking of tubes.

Location: Refinery

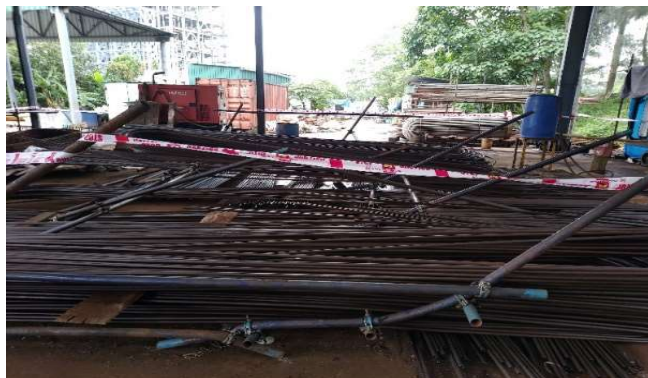
1. The temporary structure that collapsed had various flaws like

- Base plates, mandated to support all vertical metallic pipes, were not used.
- Bracings, essential for providing longitudinal stability, were absent.

Any guideline for ascertaining the structural strength (load bearing capacity) of the temporary structure was not evident, neither any assessment was done. Further, evaluation of the structural stability was also not carried out.

On calculation, it is arrived that at the time of the collapse, the temporary structure was bearing a load of about 3,300 kg of U-tubes. In absence of guidelines for the temporary structure made of scaffold material, and hence, considering the scaffolding standards outlined in OISD-GDN-192, the load on the structure would have warranted a construction similar to a medium-duty scaffolding. According to these safety standards, medium-duty scaffolding requires a maximum bay length (the distance between two vertical supports) of 1.8 meters. However, the actual distance exceeded this prescribed limit, which contributed to the instability and subsequent failure of the structure.

The above observations implied that the temporary structure was not constructed with the necessary strength to bear and transmit the imposed loads to the ground. It was neither adequately secured nor stiffened in both longitudinal and transverse directions, as required by safety standards.

Collapsed structure without base plate, braces, safety signage

The root cause of the incident was usage of an inadequately constructed structure and the failure of system to prevent/ check the same.

1. Guideline for temporary structures and its usage should be developed. The usage of the temporary structure should be restricted to the load for which it is designed. The authorization and certification processes shall be ensured for all temporary structures.

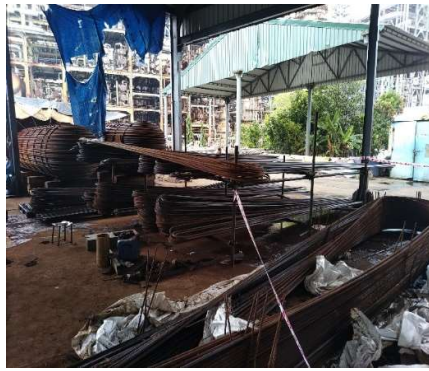
Stacking of U-Tube bundle beside the collapsed structure

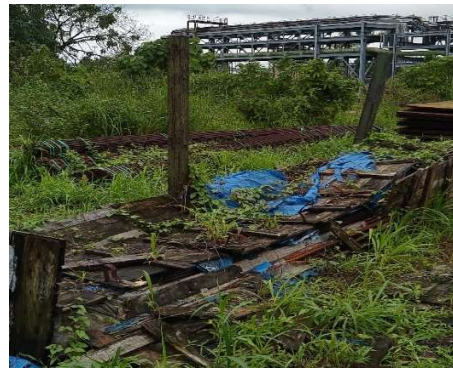
4. During the investigation, the storage location of the procured exchanger tubes was found to be an open yard without any protective shed. Upon evaluating the condition of the U-tubes, it was evident that no oil preservative coating or black bituminous paint had been applied to the tubes, indicating non-compliance with proper preservation measures.

Yard where the procured tubes were stored

4. Proper preservation process of spares should be ensured in line with clause no 4.3.2 OISD-STD-171.
5. Robust emergency communication systems, including intercoms, PA systems, intrinsically proof mobile phone and accessible emergency contact numbers, should be established and maintained. All workers should be trained on their use and understand any necessary procedures inclusive of emergency communication procedures, including any prefix codes required for dialling emergency numbers. Configuring emergency numbers in all the handsets being provided to contract personnel should be ensured.
