CASE STUDY

OISD/CS/2024-25/E&P/17

Dt.: 11.03.2025

Title: Fatal Fire incident in Heater Treater

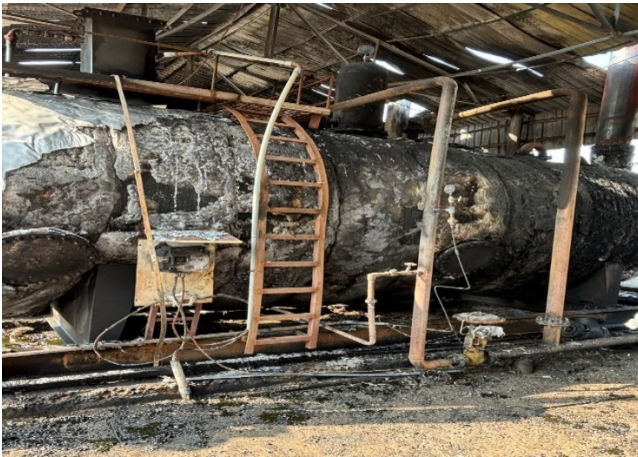
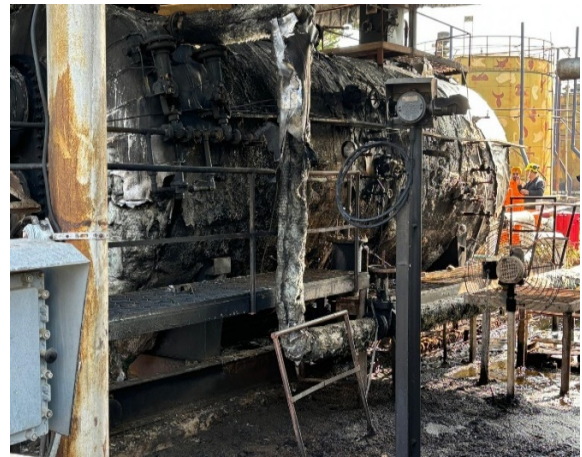
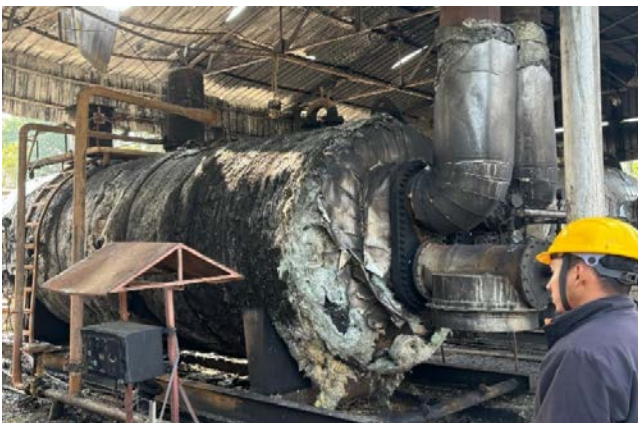
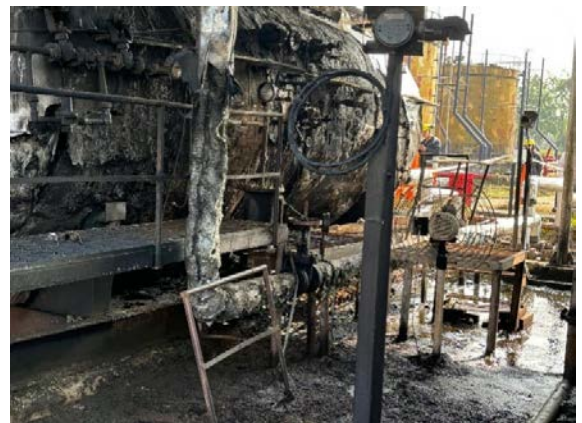
PHOTOGRAPHS OF INCIDENT

On January 7, 2025, HT(Heater Treater)-3 was shut down for PSV calibration job. Later, HT-3 start up was initiated prior to completion of PSV (Pressure Safety Valve) installation, while PSV team was preparing for PSV installation. Around 15:20 hrs, crude oil began overflowing from the open flange of the PSV of HT-3.

The fire was noticed shortly after the above incident in HT-3 area. One person got engulfed in the fire and rushed to medical college but declared dead.
