## CASE STUDY

OISD/CS/2024-25/MOPOL/06

Title : **Explosion of the Ethanol Above Ground Horizontal Tanks – 2 nos.**

Location: **POL TERMINAL**

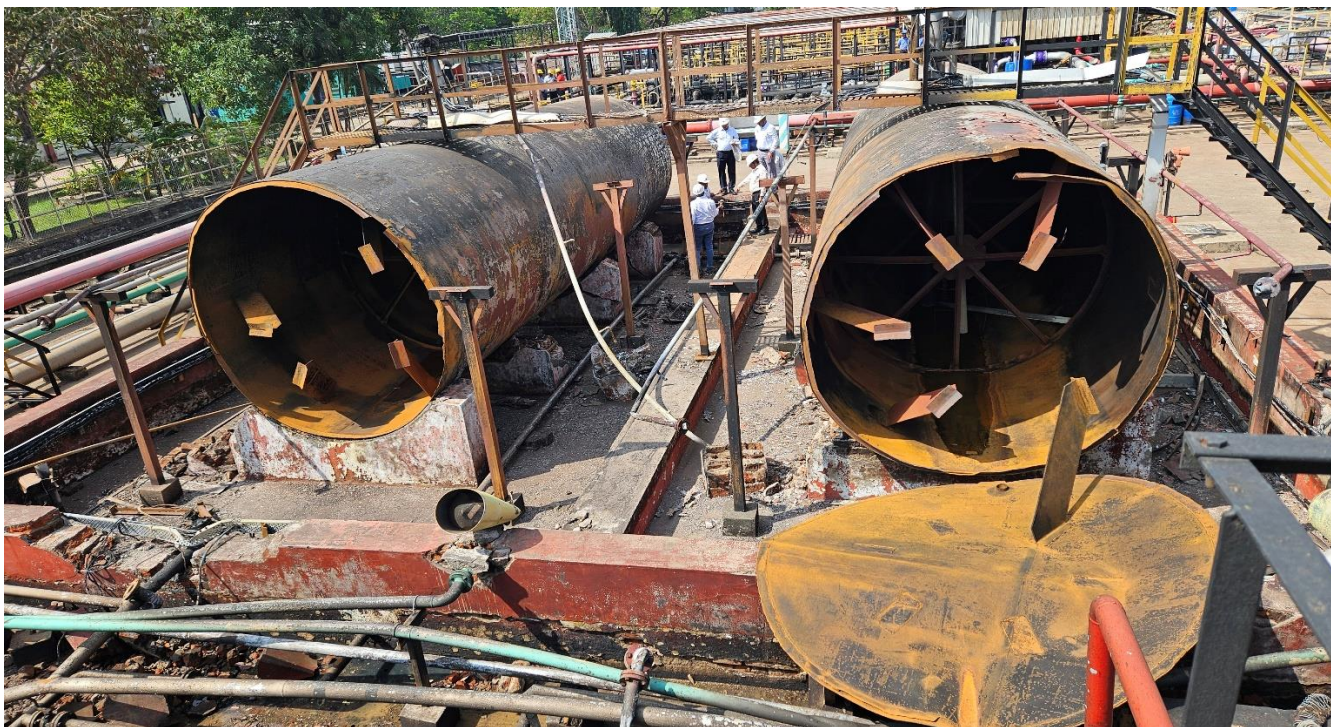
Both the Ethanol tanks after the explosion & fire. Both the end dish of left side tank flew away. Inlet dish of right side tank ruptured and fell on the dyke wall.

- b) Since there was a dead stock of approx. 1.4 KL in this tank and it was full of rich vapors, the flame caused explosion of the same. Intensity of the explosion was such that both dish ends of this tank were blown away approx. 24 & 30m respectively. Residue product of tank spilled in the dyke, resulting into pool fire there.
- c) Explosion in the first tank and fire in the dyke area might have caused heating up of adjacent tank, resulting in rise of its internal pressure and consequently its explosion & rupture. Inlet side dish of this tank fell inside the dyke area due to its rupture.

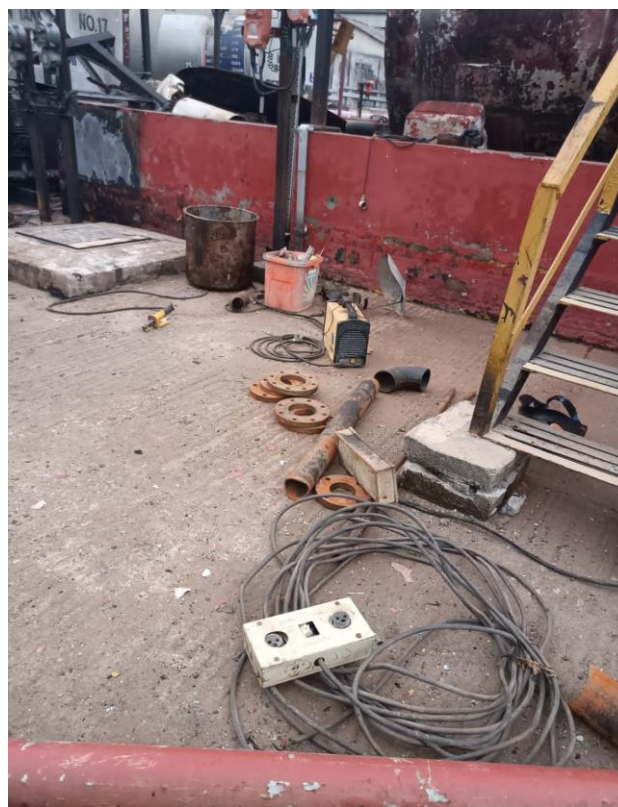
Various material viz. Buket, Grinding Machine, Welding Rectifier, Elbows, Pipe section, Electrical JB, Cables etc. at Worksite.
