CASE STUDY

OISD/CS/2024-25/P&E/08

Title: Fatal accident due to fall from height.

Location: Construction Site at Refinery Expansion Project.

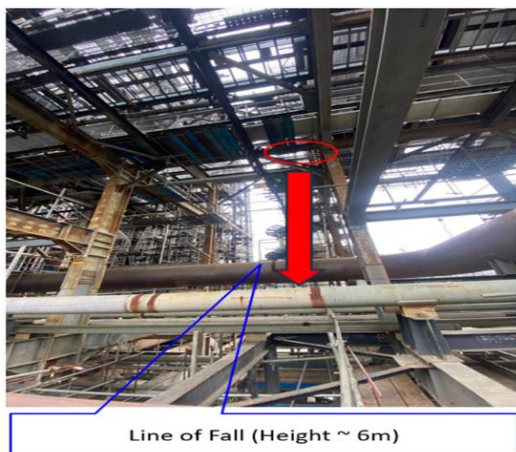
A contract worker (hereinafter called Injured Person (IP)), employed by a subcontractor of a Lump Sum Turnkey (LSTK) contractor suffered a fatal injury after falling from 23 m to 17 m level of an under-construction pipe rack (fig 1). He was engaged in paint marking of tightened bolts of the beam of the structure of the Main Pipe Rack.

4. It was evident that for the bolt torquing of the beam at incident location, no scaffolding platform had been provided for torquing and painting of the bolts on the lower side of the beam. Workers had carried out torque bolting by sitting over the beam and working bending downwards. IP had also stepped on the beam to carry out the paint-marking job. This digress possibility had not been considered in the JSA.

Fig-1 Fall of height

The root-cause of the incident was the unsafe act by IP of not anchoring the double lanyard. Further, a mechanism to prevent the unsafe act/condition (inadequate scaffold working platform and not anchoring the double lanyard while working at height) was also missing.

4. Scaffoldings with adequate platforms, handrails and all stipulated appurtenances should be available at work locations at height in line with OISD-GDN-192.
5. The provision of adequate communication means like walkie-talkies should be reviewed at the project site.
6. Alternative rescue arrangements should be developed and implemented for inaccessible areas where cranes with baskets cannot approach. The Provision for evacuating Injured person from elevations using devices like Rope Access Device and Lift Rescue along with suitable stretchers from elevations shall be reviewed.

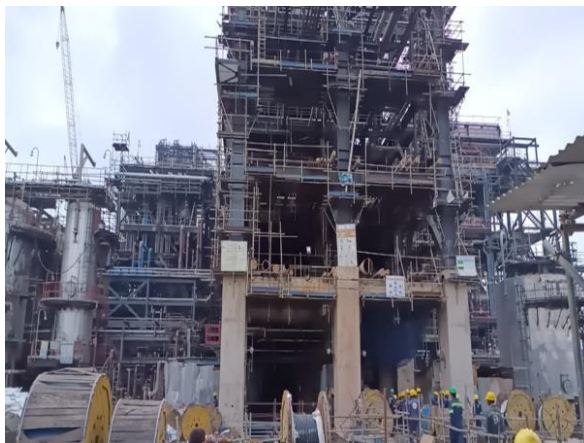
1. Structural work was under progress in a section of the Main Pipe Rack (fig 2), including torquing, bolting, and yellow paint marking of tightened bolts. Blanket Work Permits had been issued by the company. On the day of the incident, IP was assigned to carry out paint marking of tightened bolts.

Fig-2 Main Pipe rack
