CASE STUDY

OISD/CS/2024-25/E&P/03

Title: Fatal Accident at Wellsite

Location: Onshore- Wellsite

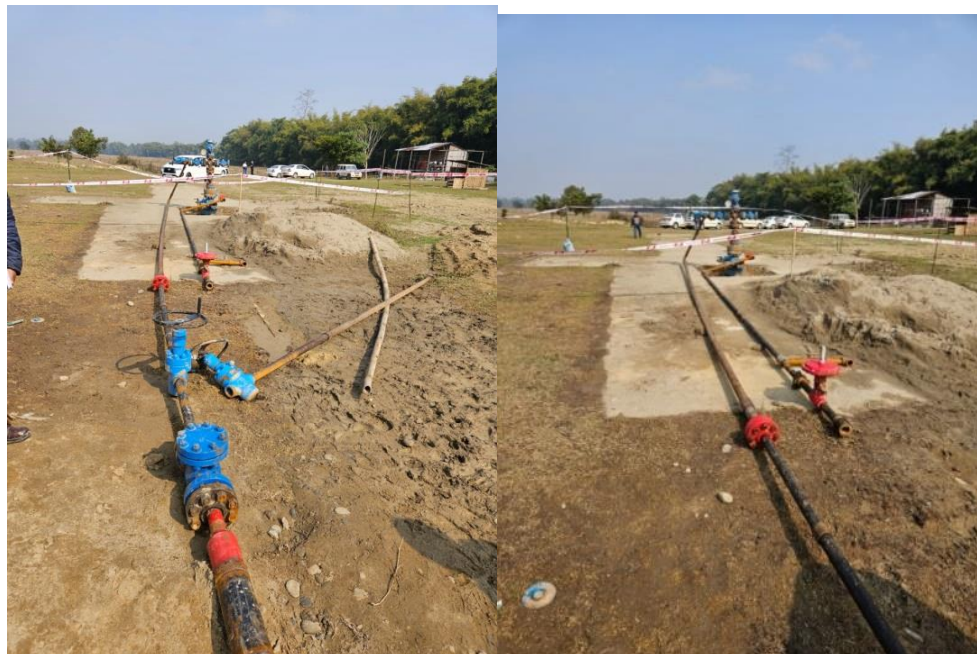
The incident occurred during bleeding of hydrotest water and gas through 2" bleed line. While opening the 2" valve fitted in the part of the artery line connection, the valve along-with bleed line got dislodged from the changeover nipple and resultant gush of water and gas hit the sand heap nearby. The sandstorm engulfed the entire wellhead area, and the crew was injured by the fast-moving sand particles.

Pic 1: Accident site overview

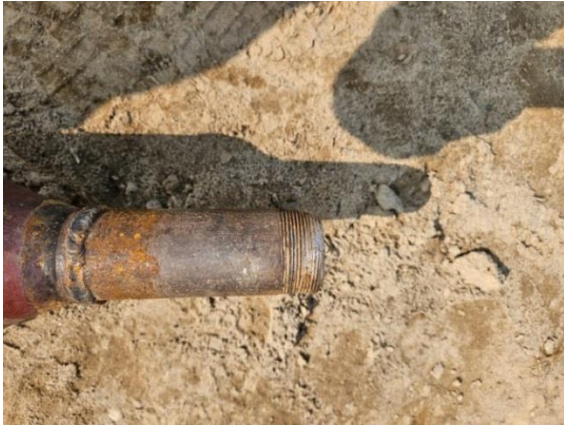
- e. Absence of SOP for dewatering gas lines post hydrotest.
- f. Unsecured valve on threaded connection
- g. The presence of sand heap in the line of water / gas and too close to the X mas tree.

Pic 2: Location of Sand

heap

- ii. SOP for Anchoring and support during line connection.
 - iii. SOP for dewatering after Hydrotesting.
3. The Job Safety Analysis shall include identification of unwanted material at site, their analysis for hazards and remedial actions.

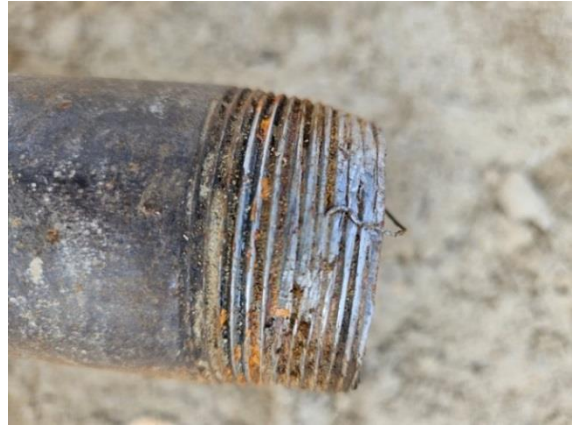
The unfortunate incident at well site NHK#162 was avoidable incident. It is seen from the observations and probable reasons that accident occurred due to failure of multiple barriers simultaneously. Some of them are unsecured lines and valves. Non-standard threaded connections on the high-pressure gas line. The presence of sand heap at the site added to the increased severity of the injury.

Pic 3: Damaged threads on pipe.

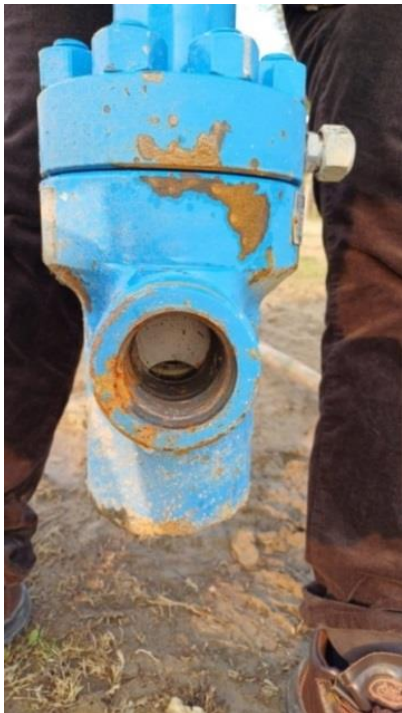
1. The detailed plan for the entire job was not prepared / available.
2. The SOP for construction of flowlines was not adequate.
3. No procedure exists for dewatering of gas pipelines after pressure testing.
4. No Anchoring or support was provided to the bleed line. Also, no specific guidelines exist for anchoring and support of the 2-inch portion of the artery line to the well head casing and flow lines.
5. The source of sand heap could not be established. The presence of sand at well plinth was major reason of injuries to the personnel.
6. The sand heap was not removed before starting the bleeding operation. The crewmember did not move to a safe area.
7. The valve fitted by threaded connection on the artery line was not properly secured.

Pic 4: Valve opening

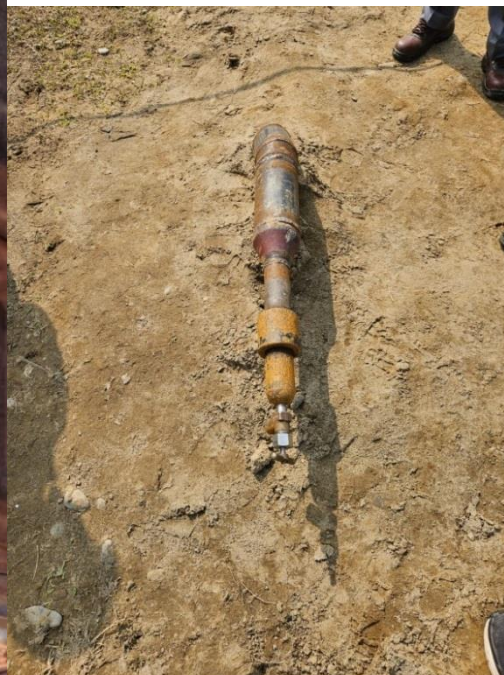
- a. Non availability of plan for the jobs at well site by Multi-disciplinary team (MDT).
- b. Unsupported and non-anchored spool used for bleeding the pressure which was not part of SOP.

Pic 5: Protected spool
