## CASE STUDY

OISD/CS/2024-25/PL/07

Title: Fatal incident in Pipeline ROW during excavation for TLP cable repair.

Location: Pipeline road crossing.

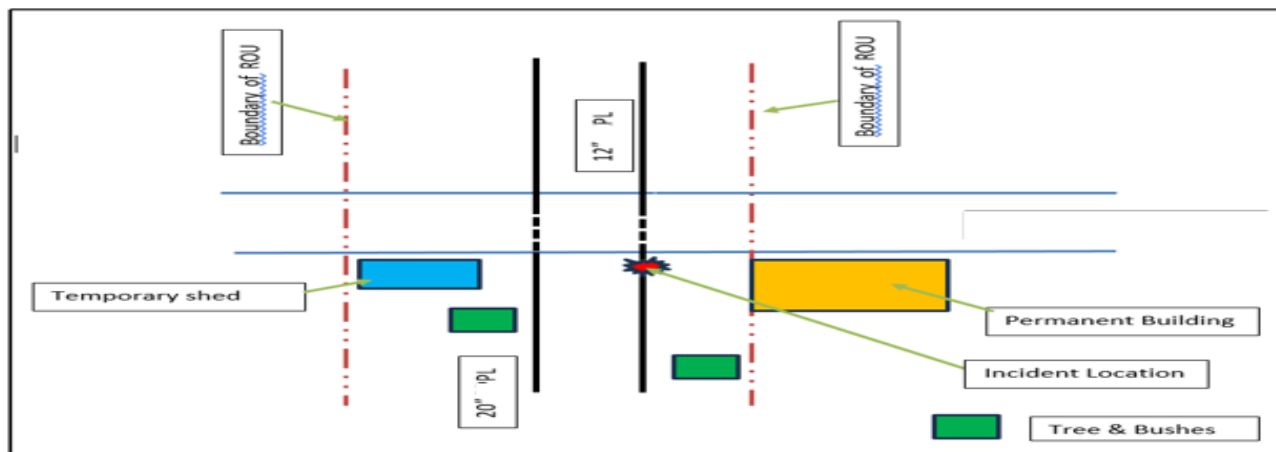
**Figure No. 1**

This repair location of the pipeline was on a state highway & pipeline had crossed the road by cased crossing. Alongside this 12" pipeline, another 20" pipeline was laid at an inter distance of 4 meter. ROW width was 18 meters. On one side of ROW, there was a permanent building (just outside on ROW edge). On other side there was a temporary hutment/ structure (inside ROW). Total ROW width between building & temporary hutment/ structure was 30 feet (9.14 meter). Maximum pipeline depth at road crossing was 3.66 meter as per latest CAT survey report. Deep rooted trees and bushes were also present in the ROW. Schematic of site is shown in Figure No. 1. Photograph of site is shown in Figure No. 2.
