CASE STUDY

OISD/CS/2024-25/E&P/05

Dt.: 28.05.2024

Title: Fall & damage of drilling rig mast.
Location: Onshore drilling rig.
Loss/ Outcome: Financial Loss.

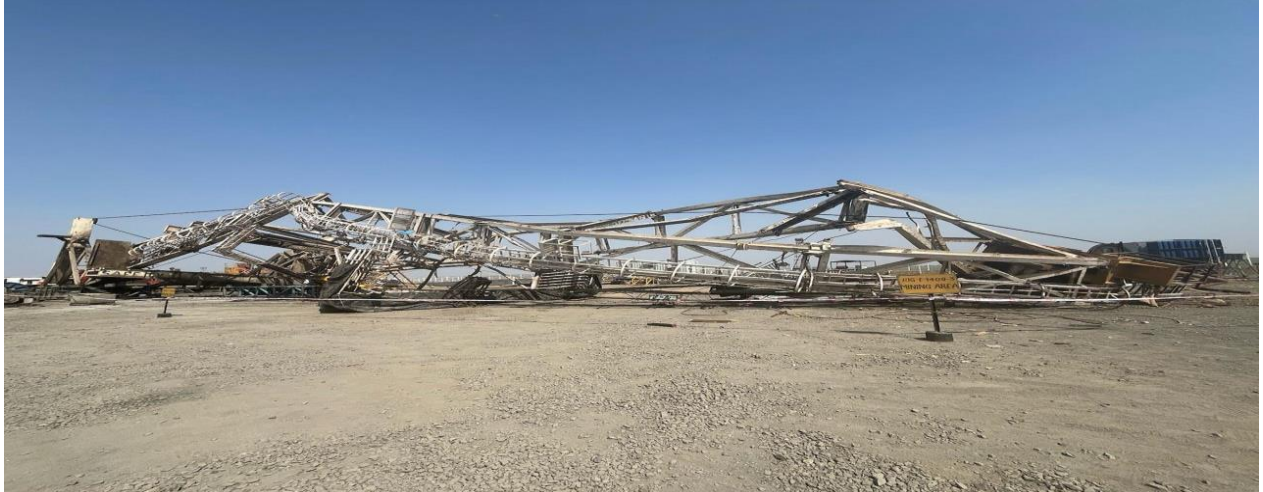
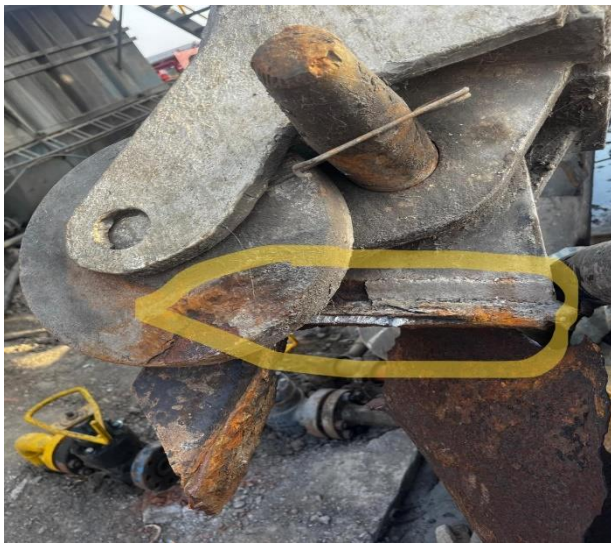
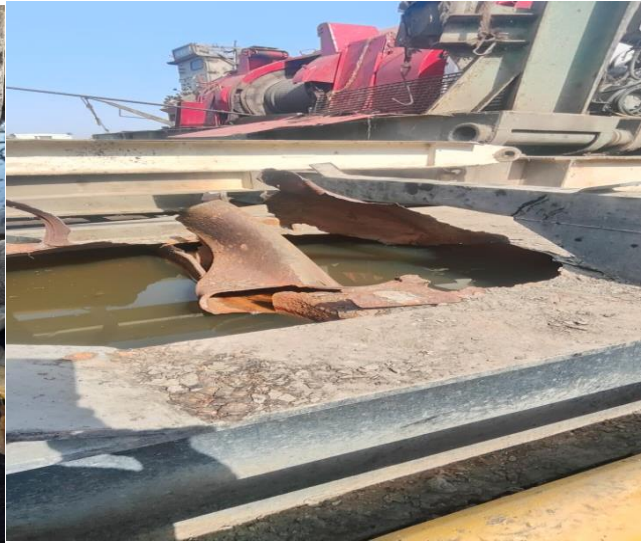
During lowering of the rig mast, Off Driller side (ODS) Junction point of A frame welded on bottom box snapped causing fall and damage of mast.

- Level II inspection was carried out by the crew prior to mast raising. However, the welding joint was not visually inspected as it was below the cover plate of bottom box. During the investigation, it was evident that the joint has developed partially crack prior to the incident.

- During the meeting held with OEM, it was shared that inspection window near the failed joint has been fabricated on other rigs in the asset but there was no such window available at this rig. It was concluded with this fact that visual/ NDT inspection of joint below cover plate of bottom box has not been carried out in the past due to inaccessibility.

- The painting inside the bottom box was not carried out which was evident as the investigating team observed heavy corrosion in the inside visible portion of the bottom box.

- Nonadherence to the OEM's recommendation as per joint inspection with the operator.
- No provision (like inspection window) for inspection of weld joints of Rear A-Frame lugs on Bottom Box.

- OEM should provide an additional openable inspection window for easy inspection of tubular and weld joints of Rear A-Frame lugs on Bottom Box for old rigs in operations.

- SOP for mast raising should be modified with inclusion of procedure of dumping of water from bottom box after mast raise or use of corrosion inhibitor in water. As per OEM recommendation, water should be drained during drilling operations.

- Periodic cleaning and painting of entire Mast, Sub-structure and of inside surfaces of water tank of Bottom Box below Rear-A-Frame should be carried out.
