## PIC24F16KL402 Family Silicon Errata and Data Sheet Clarification

The PIC24F16KL402 family devices that you have received conform functionally to the current Device Data Sheet (DS30001037C), except for the anomalies described in this document.

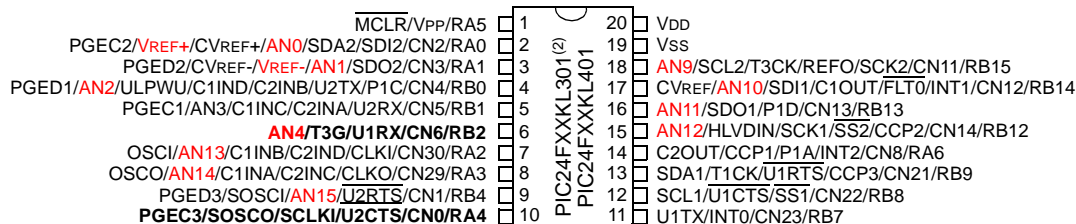
20-Pin PDIP/SSOP/SOIC<sup>(1)</sup>

The Pin Diagram: PIC24FXXKL301/401 20-Pin PDIP/SSOP/SOIC has the functions reversed for Pin 6 and Pin 10. The corrected pin functions are shown in **bold** below.
