Report Details

East Road Drainage project

East Road, Tauranga

CAR-128388489

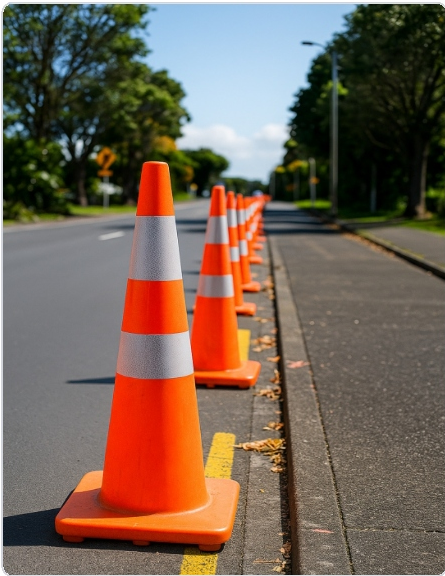
Lighting and Visibility

Good

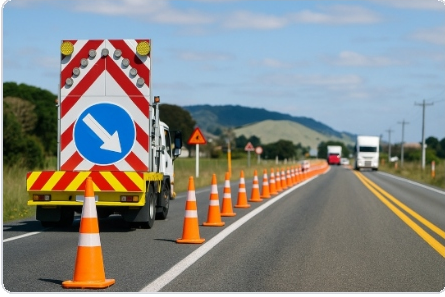
Work Zone Safety

Good

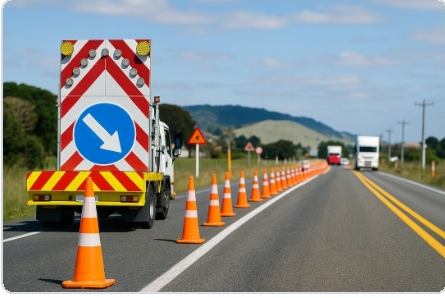
Traffic Flow Management

Good

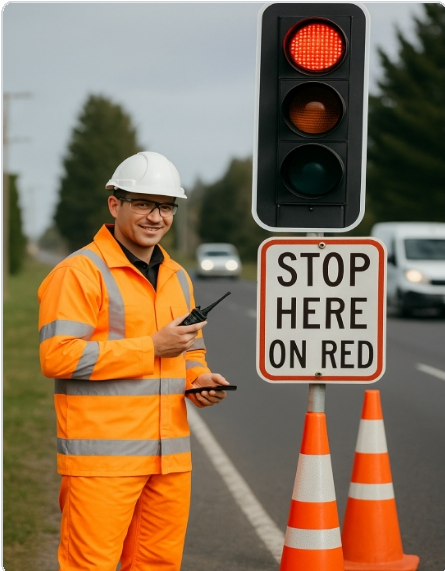
Additional Observations

Portable temporary traffic lights being used.

Good

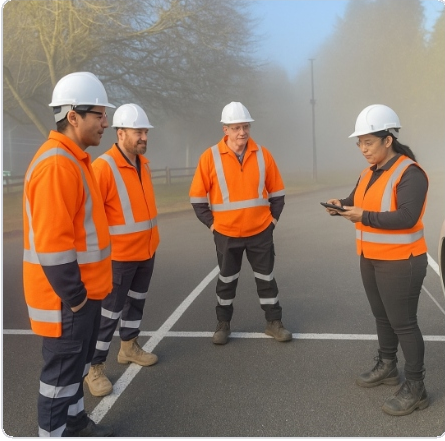
Workforce Compliance

Good

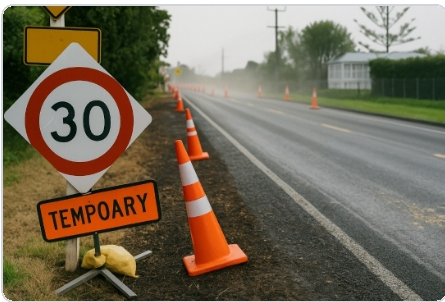
Signage Compliance

Good

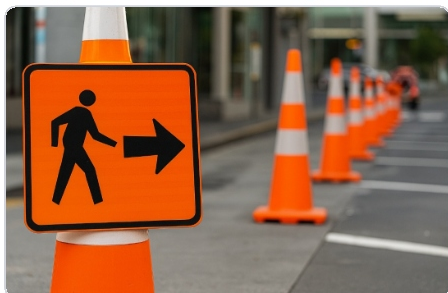
Pedestrian and Cyclist Access

Good

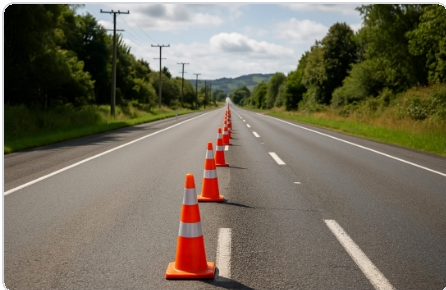
Traffic Management Setup

Good

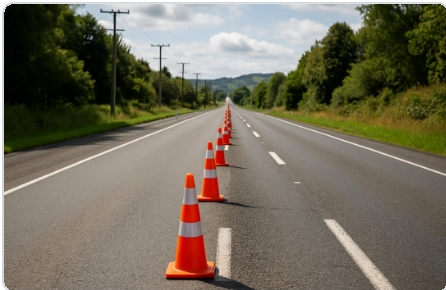
Emergency Access

Good
