Lion Air Flight 610

Abstract- On 29 October 2018, an Airbus of Aircraft type Boeing 737 MAX 8, operated by Lion Air with IATA flight No. JT610 and ICAO flight No. LNI610 registered PK-LQP departed to Depati Amir Airport Pangkal Pinang, Indonesia from Soekarno-Hatt International Airport Jakarta, Indonesia with scheduled passenger of 181 and crew 8 crashed shortly after take-off on the site Java Sea, Indonesia 5°46'15"S 107°07'16"E.

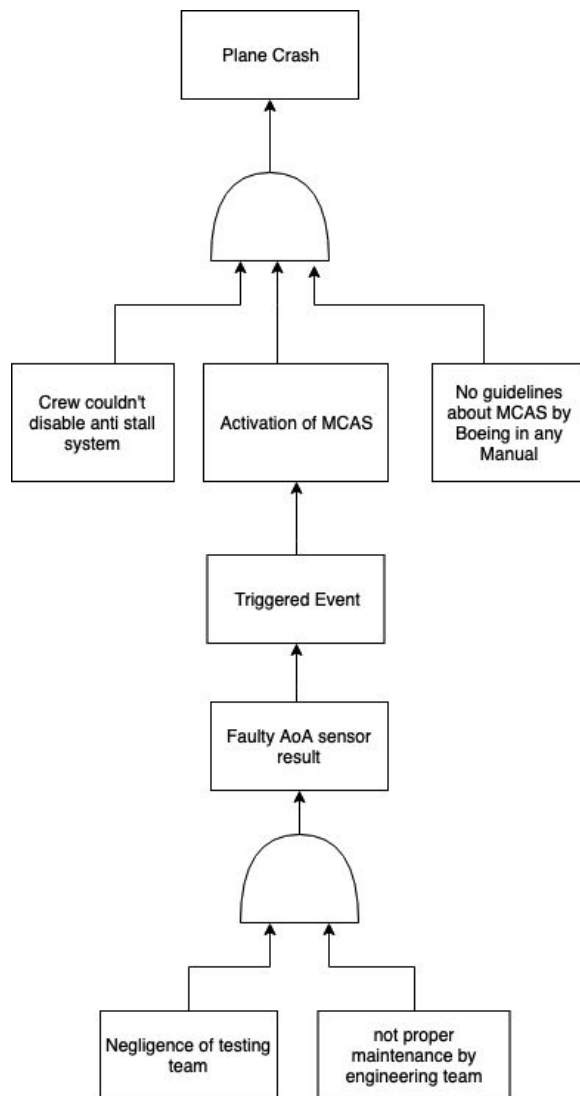
Fig: Fault tree for Lion Air 610

As we discussed about the crash, though it was minor problem but ultimately it caused death of passenger. It was caused due to minor reasons and negligence of management team, Boeing company and ignorance of crew members.

The same problem was raised in previous flights so the maintenance team and engineers should have solved the sensor and AOA problems.

The Boeing company should have mentioned about new MCAS system in their maintenance.
