# **BRAKTOOTH: Causing Havoc on Bluetooth Link Manager**

## **VULNERABILITY DISCLOSURE REPORT**

August 31, 2021

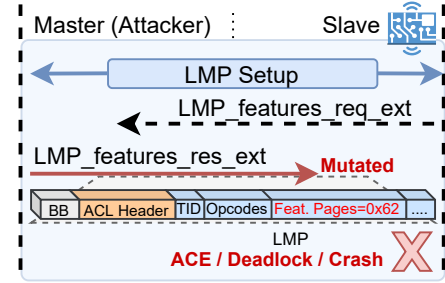
Figure 6: Feature Page Execution

**Impact:** The attacker is able to execute arbitrary functions implemented in the target ESP32’s firmware. Once the attacker acquires a dump of ESP32 firmware and the memory layout is known, functions at arbitrary addresses can be called. This allows the attacker to erase user data (NVRAM), call I/O functions that may control actuators, etc. Triggering firmware crashes or a BT deadlock is also possible during repeated attack attempts by executing invalid function addresses. In case of a deadlock, the user needs to manually reset ESP32 to restore BT communications.

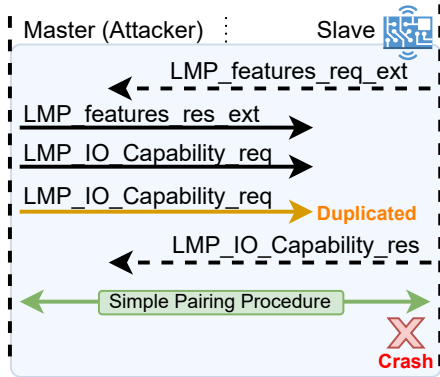
Figure 8: Duplicated IOCAP

The Bluetooth Classic implementation in Espressif ESP-IDF 4.4 and earlier [9] does not properly handle the reception of multiple *LMP\_IO\_Capability\_req* packets during the *pairing process* (see Figure 8). This allows attackers in radio range to trigger memory corruption (and consequently a crash) in

ESP32 via a replayed (duplicated) LMP packet. The issue was raised due to the sudden disconnection of ESP32 while its bluetooth host stack was still in the pairing process. The patch provided by Espressif rectifies this issue by handling a sudden disconnection during the pairing procedure (c.f., Table 5).

**Impact:** The attacker can exploit this vulnerability to promptly cause firmware crashes and therefore maintain a DoS while the attack is taking place. Since ESP32 restarts its firmware by default upon receiving a fault, no user interaction is needed to restore BT communication after the attack is stopped.

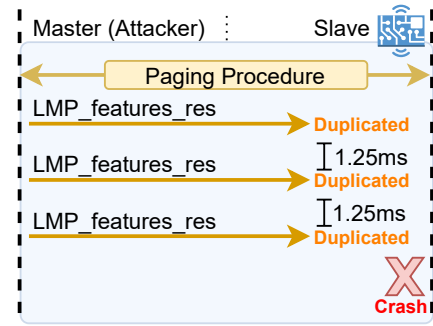
Figure 9: Feature Response Flooding

such as **JBL TUNE500BT** [21] and **Xiaomi MDZ-36-DB (Actions Semi. ATS2815)** [38, 41]. See Table 2 for all the targets affected by V4.

**Impact:** The attack triggers a firmware crash on ESP32 and a shutdown on **JBL TUNE500BT** and **Xiaomi MDZ-36-DB**. In the case of a shutdown, the user needs to manually power on the device again to restore communication. Furthermore, since all targets accept multiple BT connections, the attack can also be triggered while the target is already connected to another device. For example, it is possible to immediately stop audio from playing on JBL TUNE500BT and Xiaomi MDZ-36-DB. The attacker, however, needs to know the BDAAddress of the target to launch the attack.

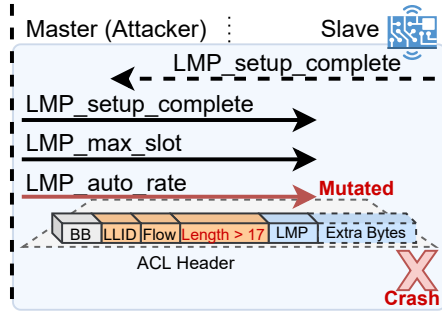
Figure 10: LMP Auto Rate Overflow

The Bluetooth Classic implementation in Silicon Labs iWRAP 6.3.0 and earlier [22] does not properly handle the reception of an oversized LMP packet greater than 17 bytes, allowing attackers in radio range to trigger a crash in WT32i [23] via a crafted LMP packet. As shown in Figure 10, the attack is triggered by sending an LMP with an ACL size higher than 17 bytes. Normally this is not allowed by the BT Core Specification [30], but ESP32 radio can indeed send such oversized LMP packets over the DM1 transport channel. Our proof of concept (PoC) firmware bypasses some length checks on the transmission path to make this possible. This attack vector also works on some **Jieli AC6905X (BT Audio Receiver)**. Note that this attack requires sending this malformed packet many times over many reconnections to trigger a firmware crash. Particularly, a firmware crash on WT32i may take around 3-5 minutes to be triggered.

**Impact:** The attack causes a firmware crash on both **WT32i** and **AC6905X**. This can be used to cause a sporadic denial of service (DoS) attacks on such devices.

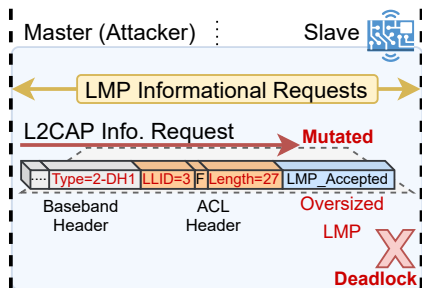
Figure 11: LMP 2-DH1 Overflow

The Bluetooth Classic implementation on Laird CSR8811 A08 [27] and CSR8510 A10 [26] SoCs allows an LMP length overflow over 2-DH1, resulting in a Deadlock (state machine or packet handler corruption) outcome. Figure 11 captures the sequence of messages exchanged to expose this vulnerability. In particular, the attack is performed by changing the transport type of the normal LMP packet to 2-DH1 and then adding more bytes to the LMP payload. This, for example, results in a total ACL length of 27.

**Impact:** The attack causes a BT deadlock on Laird CSR8811 and a firmware crash on CSR8510 operating as a standard BT dongle. While the dongle firmware crash is automatically recovered by the OS, the deadlock requires the user to perform a power cycle to restore normal BT communication. The attack does not affect Bluetooth Low Energy (BLE) communication in CSR8811.

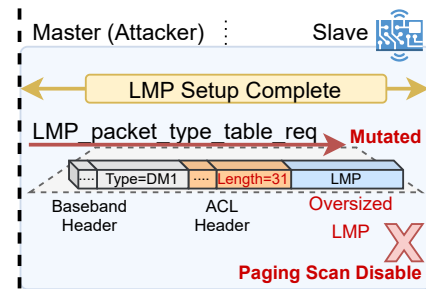
Figure 12: LMP DM1 Overflow

in radio range to prevent new BT connections (disabling the AB5301A inquiry and page scan procedures) via a crafted LMP packet. Following Figure 12, an arbitrary LMP packet (*LMP\_packet\_type\_table\_req*) is sent with an ACL length of 31, which is much higher than the expected 17 byte limit for DM1 transport. Due to a lack of check of DM1 length, an undefined behaviour on the target baseband implementation was observed. This eventually disables the paging scan procedure and hence blocks new connections. If the user is already connected to AB5301A and the attack is started (multiple BT connections are allowed), the active connection is not disrupted, but new connections or reconnection is not possible. As compared to V5 (Section 8.5), this attack works with any overflowed LMP packet rather than a specific LMP packet.

**Impact:** The impact of this attack is similar to V2 (Section 8.2), in which connections to the target are not accepted due to the page scan procedure being disabled after the attack (see Figure 1). Therefore, the user needs to manually perform a power cycle (restart) of the device to restore normal BT connectivity.

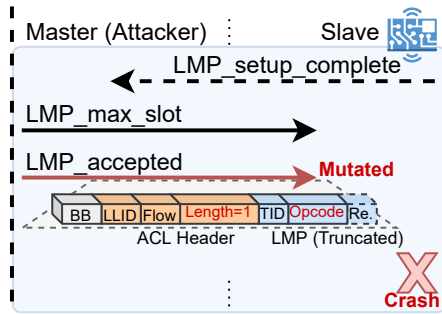
Figure 13: Truncated LMP Accepted

As the BT implementation of the target is closed source, the exact root cause of this vulnerability is not known. However, it is common that LMP procedures involving slot and

rate adjustments are usually implemented in an interrupt handler different than other non-real-time LMP packets, such as feature requests and version requests. Such a handler may miss some checks which are present on the other handlers, explaining why some overflow/underflow attacks only work for certain LMP packet opcodes. This split in the LMP handler is present, for instance, in ESP32 BT implementation.

**Impact:** The impact is a denial of service due to a firmware crash & restart. The overall risk of such an attack is reduced if AC690X and AC692X do not allow multiple BT connections. In such a scenario, the attacker could only trigger a firmware crash when no user is connected to AC690X or AC692X.

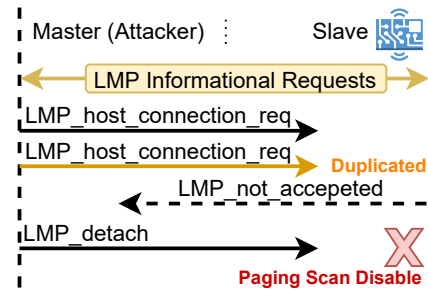
Figure 15: Host Connection Flooding

The Bluetooth Classic implementation on Actions ATS2815/ATS2819 [38] chipsets does not properly handle the reception of multiple *LMP\_host\_connection\_req* as shown in Figure 15. This allows attackers in radio range to trigger a denial of service (deadlock) if no user is connected

to the target. Manual user intervention is required to restart the device and restore Bluetooth communication.

**Impact:** An attacker in radio range can exploit the vulnerability to perform DoS and shutdown or restart products using chipsets and products based on Actions ATS2815/ATS2819. However, the impact of the attack is reduced as the vulnerability is only exploited when no other user device is connected to the target.

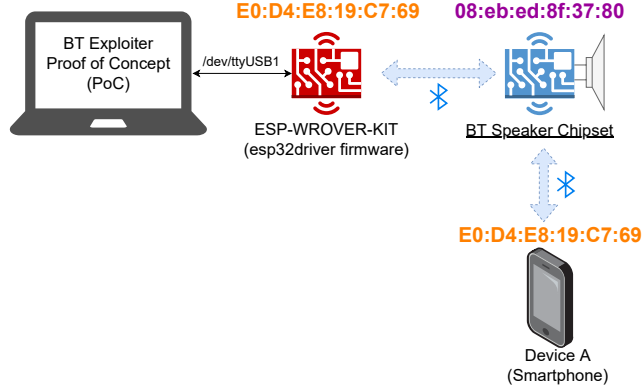
Figure 16: Same Host Connection

When reaching Actions Semi during the disclosure period, the company has informed us that they recommend the product vendors to only allow one audio BT connection. However, when we tested an ATS chipset based product *Xiaomi MDZ-36-DB*, we observed that multiple BT connections are allowed, albeit only one device can play audio at a time. Normally, connections with repeated host BDAddress are rejected on *LMP*

Setup procedure (c.f., Figure 1). However, this procedure is successful when testing *Xiaomi MDZ-36-DB* with repeated host BDAddress, leading the audio device to an undefined state.

**Impact:** An attacker in radio range can exploit this vulnerable behaviour to perform DoS and intentionally deadlock the target device.

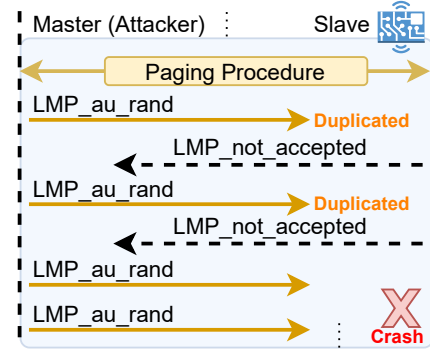
Figure 17: LMP AU Rand Flooding

Many major chipset vendors are affected by this attack as shown in Table 2. This attack is similar to Feature Response Flooding (Section 8.4), indicating that flooding testing with packets from certain LMP procedures may not have been well tested. This may arise because the *Core Specifications* only allows a limited LMP testing mode [31] that restricts the SoC to work with only a few LMP packets. This, in turn, may restrict the test flexibility for BT vendors. Specifically, vendors may have a limited capacity of tests that they can perform with their production BT firmware, such as flooding or sending out-of-order packets during normal LMP procedures.

**Impact:** An attacker in radio range can exploit this vulnerable behaviour to perform DoS and intentionally crash or deadlock the target device.

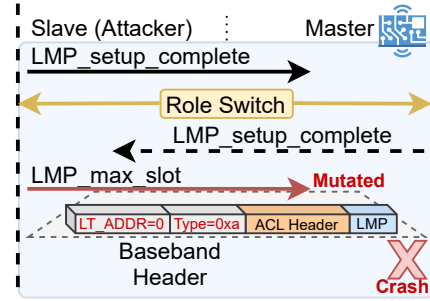
Figure 18: Invalid Max Slot Type

The Bluetooth Classic implementation in the Cypress WICED BT stack 2.9.0 [14] and earlier for CYW20735B1 [13] devices does not properly handle the reception of *LMP\_max\_slot* with an invalid Baseband packet type and *LT\_ADDRESS* (see *Type* and *LT\_ADDR* fields in Figure 18). The vulnerability is triggered after completion of the LMP setup procedure, allowing attackers in radio range to trigger a denial of service (firmware crash) via a crafted LMP packet.

**Impact:** An attacker in radio range can exploit this vulnerable behaviour to perform DoS and intentionally crash the target device.

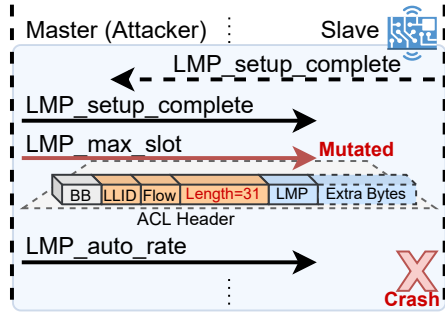
Figure 19: Max Slot Length Overflow

The Bluetooth Classic implementation in the Cypress WICED BT stack 2.9.0 [14] and earlier for CYW20735B1 [13] devices does not properly handle the reception of *LMP\_max\_slot* with a higher ACL Length (*Length=31* as shown in Figure 19) after completion of the LMP setup procedure. This allows attackers in radio range to trigger a denial of service (firmware crash) via a crafted LMP packet.

**Impact:** An attacker in radio range can exploit this vulnerability to perform DoS and intentionally crash the target device.

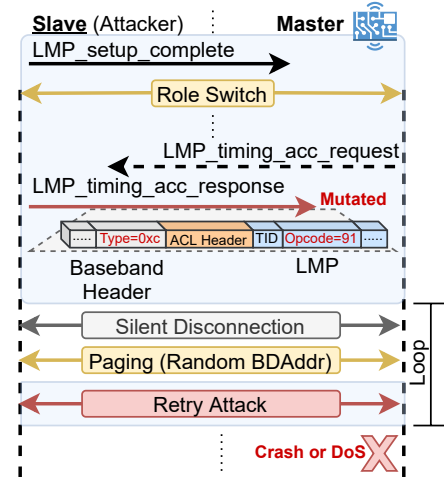
Figure 20: Invalid Timing Accuracy

**Impact:** This attack causes a denial of service (DoS) attack. Specifically, while the attack is in progress, the target devices are unable to use the Bluetooth service normally.

The impact of this attack does not persist after the attack stops. This is because the target normally tries to recover the BT connection by performing a re-connection to previously disconnected devices (e.g., Intel AX200 under Linux or Windows). In the case of a WCN3990 firmware crash, the Android OS restarts the Bluetooth daemon and re-uploads a firmware image to WCN3990. Finally, for CYW20735B1, it restarts automatically upon any fault due to its watchdog timer being enabled by default. Nevertheless, in all cases, it is not possible to normally use the device while the attack is in progress, as the BT connection can be disrupted continuously.

The attacker only needs to know the BDAAddress of the target device and no authentication is required to launch the attack.

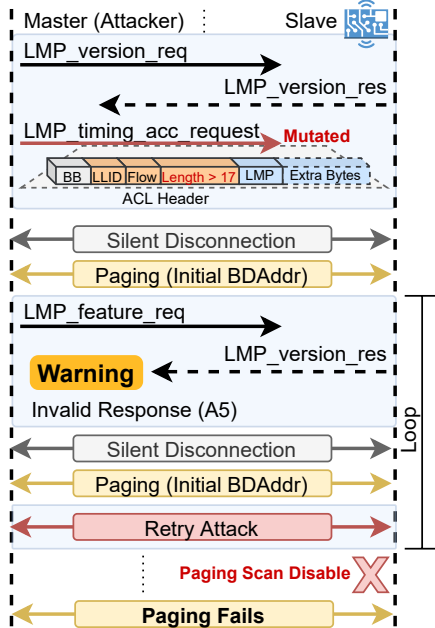
Figure 21: Paging Scan Disable

**Impact:** Once the attack is triggered and successful, the attacker can cause DoS via the following AX200 behaviours: (I) paging scan is disabled, which prevents any external device to connect to the target even if the BDAddress is known. This behaviour can be used to trick an user to connect to the attacker’s BT hardware instead of the legitimate target since AX200 paging scan is disabled; (II) Multiple active BT connections cannot be performed from the target. The user requires to manually restart the Bluetooth service to restore normal BT behaviour. On Linux and Windows, BT is recovered by disabling and enabling Bluetooth via their respective configuration menu.

Firmware crashes may be sporadically triggered on AX200 during the attacks, but no specific scenario was found to reliably trigger such crashes all the time.
