BRAKTOOTH: Causing Havoc on Bluetooth Link Manager

VULNERABILITY DISCLOSURE REPORT

August 31, 2021

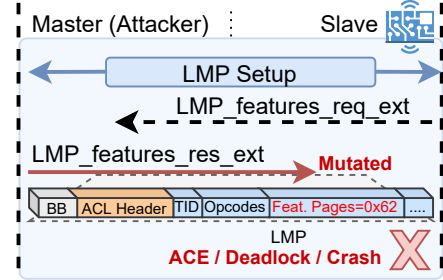
Impact: The attacker is able to execute arbitrary functions implemented in the target ESP32’s firmware. Once the attacker acquires a dump of ESP32 firmware and the memory layout is known, functions at arbitrary addresses can be called.

This allows the attacker to erase user data (NVRAM), call I/O functions that may control actuators, etc. Triggering firmware crashes or a BT deadlock is also possible during repeated attack attempts by executing invalid function addresses. In case of a deadlock, the user needs to manually reset ESP32 to restore BT communications.

Figure 6: Feature Page Execution

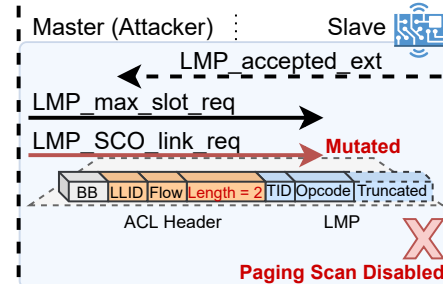
The Bluetooth Classic implementation in the Zhuhai Jieli AC6366C BT SDK 0.9.1 and earlier [33] does not properly handle the reception of truncated *LMP_SCO_Link_Request* packets while no other BT connections are active. This allows attackers in radio range to prevent new BT connections (disabling the AC6366C inquiry and page scan procedures) via a crafted LMP packet. The user needs to manually perform a power cycle (restart) of the device to restore BT communication. Following Figure 7, the attack can be launched by sending an *LMP_SCO_Link_Request* with *ACL length*=2 instead of its normal size of 7.

Impact: The attacker is able to prevent external parties to connect to the device, requiring the user to manually perform a power cycle on the device to resume normal connectivity. Attack risk is reduced if the user is already connected to AC6366C or similar chipsets that only allow one active BT connection at a time.

Figure 7: Truncated SCO Link Request

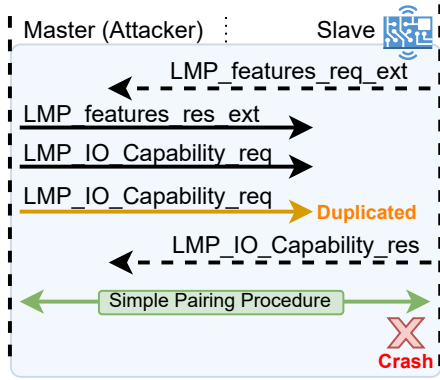
The Bluetooth Classic implementation in Espressif ESP-IDF 4.4 and earlier [7] does not properly handle the reception of multiple *LMP_IO_Capability_req* packets during the *pairing process* (see Figure 8). This allows attackers in radio range to trigger memory corruption (and consequently a crash) in ESP32 via a replayed (duplicated) LMP packet. The issue was raised due to the sudden disconnection of ESP32 while its bluedroid host stack was still in the pairing process. The patch provided by Espressif rectifies this issue by handling a sudden disconnection during the pairing procedure (c.f., Table 5).

Impact: The attacker can exploit this vulnerability to promptly cause firmware crashes and therefore maintain a DoS while the attack is taking place. Since ESP32 restarts its firmware by default upon receiving a fault, no user interaction is needed to restore BT communication after the attack is stopped.

Figure 8: Duplicated IOCAP

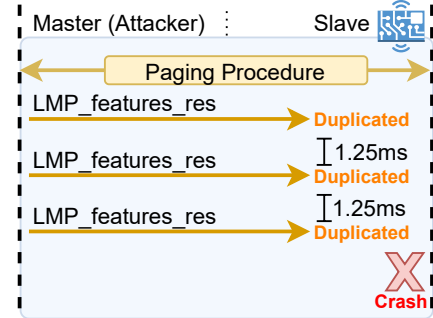
Impact: The attack triggers a firmware crash on ESP32 and a shutdown on **JBL TUNE500BT** and **Xiaomi MDZ-36-DB**.

In the case of a shutdown, the user needs to manually power on the device again to restore communication. Furthermore, since all targets accept multiple BT connections, the attack can also be triggered while the target is already connected to another device. For example, it is possible to immediately stop audio from playing on **JBL TUNE500BT** and **Xiaomi MDZ-36-DB**. The attacker, however, needs to know the BDAAddress of the target to launch the attack.

Figure 9: Feature Response Flooding

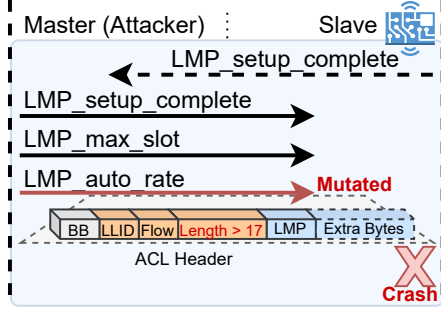
Impact: The attack causes a firmware crash on both **WT32i** and **AC6905X**. This can be used to cause a sporadic denial of service (DoS) attacks on such devices.

Figure 10: LMP Auto Rate Overflow

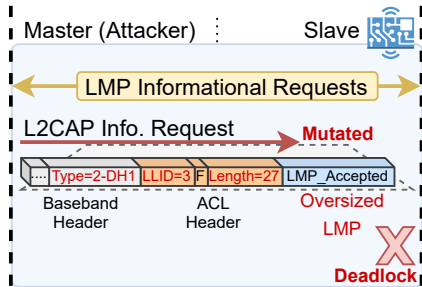
The Bluetooth Classic implementation on Laird CSR8811 A08 [23] and CSR8510 A10 [22] SoCs allows an LMP length overflow over 2-DH1, resulting in a Deadlock (state machine or packet handler corruption) outcome. Figure 11 captures the sequence of messages exchanged to expose this vulnerability.

In particular, the attack is performed by changing the transport type of the normal LMP packet to 2-DH1 and then adding more bytes to the LMP payload. This, for example, results in a total ACL length of 27.

Impact: The attack causes a BT deadlock on Laird CSR8811 and a firmware crash on CSR8510 operating as a standard BT dongle. While the dongle firmware crash is automatically recovered by the OS, the deadlock requires the user to perform a power cycle to restore normal BT communication. The attack does not affect Bluetooth Low Energy (BLE) communication in CSR8811.

Figure 11: LMP 2-DH1 Overflow

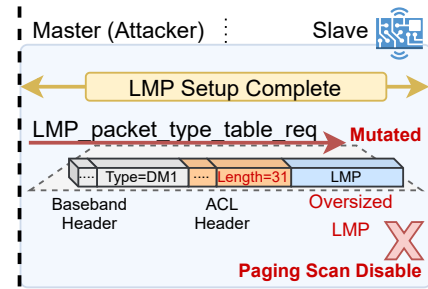
dures and hence blocks new connections. If the user is already connected to AB5301A and the attack is started (multiple BT connections are allowed), the active connection is not disrupted, but new connections or reconnection is not possible. As compared to V5 (Section 8.5), this attack works with any overflowed LMP packet rather than a specific LMP packet.

Impact: The impact of this attack is similar to V2 (Section 8.2), in which connections to the target are not accepted due to the page scan procedure being disabled after the attack (see Figure 1). Therefore, the user needs to manually perform a power cycle (restart) of the device to restore normal BT connectivity.

Figure 12: LMP DM1 Overflow

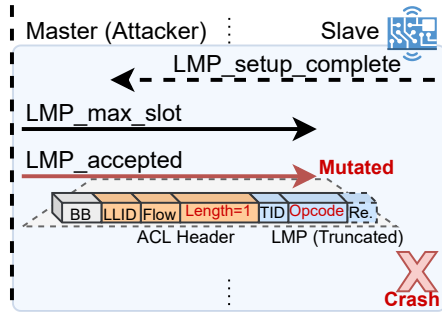
As the BT implementation of the target is closed source, the exact root cause of this vulnerability is not known. However, it is common that LMP procedures involving slot and rate adjustments are usually implemented in an interrupt handler different than other non-real-time LMP packets, such as feature requests and version requests. Such a handler may miss some checks which are present on the other handlers, explaining why some overflow/underflow attacks only work for certain LMP packet opcodes. This split in the LMP handler is present, for instance, in ESP32 BT implementation.

Impact: The impact is a denial of service due to a firmware crash & restart. The overall risk of such an attack is reduced if

AC690X and AC692X do not allow multiple BT connections. In such a scenario, the attacker could only trigger a firmware crash when no user is connected to AC690X or AC692X.

Figure 13: Truncated LMP Accepted

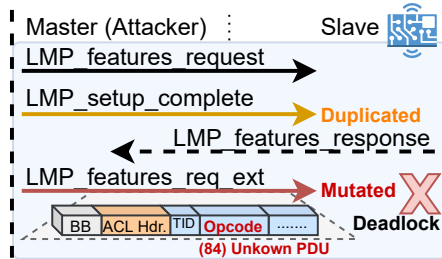
This scenario is illustrated in Figure 14. The attacker sends an unexpected (duplicated) *LMP_setup_complete*, followed by a malformed *LMP_features_req_ext* with an invalid LMP opcode such as 0x64. The behaviour seen in Figure 14 allows attackers in radio range to deadlock a device via injecting crafted LMP packets. Moreover, the user needs to manually reboot the device to restore communication.

Impact: An attacker can exploit this vulnerability to perform a DoS. The overall risk of such an attack is reduced if AC690X and AC692X do not allow multiple BT connections.

Figure 14: Invalid Setup Complete

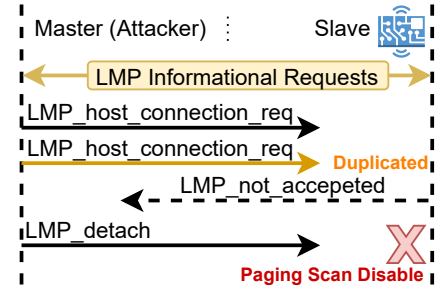
handle the reception of multiple *LMP_host_connection_req* as shown in Figure 15. This allows attackers in radio range to trigger a denial of service (deadlock) if no user is connected to the target. Manual user intervention is required to restart the device and restore Bluetooth communication.

Impact: An attacker in radio range can exploit the vulnerability to perform DoS and shutdown or restart products using chipsets and products based on Actions ATS2815/ATS2819. However, the impact of the attack is reduced as the vulnerability is only exploited when no other user device is connected to the target.

Figure 15: Host Connection Flooding

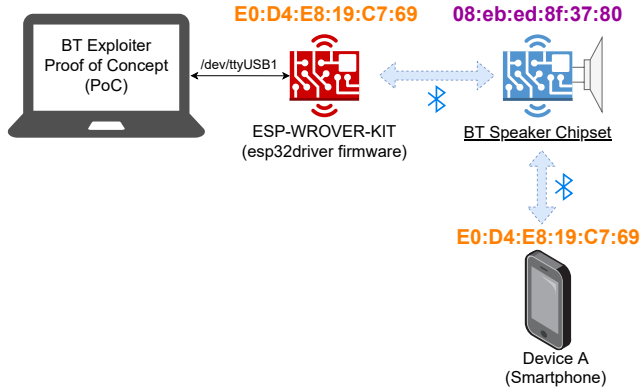
When reaching Actions Semi during the disclosure period, the company has informed us that they recommend the product vendors to only allow one audio BT connection. However, when we tested an ATS chipset based product *Xiaomi MDZ-36-DB*, we observed that multiple BT connections are allowed, albeit only one device can play audio at a time. Normally, connections with repeated host BDAddress are rejected on *LMP Setup* procedure (c.f., Figure 1). However, this procedure is successful when testing *Xiaomi MDZ-36-DB* with repeated host BDAddress, leading the audio device to an undefined state.

Impact: An attacker in radio range can exploit this vulnerable behaviour to perform DoS and intentionally deadlock the target device.

Figure 16: Same Host Connection

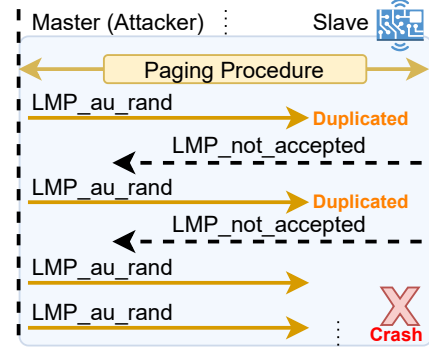
Figure 17: LMP AU Rand Flooding

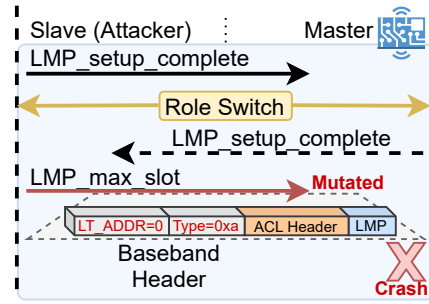
The Bluetooth Classic implementation in the Cypress WICED BT stack 2.9.0 [12] and earlier for CYW20735B1 [11] devices does not properly handle the reception of *LMP_max_slot* with an invalid Baseband packet type and *LT_ADDRESS* (see *Type* and *LT_ADDR* fields in Figure 18). The vulnerability is triggered after completion of the LMP setup procedure,

allowing attackers in radio range to trigger a denial of service (firmware crash) via a crafted LMP packet.

Impact: An attacker in radio range can exploit this vulnerable behaviour to perform DoS and intentionally crash the target device.

Figure 18: Invalid Max Slot Type

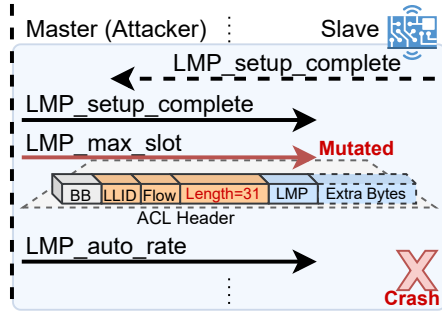
Figure 19: Max Slot Length Overflow

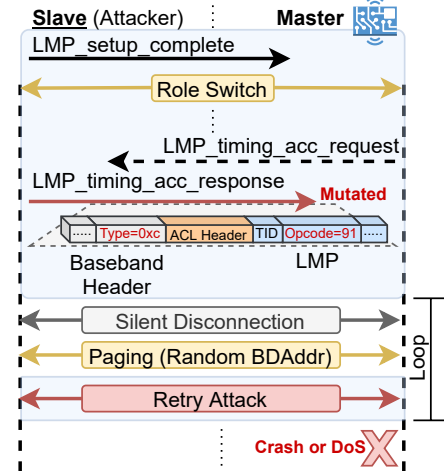
The Bluetooth Classic implementations in the Cypress WICED BT stack 2.9.0 [12] and earlier for CYW20735B1 [11] devices, **Intel AX200** [16] and **Qualcomm WCN3990**

[29] chipsets do not properly handle the reception of a malformed LMP timing accuracy response followed by multiple re-connections to the target link slave. This allows attackers to exhaust device BT resources. Eventually, the attacker can trigger a crash or BT disturbance via multiple attempts of sending a crafted *LMP_timing_acc_response* (i.e. LMP timing accuracy response) followed by a sudden reconnection to the target with a random BDAddress.

Impact: This attack causes a denial of service (DoS) attack. Specifically, while the attack is in progress, the target devices are unable to use the Bluetooth service normally.

Figure 20: Invalid Timing Accuracy

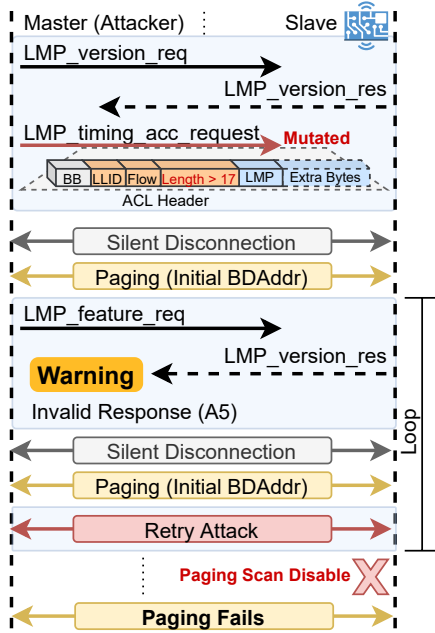
This vulnerability is depicted in Figure 21. As shown in Figure 21, sending an invalid packet during the LMP timing accuracy procedure (i.e. packet *LMP_timing_acc_request*), followed by a forced re-connection with the same BDAddress

(any arbitrary BDAddress of choice of the attacker), leads **Intel AX200** to reject any externally initiated BT connections for an undetermined amount of time. This persists even after the attack stops and requires user intervention to recover **AX200** normal functionalities.

Impact: Once the attack is triggered and successful, the attacker can cause DoS via the following **AX200** behaviours: **(I)** paging scan is disabled, which prevents any external de-

vice to connect to the target even if the BDAAddress is known. This behaviour can be used to trick an user to connect to the attacker’s BT hardware instead of the legitimate target since **AX200** paging scan is disabled; **(II)** Multiple active BT connections cannot be performed from the target. The user requires to manually restart the Bluetooth service to restore normal BT behaviour. On Linux and Windows, BT is recovered by disabling and enabling Bluetooth via their respective configuration menu.

Firmware crashes may be sporadically triggered on **AX200** during the attacks, but no specific scenario was found to reliably trigger such crashes all the time.

Figure 21: Paging Scan Disable
