BRAKTOOTH: Causing Havoc on Bluetooth Link Manager

VULNERABILITY DISCLOSURE REPORT

August 31, 2021

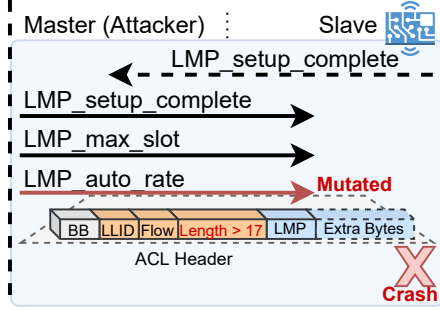
Figure 10: LMP Auto Rate Overflow

8.5 V5: LMP Auto Rate Overflow (CVE-2021-31609/31612)

Impact: The attack causes a firmware crash on both **WT32i** and **AC6905X**. This can be used to cause a sporadic denial of service (DoS) attacks on such devices.

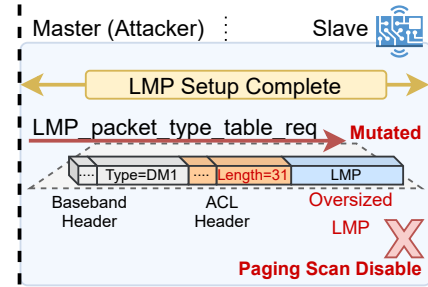
Figure 12: LMP DM1 Overflow

8.7 V7: LMP DM1 Overflow (CVE-2021-34150)

dures and hence blocks new connections. If the user is already connected to AB5301A and the attack is started (multiple BT connections are allowed), the active connection is not disrupted, but new connections or reconnection is not possible. As compared to V5 (Section 8.5), this attack works with any overflowed LMP packet rather than a specific LMP packet.

Impact: The impact of this attack is similar to V2 (Section 8.2), in which connections to the target are not accepted due to the page scan procedure being disabled after the attack (see Figure 1). Therefore, the user needs to manually perform a power cycle (restart) of the device to restore normal BT connectivity.

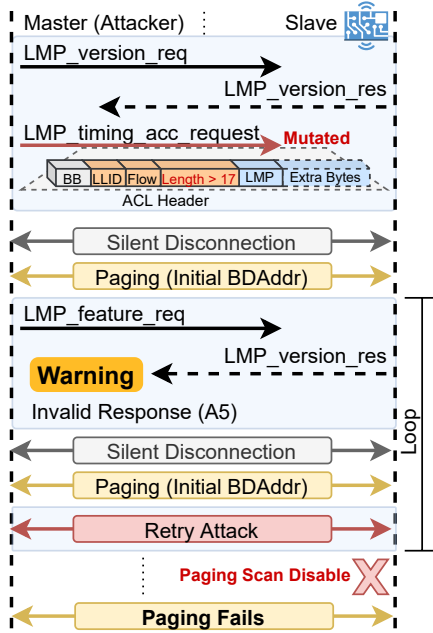
Figure 21: Paging Scan Disable

8.16 V16: Paging Scan Disable (Pending CVE)

This vulnerability is depicted in Figure 21. As shown in Figure 21, sending an invalid packet during the LMP timing accuracy procedure (i.e. packet *LMP_timing_acc_request*), followed by a forced re-connection with the same BDAddress

(any arbitrary BDAddress of choice of the attacker), leads **Intel AX200** to reject any externally initiated BT connections for an undetermined amount of time. This persists even after the attack stops and requires user intervention to recover **AX200** normal functionalities.

Impact: Once the attack is triggered and successful, the attacker can cause DoS via the following **AX200** behaviours: (I) paging scan is disabled, which prevents any external de-

vice to connect to the target even if the BDAAddress is known. This behaviour can be used to trick an user to connect to the attacker’s BT hardware instead of the legitimate target since **AX200** paging scan is disabled; **(II)** Multiple active BT connections cannot be performed from the target. The user requires to manually restart the Bluetooth service to restore normal BT behaviour. On Linux and Windows, BT is recovered by disabling and enabling Bluetooth via their respective configuration menu.

Firmware crashes may be sporadically triggered on **AX200** during the attacks, but no specific scenario was found to reliably trigger such crashes all the time.
