BRAKTOOTH: Causing Havoc on Bluetooth Link Manager

VULNERABILITY DISCLOSURE REPORT

August 31, 2021

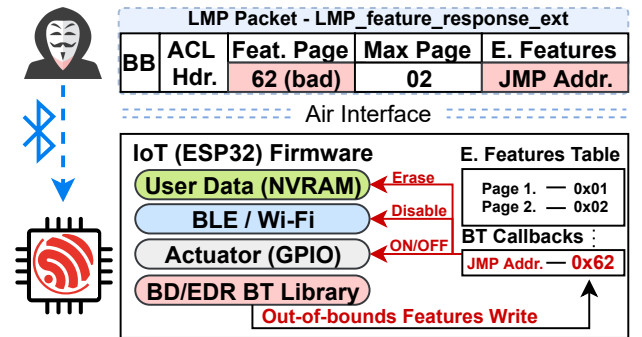
Figure 3: An Illustration of CVE-2021-28138.

The most critical vulnerability (**V1** in Table 2 - 8.1) affects ESP32 SoC [36], which is used in many Wi-Fi and Bluetooth IoT appliances such as Industry Automation, Smart Home, Fitness, etc. The attack is illustrated in Figure 3. A lack of out-of-bounds check in ESP32 *BT Library* [11] allows the reception of a *mutated LMP_feature_response_ext*. This results in the injection of eight bytes of arbitrary data outside the bounds of *Extended Feature Page Table* ("E. Features Table" in Figure 3). An attacker, which knows the firmware layout of a target device, can write a known function address (*JMP Addr.*) to the offset pointed by *Features Page* ("Feat. Page" in the *LMP_feature_response_ext* packet) field. It turns out that the *BT Library* stores some callback pointers within the out-of-bounds *Features Page* offset and such a callback is even-

tually invoked during the BT connection. While exploiting this vulnerability, we forced ESP32 into erasing its NVRAM data (normally written during product manufacturing) by setting *JMP Addr.* to the address of *nvs_flash_erase*. Such erase function is always included in ESP32 SDK [9] and therefore, it is present in any ESP32 firmware. Similarly, disabling BT or BLE can be done via *esp_bt_controller_disable* and Wi-Fi via *disable_wifi_agc*. Additionally, general-purpose input/output (GPIO) can be controlled if the attacker knows addresses to functions controlling actuators attached to ESP32. As expected, this has serious implications if such an attack is applied to Bluetooth-enabled Smart Home products.

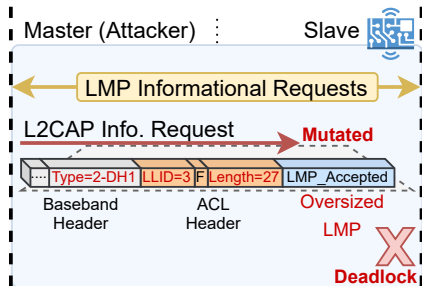
Figure 11: LMP 2-DH1 Overflow

The Bluetooth Classic implementation on Laird CSR8811 A08 [27] and CSR8510 A10 [26] SoCs allows an LMP length overflow over 2-DH1, resulting in a Deadlock (state machine or packet handler corruption) outcome. Figure 11 captures the sequence of messages exchanged to expose this vulnerability. In particular, the attack is performed by changing the transport type of the normal LMP packet to 2-DH1 and then adding more bytes to the LMP payload. This, for example, results in a total ACL length of 27.

Impact: The attack causes a BT deadlock on Laird CSR8811 and a firmware crash on CSR8510 operating as a standard BT dongle. While the dongle firmware crash is automatically recovered by the OS, the deadlock requires the user to perform a power cycle to restore normal BT communication. The attack does not affect Bluetooth Low Energy (BLE) communication in CSR8811.

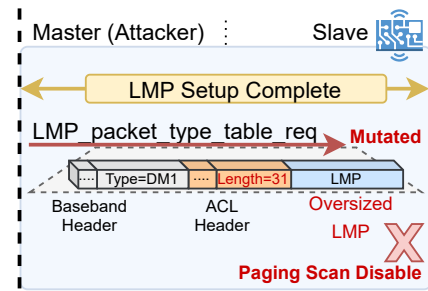
Figure 12: LMP DM1 Overflow

in radio range to prevent new BT connections (disabling the AB5301A inquiry and page scan procedures) via a crafted LMP packet. Following Figure 12, an arbitrary LMP packet (*LMP_packet_type_table_req*) is sent with an ACL length of 31, which is much higher than the expected 17 byte limit for DM1 transport. Due to a lack of check of DM1 length, an undefined behaviour on the target baseband implementation was observed. This eventually disables the paging scan procedure and hence blocks new connections. If the user is already connected to AB5301A and the attack is started (multiple BT connections are allowed), the active connection is not disrupted, but new connections or reconnection is not possible. As compared to V5 (Section 8.5), this attack works with any overflown LMP packet rather than a specific LMP packet.

Impact: The impact of this attack is similar to V2 (Section 8.2), in which connections to the target are not accepted due to the page scan procedure being disabled after the attack (see Figure 1). Therefore, the user needs to manually perform a power cycle (restart) of the device to restore normal BT connectivity.

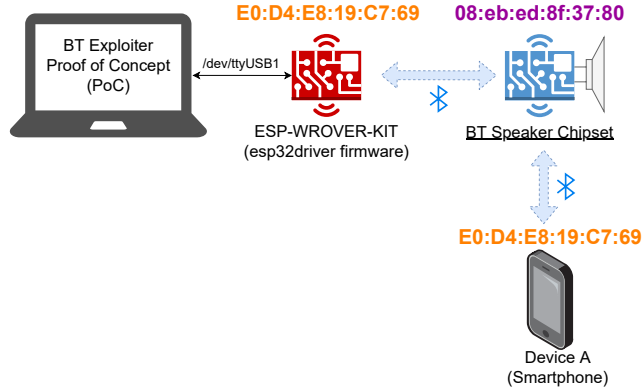
Figure 16: Same Host Connection

When reaching Actions Semi during the disclosure period, the company has informed us that they recommend the product vendors to only allow one audio BT connection. However, when we tested an ATS chipset based product *Xiaomi MDZ-36-DB*, we observed that multiple BT connections are allowed, albeit only one device can play audio at a time. Normally, connections with repeated host BDAddress are rejected on *LMP*

Setup procedure (c.f., Figure 1). However, this procedure is successful when testing *Xiaomi MDZ-36-DB* with repeated host BDAddress, leading the audio device to an undefined state.

Impact: An attacker in radio range can exploit this vulnerable behaviour to perform DoS and intentionally deadlock the target device.

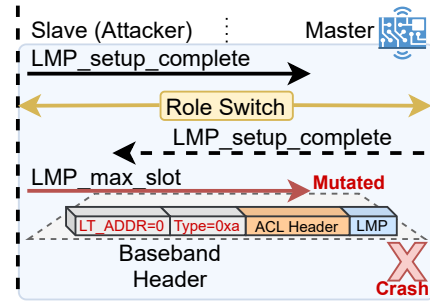
Figure 18: Invalid Max Slot Type

The Bluetooth Classic implementation in the Cypress WICED BT stack 2.9.0 [14] and earlier for CYW20735B1 [13] devices does not properly handle the reception of *LMP_max_slot* with an invalid Baseband packet type and *LT_ADDRESS* (see *Type* and *LT_ADDR* fields in Figure 18). The vulnerability is triggered after completion of the LMP setup procedure, allowing attackers in radio range to trigger a denial of service (firmware crash) via a crafted LMP packet.

Impact: An attacker in radio range can exploit this vulnerable behaviour to perform DoS and intentionally crash the target device.
