# **BRAKTOOTH: Causing Havoc on Bluetooth Link Manager**

## **VULNERABILITY DISCLOSURE REPORT**

August 31, 2021

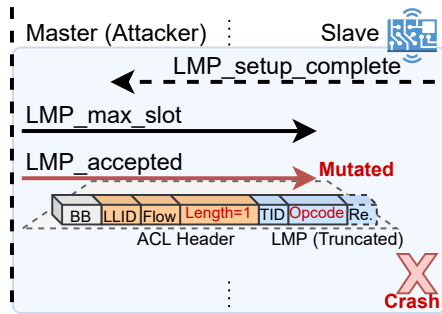
Figure 13: Truncated LMP Accepted

As the BT implementation of the target is closed source, the exact root cause of this vulnerability is not known. However, it is common that LMP procedures involving slot and rate adjustments are usually implemented in an interrupt handler different than other non-real-time LMP packets, such as feature requests and version requests. Such a handler may miss some checks which are present on the other handlers, explaining why some overflow/underflow attacks only work for certain LMP packet opcodes. This split in the LMP handler is present, for instance, in ESP32 BT implementation.

**Impact:** The impact is a denial of service due to a firmware crash & restart. The overall risk of such an attack is reduced if

AC690X and AC692X do not allow multiple BT connections. In such a scenario, the attacker could only trigger a firmware crash when no user is connected to AC690X or AC692X.

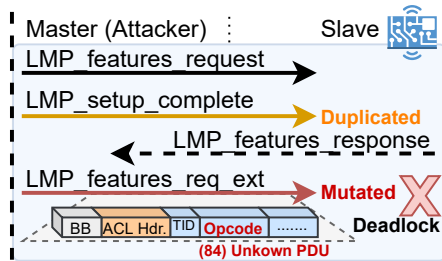
Figure 14: Invalid Setup Complete

This scenario is illustrated in Figure 14. The attacker sends an unexpected (duplicated) *LMP\_setup\_complete*, followed by a malformed *LMP\_features\_req\_ext* with an invalid LMP opcode such as 0x64. The behaviour seen in Figure 14 allows attackers in radio range to deadlock a device via injecting crafted LMP packets. Moreover, the user needs to manually reboot the device to restore communication.

**Impact:** An attacker can exploit this vulnerability to perform a DoS. The overall risk of such an attack is reduced if AC690X and AC692X do not allow multiple BT connections.

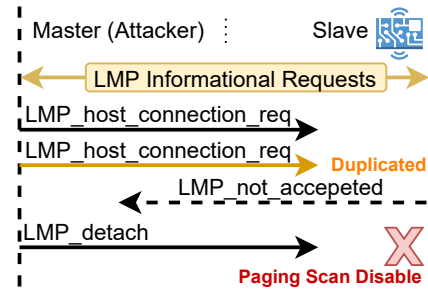
Figure 15: Host Connection Flooding

handle the reception of multiple *LMP\_host\_connection\_req* as shown in Figure 15. This allows attackers in radio range to trigger a denial of service (deadlock) if no user is connected to the target. Manual user intervention is required to restart the device and restore Bluetooth communication.

**Impact:** An attacker in radio range can exploit the vulnerability to perform DoS and shutdown or restart products using chipsets and products based on Actions ATS2815/ATS2819. However, the impact of the attack is reduced as the vulnerability is only exploited when no other user device is connected to the target.
