BRAKTOOTH: Causing Havoc on Bluetooth Link Manager

VULNERABILITY DISCLOSURE REPORT

August 31, 2021

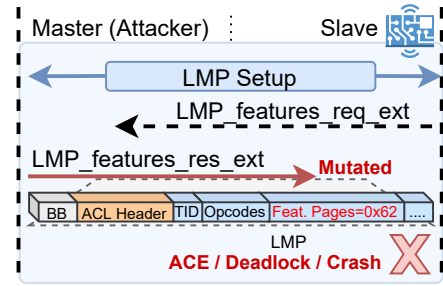
Figure 6: Feature Page Execution

(c.f., Figure 1). Moreover, the contents of extended features in the *LMP_feature_res_ext* can be used to execute code at an arbitrary address within the ESP32 firmware. For example, as described in Section 4.1, such an address may point to the erase function (*nvs_flash_erase*) and disabling Wi-Fi (*disable_wifi_agc*), among others.

Impact: The attacker is able to execute arbitrary functions implemented in the target ESP32's firmware. Once the attacker acquires a dump of ESP32 firmware and the memory layout is known, functions at arbitrary addresses can be called. This allows the attacker to erase user data (NVRAM), call I/O functions that may control actuators, etc. Triggering firmware crashes or a BT deadlock is also possible during repeated attack attempts by executing invalid function addresses. In case of a deadlock, the user needs to manually reset ESP32 to restore BT communications.

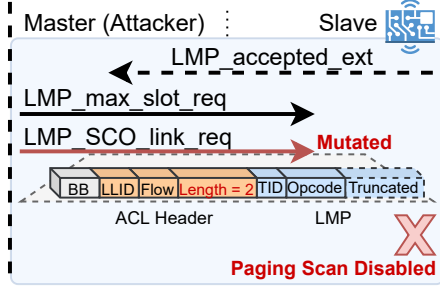
Figure 7: Truncated SCO Link Request

The Bluetooth Classic implementation in the Zhuhai Jieli AC6366C BT SDK 0.9.1 and earlier [39] does not properly handle the reception of truncated *LMP_SCO_Link_Request* packets while no other BT connections are active. This allows attackers in radio range to prevent new BT connections (disabling the AC6366C inquiry and page scan procedures) via a crafted LMP packet. The user needs to manually perform a power cycle (restart) of the device to restore BT communication. Following Figure 7, the attack can be launched by sending an *LMP_SCO_Link_Request* with *ACL length*=2 instead of its normal size of 7.

Impact: The attacker is able to prevent external parties to connect to the device, requiring the user to manually perform a power cycle on the device to resume normal connectivity. Attack risk is reduced if the user is already connected to AC6366C or similar chipsets that only allow one active BT connection at a time.

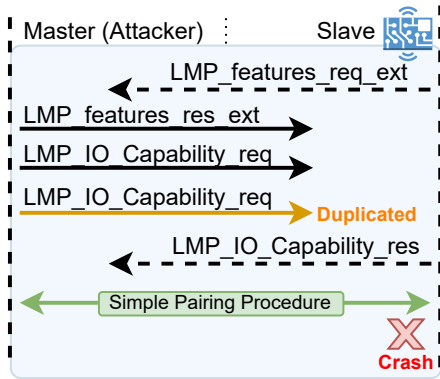
Figure 8: Duplicated IOCAP

The Bluetooth Classic implementation in Espressif ESP-IDF 4.4 and earlier [9] does not properly handle the reception of multiple *LMP_IO_Capability_req* packets during the *pairing process* (see Figure 8). This allows attackers in radio range to trigger memory corruption (and consequently a crash) in ESP32 via a replayed (duplicated) LMP packet. The issue was raised due to the sudden disconnection of ESP32 while its bluedroid host stack was still in the pairing process. The patch provided by Espressif rectifies this issue by handling a sudden disconnection during the pairing procedure (c.f., Table 5).

Impact: The attacker can exploit this vulnerability to promptly cause firmware crashes and therefore maintain a DoS while the attack is taking place. Since ESP32 restarts its firmware by default upon receiving a fault, no user interaction is needed to restore BT communication after the attack is stopped.

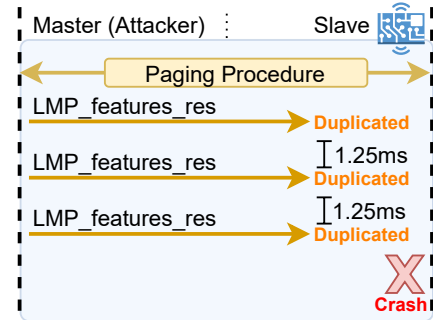
Figure 9: Feature Response Flooding

The Bluetooth Classic implementation in Espressif ESP-IDF 4.4 and earlier [9] does not properly handle the reception of continuous unsolicited LMP responses. This allows attackers in radio range to trigger a denial of service (crash) in ESP32 by flooding the target device with LMP Feature Response data. As shown in Figure 9, *LMP_features_res* packets are sent within a BT transmission slot of 1.25ms, which effectively floods the Slave with unsolicited responses. This attack vector is also effective against a range of other BT chipsets such as **JBL TUNE500BT** [21] and **Xiaomi MDZ-36-DB (Actions Semi. ATS2815)** [38, 41]. See Table 2 for all the targets affected by V4.

Impact: The attack triggers a firmware crash on ESP32 and a shutdown on **JBL TUNE500BT** and **Xiaomi MDZ-36-DB**. In the case of a shutdown, the user needs to manually power on the device again to restore communication. Furthermore, since all targets accept multiple BT connections, the attack can also be triggered while the target is already connected to another device. For example, it is possible to immediately stop audio from playing on JBL TUNE500BT and Xiaomi MDZ-36-DB. The attacker, however, needs to know the BDAAddress of the target to launch the attack.

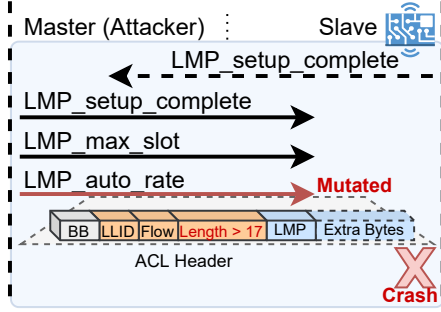
Figure 10: LMP Auto Rate Overflow

attack vector also works on some **Jieli AC6905X (BT Audio Receiver)**. Note that this attack requires sending this malformed packet many times over many reconnections to trigger a firmware crash. Particularly, a firmware crash on WT32i may take around 3-5 minutes to be triggered.

Impact: The attack causes a firmware crash on both **WT32i** and **AC6905X**. This can be used to cause a sporadic denial of service (DoS) attacks on such devices.

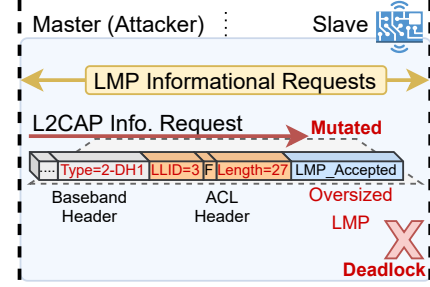
Figure 11: LMP 2-DH1 Overflow

Impact: The attack causes a BT deadlock on Laird CSR8811 and a firmware crash on CSR8510 operating as a standard BT dongle. While the dongle firmware crash is automatically recovered by the OS, the deadlock requires the user to perform a power cycle to restore normal BT communication. The attack does not affect Bluetooth Low Energy (BLE) communication in CSR8811.

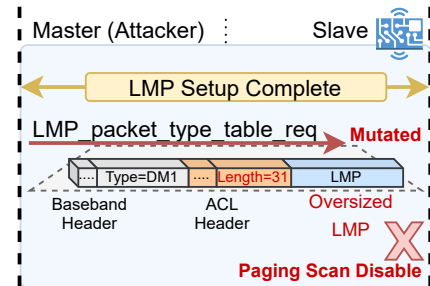
Figure 12: LMP DM1 Overflow

The Bluetooth Classic implementation on Bluetooth AB5301A [5] (tested with AB32VG1 dev. kit [4]) with *unspecified* firmware versions does not properly handle the reception of oversized DM1 LMP packets. This allows attackers in radio range to prevent new BT connections (disabling the AB5301A inquiry and page scan procedures) via a crafted LMP packet. Following Figure 12, an arbitrary LMP packet

(*LMP_packet_type_table_req*) is sent with an ACL length of 31, which is much higher than the expected 17 byte limit for DM1 transport. Due to a lack of check of DM1 length, an undefined behaviour on the target baseband implementation was observed. This eventually disables the paging scan procedure and hence blocks new connections. If the user is already connected to AB5301A and the attack is started (multiple BT connections are allowed), the active connection is not disrupted, but new connections or reconnection is not possible. As compared to V5 (Section 8.5), this attack works with any overflow LMP packet rather than a specific LMP packet.

Impact: The impact of this attack is similar to V2 (Section 8.2), in which connections to the target are not accepted due to the page scan procedure being disabled after the attack (see Figure 1). Therefore, the user needs to manually perform a power cycle (restart) of the device to restore normal BT connectivity.

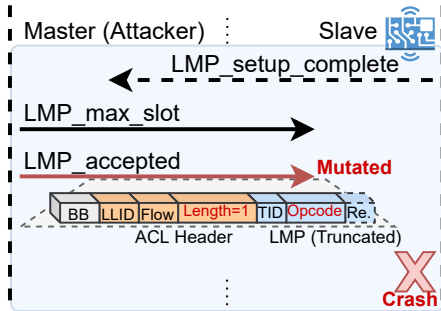
Figure 13: Truncated LMP Accepted

As the BT implementation of the target is closed source, the exact root cause of this vulnerability is not known. However, it is common that LMP procedures involving slot and rate adjustments are usually implemented in an interrupt handler different than other non-real-time LMP packets, such as feature requests and version requests. Such a handler may miss some checks which are present on the other handlers, explaining why some overflow/underflow attacks only work for certain LMP packet opcodes. This split in the LMP handler is present, for instance, in ESP32 BT implementation.

Impact: The impact is a denial of service due to a firmware crash & restart. The overall risk of such an attack is reduced if AC690X and AC692X do not allow multiple BT connections. In such a scenario, the attacker could only trigger a firmware crash when no user is connected to AC690X or AC692X.

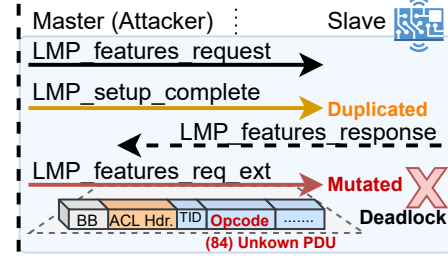
Figure 14: Invalid Setup Complete

This scenario is illustrated in Figure 14. The attacker sends an unexpected (duplicated) *LMP_setup_complete*, followed by a malformed *LMP_features_req_ext* with an invalid LMP opcode such as 0x64. The behaviour seen in Figure 14 allows attackers in radio range to deadlock a device via injecting crafted LMP packets. Moreover, the user needs to manually reboot the device to restore communication.

Impact: An attacker can exploit this vulnerability to perform a DoS. The overall risk of such an attack is reduced if AC690X and AC692X do not allow multiple BT connections.

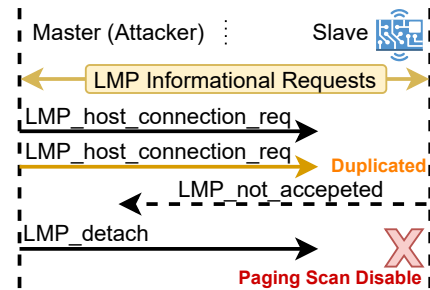
Figure 15: Host Connection Flooding

The Bluetooth Classic implementation on Actions ATS2815/ATS2819 [38] chipsets does not properly handle the reception of multiple *LMP_host_connection_req* as shown in Figure 15. This allows attackers in radio range to trigger a denial of service (deadlock) if no user is connected to the target. Manual user intervention is required to restart the device and restore Bluetooth communication.

Impact: An attacker in radio range can exploit the vulnerability to perform DoS and shutdown or restart products using chipsets and products based on Actions ATS2815/ATS2819. However, the impact of the attack is reduced as the vulnerability is only exploited when no other user device is connected to the target.

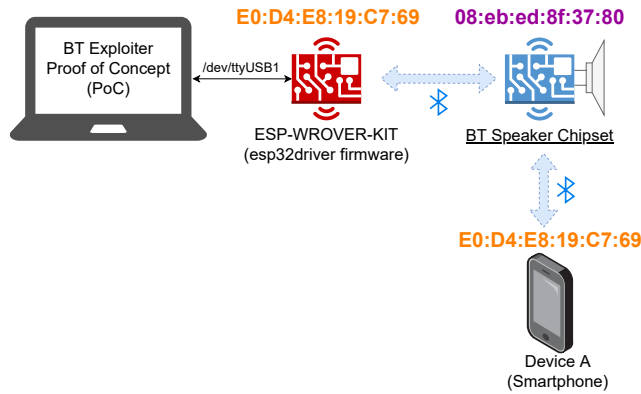
Figure 16: Same Host Connection

When reaching Actions Semi during the disclosure period, the company has informed us that they recommend the product vendors to only allow one audio BT connection. However, when we tested an ATS chipset based product *Xiaomi MDZ-36-DB*, we observed that multiple BT connections are allowed, albeit only one device can play audio at a time. Normally, connections with repeated host BDAddress are rejected on *LMP Setup* procedure (c.f., Figure 1). However, this procedure is successful when testing *Xiaomi MDZ-36-DB* with repeated host BDAddress, leading the audio device to an undefined state.

Impact: An attacker in radio range can exploit this vulnerable behaviour to perform DoS and intentionally deadlock the target device.

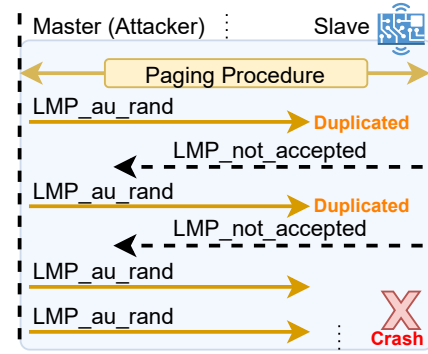
Figure 17: LMP AU Rand Flooding

have a limited capacity of tests that they can perform with their production BT firmware, such as flooding or sending out-of-order packets during normal LMP procedures.

Impact: An attacker in radio range can exploit this vulnerable behaviour to perform DoS and intentionally crash or deadlock the target device.

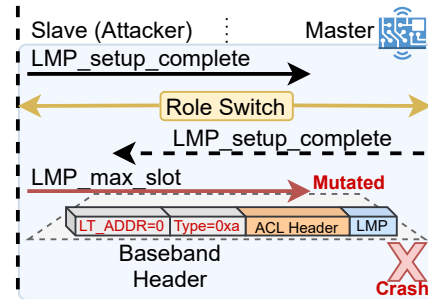
Figure 18: Invalid Max Slot Type

The Bluetooth Classic implementation in the Cypress WICED BT stack 2.9.0 [14] and earlier for CYW20735B1 [13] devices does not properly handle the reception of *LMP_max_slot* with an invalid Baseband packet type and *LT_ADDRESS* (see *Type* and *LT_ADDR* fields in Figure 18). The vulnerability is triggered after completion of the LMP setup procedure, allowing attackers in radio range to trigger a denial of service (firmware crash) via a crafted LMP packet.

Impact: An attacker in radio range can exploit this vulnerable behaviour to perform DoS and intentionally crash the target device.

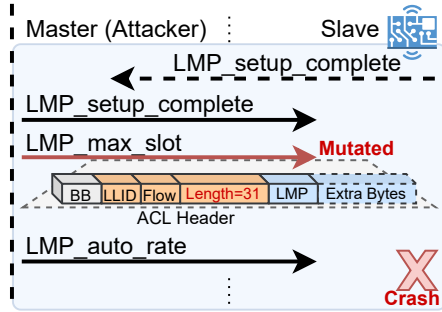
Figure 19: Max Slot Length Overflow

The Bluetooth Classic implementation in the Cypress WICED BT stack 2.9.0 [14] and earlier for CYW20735B1 [13] devices does not properly handle the reception of *LMP_max_slot* with a higher ACL Length (*Length=31* as shown in Figure 19) after completion of the LMP setup procedure. This allows attackers in radio range to trigger a denial of service (firmware crash) via a crafted LMP packet.

Impact: An attacker in radio range can exploit this vulnerability to perform DoS and intentionally crash the target device.

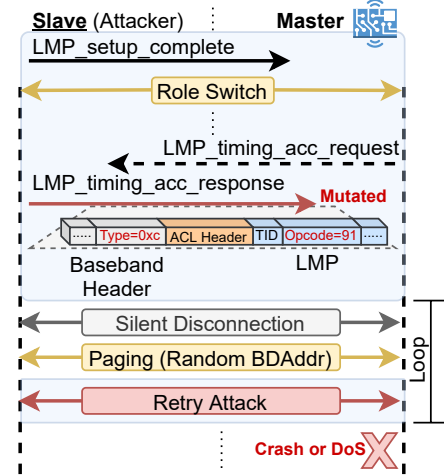
Figure 20: Invalid Timing Accuracy

Impact: This attack causes a denial of service (DoS) attack. Specifically, while the attack is in progress, the target devices are unable to use the Bluetooth service normally.

The impact of this attack does not persist after the attack stops. This is because the target normally tries to recover

the BT connection by performing a re-connection to previously disconnected devices (e.g., Intel AX200 under Linux or Windows). In the case of a WCN3990 firmware crash, the Android OS restarts the Bluetooth daemon and re-uploads a firmware image to WCN3990. Finally, for CYW20735B1, it restarts automatically upon any fault due to its watchdog timer being enabled by default. Nevertheless, in all cases, it is not possible to normally use the device while the attack is in progress, as the BT connection can be disrupted continuously. The attacker only needs to know the BDAAddress of the target device and no authentication is required to launch the attack.

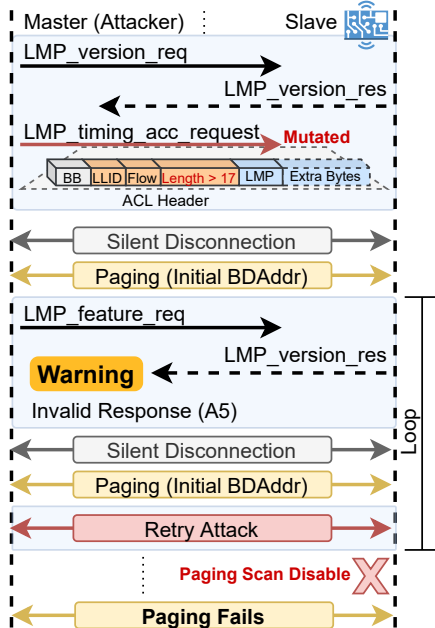
Figure 21: Paging Scan Disable

Impact: Once the attack is triggered and successful, the attacker can cause DoS via the following **AX200** behaviours: **(I)** paging scan is disabled, which prevents any external device to connect to the target even if the BDAddress is known. This behaviour can be used to trick an user to connect to the attacker’s BT hardware instead of the legitimate target since **AX200** paging scan is disabled; **(II)** Multiple active BT connections cannot be performed from the target. The user requires to manually restart the Bluetooth service to restore normal BT behaviour. On Linux and Windows, BT is recovered by disabling and enabling Bluetooth via their respective configuration menu.

Firmware crashes may be sporadically triggered on **AX200** during the attacks, but no specific scenario was found to reliably trigger such crashes all the time.
