# **BRAKTOOTH: Causing Havoc on Bluetooth Link Manager**

## **VULNERABILITY DISCLOSURE REPORT**

August 31, 2021

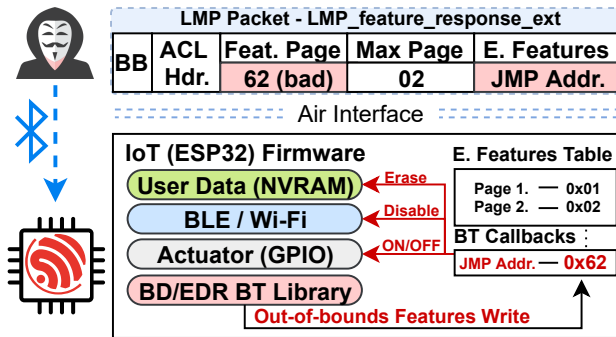
Figure 3: An Illustration of CVE-2021-28138.

The most critical vulnerability (V1 in Table 2 - 8.1) affects *ESP32* SoC [37], which is used in many Wi-Fi and Bluetooth IoT appliances such as Industry Automation, Smart Home, Fitness, etc. The attack is illustrated in Figure 3. A lack of out-of-bounds check in *ESP32 BT Library* [11] allows the reception of a *mutated LMP\_feature\_response\_ext*. This results in the injection of eight bytes of arbitrary data outside the bounds of *Extended Feature Page Table* ("E. Features Table" in Figure 3). An attacker, which knows the firmware layout of a target device, can write a known function address (*JMP Addr.*) to the offset pointed by *Features Page* ("Feat. Page" in the *LMP\_feature\_response\_ext* packet) field. It turns out that the *BT Library* stores some callback pointers within the out-of-bounds *Features Page* offset and such a callback is eventually invoked during the BT connection. While exploiting this vulnerability, we forced *ESP32* into erasing its NVRAM data (normally written during product manufacturing) by setting *JMP Addr.* to the address of *nvs\_flash\_erase*. Such erase function is always included in *ESP32* SDK [9] and therefore, it is present in any *ESP32* firmware. Similarly, disabling BT or BLE can be done via *esp\_bt\_controller\_disable* and Wi-Fi via *disable\_wifi\_apc*. Additionally, general-purpose input/output (GPIO) can be controlled if the attacker knows addresses to functions controlling actuators attached to *ESP32*. As expected, this has serious implications if such an attack is applied to Bluetooth-enabled Smart Home products.

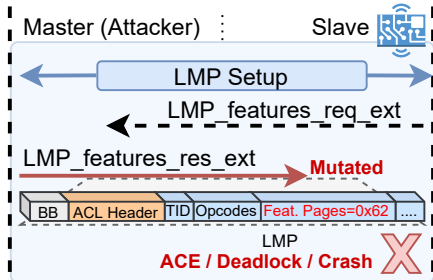
Figure 6: Feature Page Execution

The Bluetooth Classic implementation in Espressif ESP-IDF 4.4 and earlier [9] does not properly restrict the Feature Page upon reception of an LMP Feature Response Extended packet, allowing attackers in radio range to trigger arbitrary code execution (ACE) in ESP32 via a crafted Extended Features bitfield payload. As shown in Figure 6, the ACE vulnerability is triggered by simply sending *LMP\_feature\_res\_ext* with an invalid feature page of 0x62 after *LMP\_Setup* procedure (c.f., Figure 1). Moreover, the contents of extended features in the *LMP\_feature\_res\_ext* can be used to execute code at an arbitrary address within the ESP32 firmware. For example, as described in Section 4.1, such an address may point to the erase function (*nvs\_flash\_erase*) and disabling Wi-Fi (*disable\_wifi\_agc*), among others.

**Impact:** The attacker is able to execute arbitrary functions implemented in the target ESP32's firmware. Once the attacker acquires a dump of ESP32 firmware and the memory layout is known, functions at arbitrary addresses can be called. This allows the attacker to erase user data (NVRAM), call I/O functions that may control actuators, etc. Triggering firmware crashes or a BT deadlock is also possible during repeated attack attempts by executing invalid function addresses. In case of a deadlock, the user needs to manually reset ESP32 to restore BT communications.

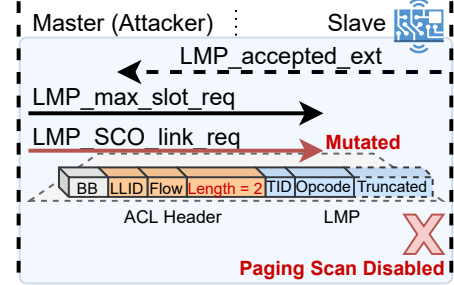
Figure 7: Truncated SCO Link Request

a power cycle (restart) of the device to restore BT communication. Following Figure 7, the attack can be launched by sending an *LMP\_SCO\_Link\_Request* with *ACL length*=2 instead of its normal size of 7.

**Impact:** The attacker is able to prevent external parties to connect to the device, requiring the user to manually perform a power cycle on the device to resume normal connectivity. Attack risk is reduced if the user is already connected to AC6366C or similar chipsets that only allow one active BT connection at a time.

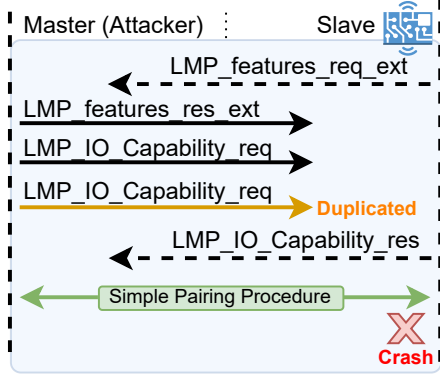
Figure 8: Duplicated IOCAP

**Impact:** The attacker can exploit this vulnerability to promptly cause firmware crashes and therefore maintain a DoS while the attack is taking place. Since ESP32 restarts its firmware by default upon receiving a fault, no user interaction is needed to restore BT communication after the attack is stopped.

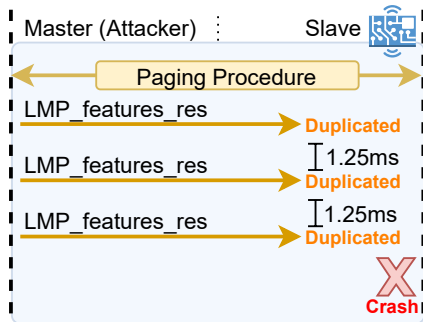
Figure 9: Feature Response Flooding

The Bluetooth Classic implementation in Espressif ESP-IDF 4.4 and earlier [9] does not properly handle the reception of continuous unsolicited LMP responses. This allows attackers in radio range to trigger a denial of service (crash) in ESP32 by flooding the target device with LMP Feature Response

data. As shown in Figure 9, *LMP\_features\_res* packets are sent within a BT transmission slot of 1.25ms, which effectively floods the Slave with unsolicited responses. This attack vector is also effective against a range of other BT chipsets such as **JBL TUNE500BT** [21] and **Xiaomi MDZ-36-DB (Actions Semi. ATS2815)** [39, 42]. See Table 2 for all the targets affected by V4.

**Impact:** The attack triggers a firmware crash on ESP32 and a shutdown on **JBL TUNE500BT** and **Xiaomi MDZ-36-DB**. In the case of a shutdown, the user needs to manually power on the device again to restore communication. Furthermore, since all targets accept multiple BT connections, the attack can also be triggered while the target is already connected to another device. For example, it is possible to immediately stop audio from playing on JBL TUNE500BT and Xiaomi MDZ-36-DB. The attacker, however, needs to know the BDAAddress of the target to launch the attack.

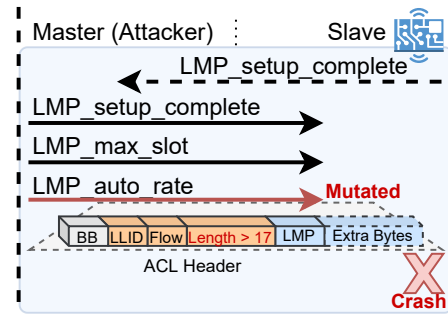
Figure 10: LMP Auto Rate Overflow

bytes, allowing attackers in radio range to trigger a crash in WT32i [24] via a crafted LMP packet. As shown in Figure 10, the attack is triggered by sending an LMP with an ACL size higher than 17 bytes. Normally this is not allowed by the BT Core Specification [31], but ESP32 radio can indeed send such oversized LMP packets over the DM1 transport channel. Our proof of concept (PoC) firmware bypasses some length checks on the transmission path to make this possible. This attack vector also works on some **Jieli AC6905X (BT Audio Receiver)**. Note that this attack requires sending this malformed packet many times over many reconnections to trigger a firmware crash. Particularly, a firmware crash on WT32i may take around 3-5 minutes to be triggered.

**Impact:** The attack causes a firmware crash on both **WT32i** and **AC6905X**. This can be used to cause a sporadic denial of service (DoS) attacks on such devices.

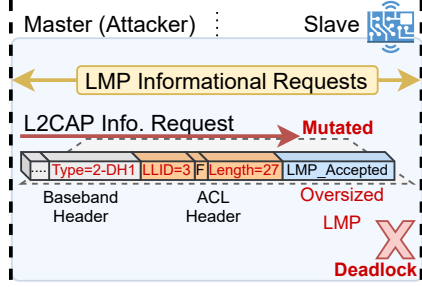
Figure 11: LMP 2-DH1 Overflow

The Bluetooth Classic implementation on Laird CSR8811 A08 [28] and CSR8510 A10 [27] SoCs allows an LMP length overflow over 2-DH1, resulting in a Deadlock (state machine or packet handler corruption) outcome. Figure 11 captures the sequence of messages exchanged to expose this vulnerability. In particular, the attack is performed by changing the transport type of the normal LMP packet to 2-DH1 and then adding more bytes to the LMP payload. This, for example, results in a total ACL length of 27.

**Impact:** The attack causes a BT deadlock on Laird CSR8811 and a firmware crash on CSR8510 operating as a standard BT dongle. While the dongle firmware crash is automatically recovered by the OS, the deadlock requires the user to perform a power cycle to restore normal BT communication. The attack does not affect Bluetooth Low Energy (BLE) communication in CSR8811.

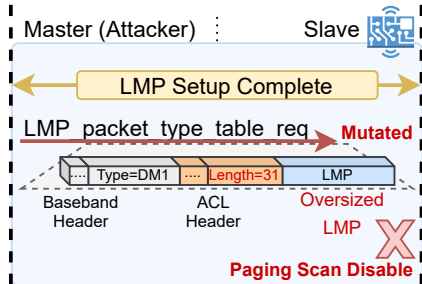
Figure 12: LMP DM1 Overflow

The Bluetooth Classic implementation on Bluetooth AB5301A [5] (tested with AB32VG1 dev. kit [4]) with *unspecified* firmware versions does not properly handle the reception of oversized DM1 LMP packets. This allows attackers in radio range to prevent new BT connections (disabling the AB5301A inquiry and page scan procedures) via a crafted LMP packet. Following Figure 12, an arbitrary LMP packet (*LMP\_packet\_type\_table\_req*) is sent with an ACL length of 31, which is much higher than the expected 17 byte limit for DM1 transport. Due to a lack of check of DM1 length, an undefined behaviour on the target baseband implementation was observed. This eventually disables the paging scan procedure and hence blocks new connections. If the user is already connected to AB5301A and the attack is started (multiple BT connections are allowed), the active connection is not disrupted, but new connections or reconnection is not possible. As compared to V5 (Section 8.5), this attack works with any overflowed LMP packet rather than a specific LMP packet.

**Impact:** The impact of this attack is similar to V2 (Section 8.2), in which connections to the target are not accepted due to the page scan procedure being disabled after the attack (see Figure 1). Therefore, the user needs to manually perform a power cycle (restart) of the device to restore normal BT connectivity.

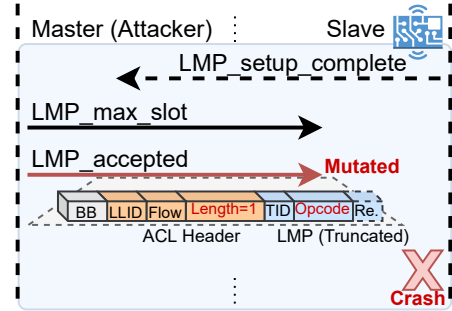
Figure 13: Truncated LMP Accepted

As the BT implementation of the target is closed source, the exact root cause of this vulnerability is not known. However, it is common that LMP procedures involving slot and rate adjustments are usually implemented in an interrupt handler different than other non-real-time LMP packets, such as feature requests and version requests. Such a handler may miss some checks which are present on the other handlers, explaining why some overflow/underflow attacks only work for certain LMP packet opcodes. This split in the LMP handler is present, for instance, in ESP32 BT implementation.

**Impact:** The impact is a denial of service due to a firmware crash & restart. The overall risk of such an attack is reduced if AC690X and AC692X do not allow multiple BT connections. In such a scenario, the attacker could only trigger a firmware crash when no user is connected to AC690X or AC692X.

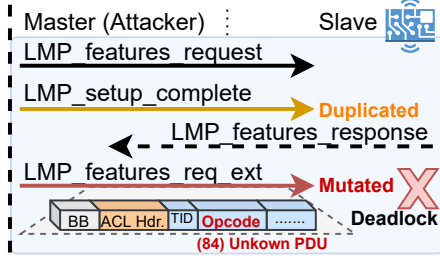
Figure 14: Invalid Setup Complete

This scenario is illustrated in Figure 14. The attacker sends an unexpected (duplicated) *LMP\_setup\_complete*, followed by a malformed *LMP\_features\_req\_ext* with an invalid LMP opcode such as 0x64. The behaviour seen in Figure 14 allows attackers in radio range to deadlock a device via injecting crafted LMP packets. Moreover, the user needs to manually reboot the device to restore communication.

**Impact:** An attacker can exploit this vulnerability to perform a DoS. The overall risk of such an attack is reduced if AC690X and AC692X do not allow multiple BT connections.

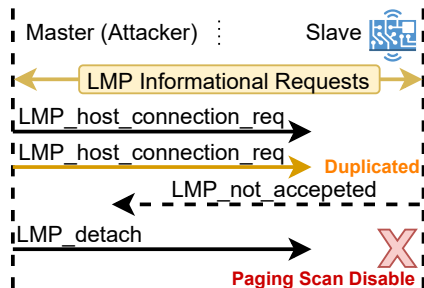
Figure 15: Host Connection Flooding

The Bluetooth Classic implementation on Actions ATS2815/ATS2819 [39] chipsets does not properly handle the reception of multiple *LMP\_host\_connection\_req* as shown in Figure 15. This allows attackers in radio range to trigger a denial of service (deadlock) if no user is connected to the target. Manual user intervention is required to restart the device and restore Bluetooth communication.

**Impact:** An attacker in radio range can exploit the vulnerability to perform DoS and shutdown or restart products using chipsets and products based on Actions ATS2815/ATS2819. However, the impact of the attack is reduced as the vulnerability is only exploited when no other user device is connected to the target.

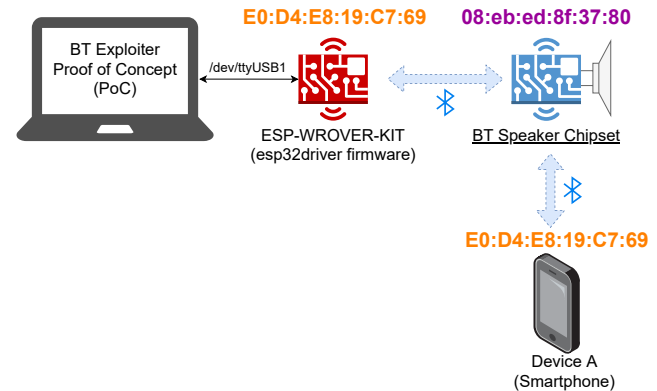
Figure 16: Same Host Connection

When reaching Actions Semi during the disclosure period, the company has informed us that they recommend the product vendors to only allow one audio BT connection. However, when we tested an ATS chipset based product *Xiaomi MDZ-36-DB*, we observed that multiple BT connections are allowed, albeit only one device can play audio at a time. Normally, connections with repeated host BDAddress are rejected on *LMP Setup* procedure (c.f., Figure 1). However, this procedure is successful when testing *Xiaomi MDZ-36-DB* with repeated host BDAddress, leading the audio device to an undefined state.

**Impact:** An attacker in radio range can exploit this vulnerable behaviour to perform DoS and intentionally deadlock the target device.

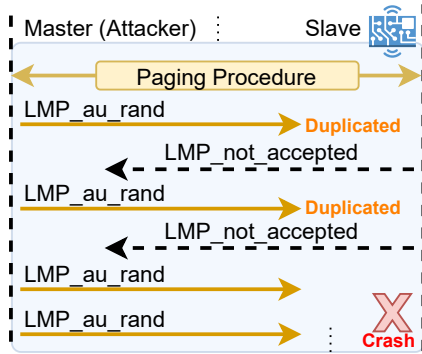
Figure 17: LMP AU Rand Flooding

Many major chipset vendors are affected by this attack as shown in Table 2. This attack is similar to Feature Response Flooding (Section 8.4), indicating that flooding testing with packets from certain LMP procedures may not have been well tested. This may arise because the *Core Specifications* only allows a limited LMP testing mode [32] that restricts the SoC to work with only a few LMP packets. This, in turn, may restrict the test flexibility for BT vendors. Specifically, vendors may have a limited capacity of tests that they can perform with their production BT firmware, such as flooding or sending out-of-order packets during normal LMP procedures.

**Impact:** An attacker in radio range can exploit this vulnerable behaviour to perform DoS and intentionally crash or deadlock the target device.

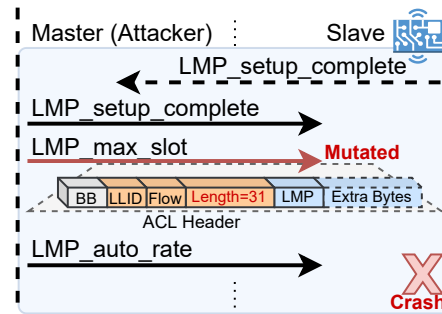
Figure 19: Max Slot Length Overflow

does not properly handle the reception of *LMP\_max\_slot* with a higher ACL Length (*Length=31* as shown in Figure 19) after completion of the LMP setup procedure. This allows attackers in radio range to trigger a denial of service (firmware crash) via a crafted LMP packet.

**Impact:** An attacker in radio range can exploit this vulnerability to perform DoS and intentionally crash the target device.

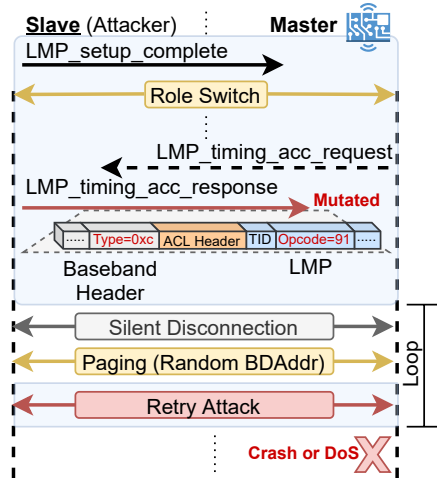
Figure 20: Invalid Timing Accuracy

The first DoS (**Invalid Timing Accuracy** - 8.14) is due to a failure in the SoC to free resources upon receiving an invalid *LMP\_timing\_accuracy\_response* from a BT slave. The attacker can exhaust the SoC by (a) *paging*, (b) sending the malformed packet, and (c) disconnecting without sending *LMP\_detach*. These steps are repeated with a different BT address (i.e., BDAddress) until the SoC is exhausted from accepting new connections. On exhaustion, the SoC fails to recover itself and disrupts current active connections, triggering firmware crashes sporadically. This vulnerability allows an attacker to forcibly disconnect *slave* BT devices currently connected to *AX200* under Windows or Linux Laptops. Similarly, Android phones such as Pocophone F1 and Oppo Reno 5G [26] experience BT disruptions. For example, users connected to BT Headsets experience audio to be continuously "cut" during the attack. This also results in firmware crashes and restart of Android BT Service. In all cases, the OS tries to recover connectivity which can be continuously disrupted.

**Impact:** This attack causes a denial of service (DoS) attack. Specifically, while the attack is in progress, the target devices are unable to use the Bluetooth service normally.

The impact of this attack does not persist after the attack stops. This is because the target normally tries to recover the BT connection by performing a re-connection to previously disconnected devices (e.g., Intel AX200 under Linux or Windows). In the case of a WCN3990 firmware crash, the Android OS restarts the Bluetooth daemon and re-uploads a firmware image to WCN3990. Finally, for CYW20735B1, it restarts automatically upon any fault due to its watchdog timer being enabled by default. Nevertheless, in all cases, it is not possible to normally use the device while the attack is in progress, as the BT connection can be disrupted continuously. The attacker only needs to know the BDAddress of the target device and no authentication is required to launch the attack.

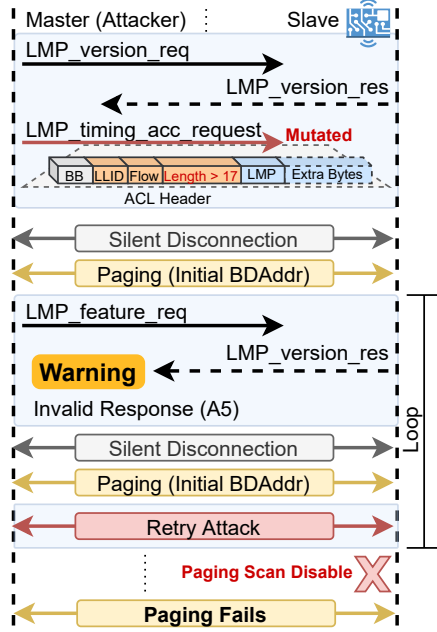
Figure 21: Paging Scan Disable

The second DoS (**Paging Scan Disable** - 8.16) affects only devices using *Intel AX200* and it is triggered when an oversized *LMP\_timing\_accuracy\_request* (>17 bytes) is sent to *AX200 slave*. This temporarily corrupts *AX200* firmware, which responds incorrectly during a subsequent BT connection and eventually disables the *paging scan* procedure (cf., Figure 1). Thus, scanning *AX200* works, but no connection is established from an external BT device. Therefore, this attack can be used to trick an user to connect to the attacker's BT hardware instead of the legitimate target since *AX200* paging scan is disabled. Indeed, the user needs to manually re-enable BT to restore functionality. The attack is also used to disconnect certain *master* BT devices connected to a vulnerable Laptop. This leads to sporadic BT firmware crashes.

**Impact:** Once the attack is triggered and successful, the attacker can cause DoS via the following AX200 behaviours: (I) paging scan is disabled, which prevents any external device to connect to the target even if the BDAddress is known. This behaviour can be used to trick an user to connect to the attacker's BT hardware instead of the legitimate target since AX200 paging scan is disabled; (II) Multiple active BT connections cannot be performed from the target. The user requires to manually restart the Bluetooth service to restore normal BT behaviour. On Linux and Windows, BT is recovered by disabling and enabling Bluetooth via their respective configuration menu.

Firmware crashes may be sporadically triggered on AX200 during the attacks, but no specific scenario was found to reliably trigger such crashes all the time.
