BRAKTOOTH: Causing Havoc on Bluetooth Link Manager

VULNERABILITY DISCLOSURE REPORT

August 31, 2021

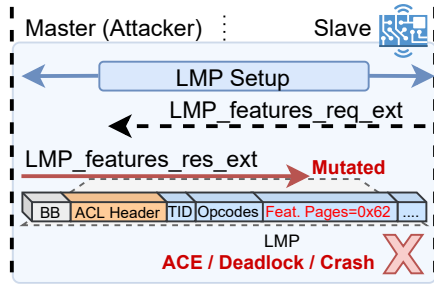
Figure 6: Feature Page Execution

allowing attackers in radio range to trigger arbitrary code execution (ACE) in ESP32 via a crafted Extended Features bitfield payload. As shown in Figure 6, the ACE vulnerability is triggered by simply sending *LMP_feature_res_ext* with an invalid feature page of 0x62 after *LMP_Setup* procedure (c.f., Figure 1). Moreover, the contents of extended features in the *LMP_feature_res_ext* can be used to execute code at an arbitrary address within the ESP32 firmware. For example, as described in Section 4.1, such an address may point to the erase function (*nvs_flash_erase*) and disabling Wi-Fi (*disable_wifi_age*), among others.

Impact: The attacker is able to execute arbitrary functions implemented in the target ESP32’s firmware. Once the attacker acquires a dump of ESP32 firmware and the memory layout is known, functions at arbitrary addresses can be called. This allows the attacker to erase user data (NVRAM), call I/O functions that may control actuators, etc. Triggering firmware crashes or a BT deadlock is also possible during repeated attack attempts by executing invalid function addresses. In case of a deadlock, the user needs to manually reset ESP32 to restore BT communications.

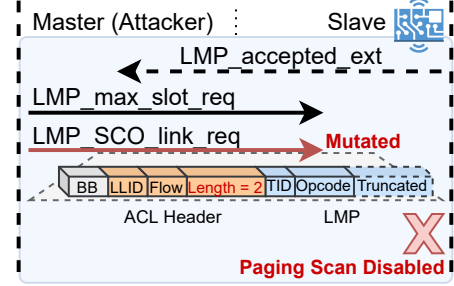
Figure 7: Truncated SCO Link Request

Impact: The attacker is able to prevent external parties to connect to the device, requiring the user to manually perform a power cycle on the device to resume normal connectivity. Attack risk is reduced if the user is already connected to

AC6366C or similar chipsets that only allow one active BT connection at a time.

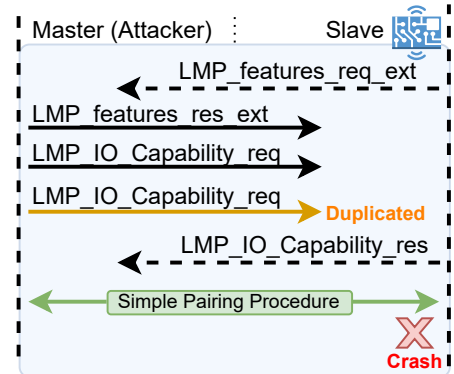
Figure 8: Duplicated IOCAP

The Bluetooth Classic implementation in Espressif ESP-IDF 4.4 and earlier [9] does not properly handle the reception of multiple *LMP_IO_Capability_req* packets during the *pairing process* (see Figure 8). This allows attackers in radio range to trigger memory corruption (and consequently a crash) in ESP32 via a replayed (duplicated) LMP packet. The issue was raised due to the sudden disconnection of ESP32 while its bluedroid host stack was still in the pairing process. The patch provided by Espressif rectifies this issue by handling a sudden disconnection during the pairing procedure (c.f., Table 5).

Impact: The attacker can exploit this vulnerability to promptly cause firmware crashes and therefore maintain a DoS while the attack is taking place. Since ESP32 restarts its firmware by default upon receiving a fault, no user interaction is needed to restore BT communication after the attack is stopped.

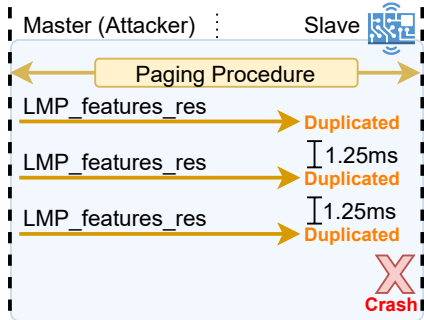
Figure 9: Feature Response Flooding

The Bluetooth Classic implementation in Espressif ESP-IDF 4.4 and earlier [9] does not properly handle the reception of continuous unsolicited LMP responses. This allows attackers in radio range to trigger a denial of service (crash) in ESP32 by flooding the target device with LMP Feature Response data. As shown in Figure 9, *LMP_features_res* packets are sent within a BT transmission slot of 1.25ms, which effectively floods the Slave with unsolicited responses. This attack vector is also effective against a range of other BT chipsets such as **JBL TUNE500BT** [21] and **Xiaomi MDZ-36-DB (Actions Semi. ATS2815)** [39, 42]. See Table 2 for all the targets affected by V4.

Impact: The attack triggers a firmware crash on ESP32 and a shutdown on **JBL TUNE500BT** and **Xiaomi MDZ-36-DB**. In the case of a shutdown, the user needs to manually power on the device again to restore communication. Furthermore, since all targets accept multiple BT connections, the attack can also be triggered while the target is already connected to another device. For example, it is possible to immediately stop audio from playing on JBL TUNE500BT and Xiaomi MDZ-36-DB. The attacker, however, needs to know the BDAAddress of the target to launch the attack.

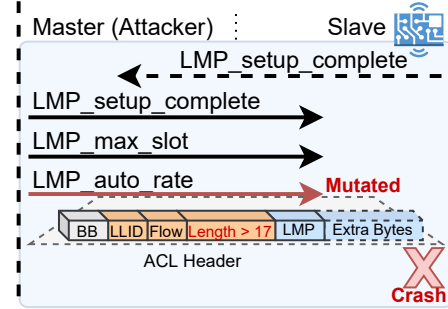
Figure 10: LMP Auto Rate Overflow

attack vector also works on some **Jieli AC6905X (BT Audio Receiver)**. Note that this attack requires sending this malformed packet many times over many reconnections to trigger a firmware crash. Particularly, a firmware crash on WT32i may take around 3-5 minutes to be triggered.

Impact: The attack causes a firmware crash on both **WT32i** and **AC6905X**. This can be used to cause a sporadic denial of service (DoS) attacks on such devices.

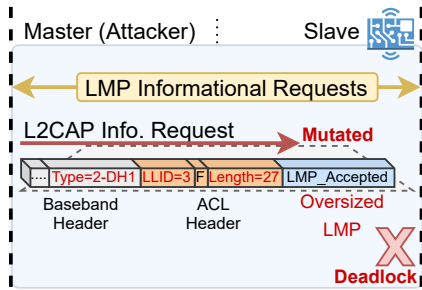
Figure 11: LMP 2-DH1 Overflow

Impact: The attack causes a BT deadlock on Laird CSR8811 and a firmware crash on CSR8510 operating as a standard BT dongle. While the dongle firmware crash is automatically recovered by the OS, the deadlock requires the user to perform a power cycle to restore normal BT communication. The attack does not affect Bluetooth Low Energy (BLE) communication in CSR8811.

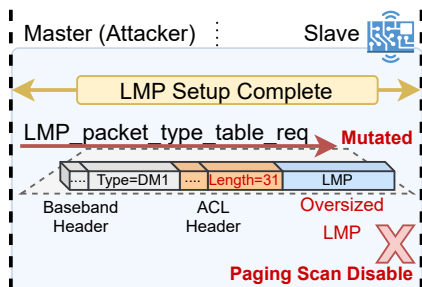
Figure 12: LMP DM1 Overflow

The Bluetooth Classic implementation on Bluetooth AB5301A [5] (tested with AB32VG1 dev. kit [4]) with *unspecified* firmware versions does not properly handle the reception of oversized DM1 LMP packets. This allows attackers in radio range to prevent new BT connections (disabling the AB5301A inquiry and page scan procedures) via a crafted LMP packet. Following Figure 12, an arbitrary LMP packet

(*LMP_packet_type_table_req*) is sent with an ACL length of 31, which is much higher than the expected 17 byte limit for DM1 transport. Due to a lack of check of DM1 length, an undefined behaviour on the target baseband implementation was observed. This eventually disables the paging scan procedure and hence blocks new connections. If the user is already connected to AB5301A and the attack is started (multiple BT connections are allowed), the active connection is not disrupted, but new connections or reconnection is not possible. As compared to **V5** (Section 8.5), this attack works with any overflown LMP packet rather than a specific LMP packet.

Impact: The impact of this attack is similar to **V2** (Section 8.2), in which connections to the target are not accepted due to the page scan procedure being disabled after the attack (see Figure 1). Therefore, the user needs to manually perform a power cycle (restart) of the device to restore normal BT connectivity.

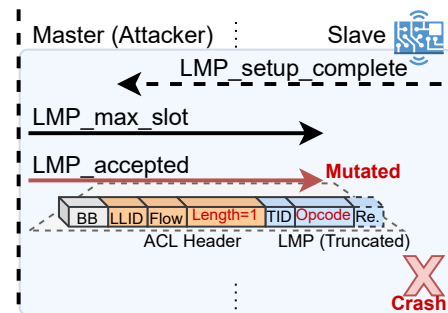
Figure 13: Truncated LMP Accepted

As the BT implementation of the target is closed source, the exact root cause of this vulnerability is not known. However, it is common that LMP procedures involving slot and rate adjustments are usually implemented in an interrupt handler different than other non-real-time LMP packets, such as feature requests and version requests. Such a handler may miss some checks which are present on the other handlers, explaining why some overflow/underflow attacks only work for certain LMP packet opcodes. This split in the LMP handler is present, for instance, in ESP32 BT implementation.

Impact: The impact is a denial of service due to a firmware crash & restart. The overall risk of such an attack is reduced if AC690X and AC692X do not allow multiple BT connections. In such a scenario, the attacker could only trigger a firmware crash when no user is connected to AC690X or AC692X.

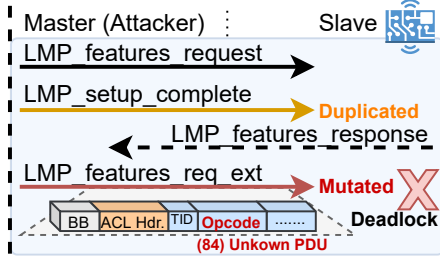
Figure 14: Invalid Setup Complete

This scenario is illustrated in Figure 14. The attacker sends an unexpected (duplicated) *LMP_setup_complete*, followed by a malformed *LMP_features_req_ext* with an invalid LMP opcode such as 0x64. The behaviour seen in Figure 14 allows attackers in radio range to deadlock a device via injecting crafted LMP packets. Moreover, the user needs to manually reboot the device to restore communication.

Impact: An attacker can exploit this vulnerability to perform a DoS. The overall risk of such an attack is reduced if AC690X and AC692X do not allow multiple BT connections.

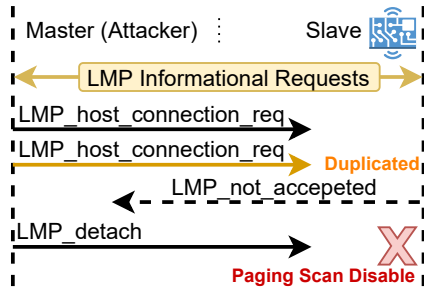
Figure 15: Host Connection Flooding

The Bluetooth Classic implementation on Actions ATS2815/ATS2819 [39] chipsets does not properly handle the reception of multiple *LMP_host_connection_req* as shown in Figure 15. This allows attackers in radio range to trigger a denial of service (deadlock) if no user is connected to the target. Manual user intervention is required to restart the device and restore Bluetooth communication.

Impact: An attacker in radio range can exploit the vulnerability to perform DoS and shutdown or restart products using chipsets and products based on Actions ATS2815/ATS2819. However, the impact of the attack is reduced as the vulnerability is only exploited when no other user device is connected to the target.

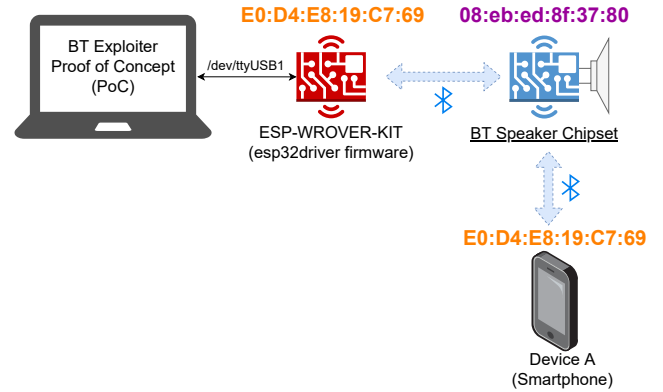
Figure 16: Same Host Connection

When reaching Actions Semi during the disclosure period, the company has informed us that they recommend the product vendors to only allow one audio BT connection. However, when we tested an ATS chipset based product *Xiaomi MDZ-36-DB*, we observed that multiple BT connections are allowed, albeit only one device can play audio at a time. Normally, connections with repeated host BDAAddress are rejected on *LMP_Setup* procedure (c.f., Figure 1). However, this procedure is successful when testing *Xiaomi MDZ-36-DB* with repeated host BDAAddress, leading the audio device to an undefined state.

Impact: An attacker in radio range can exploit this vulnerable behaviour to perform DoS and intentionally deadlock the target device.

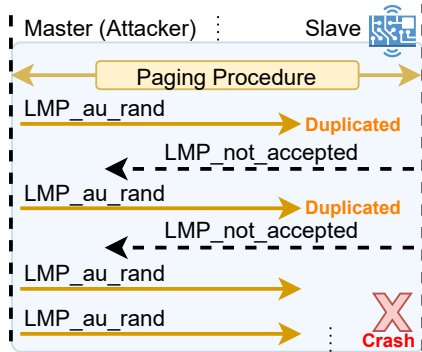
Figure 17: LMP AU Rand Flooding

have a limited capacity of tests that they can perform with their production BT firmware, such as flooding or sending out-of-order packets during normal LMP procedures.

Impact: An attacker in radio range can exploit this vulnerable behaviour to perform DoS and intentionally crash or deadlock the target device.

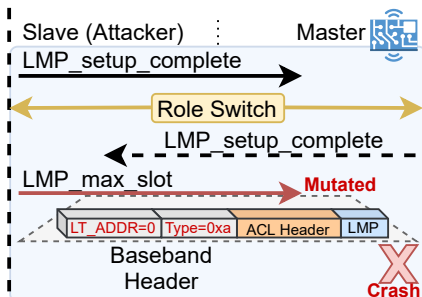
Figure 18: Invalid Max Slot Type

The Bluetooth Classic implementation in the Cypress WICED BT stack 2.9.0 [14] and earlier for CYW20735B1 [13] devices does not properly handle the reception of *LMP_max_slot* with an invalid Baseband packet type and *LT_ADDRESS* (see *Type* and *LT_ADDR* fields in Figure 18). The vulnerability is triggered after completion of the LMP setup procedure, allowing attackers in radio range to trigger a denial of service (firmware crash) via a crafted LMP packet.

Impact: An attacker in radio range can exploit this vulnerable behaviour to perform DoS and intentionally crash the target device.

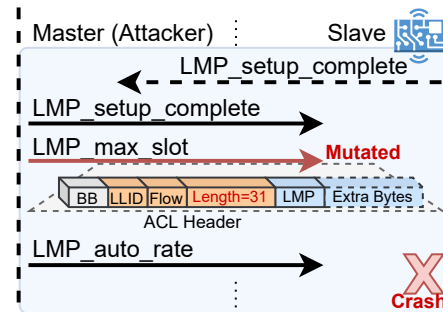
Figure 19: Max Slot Length Overflow

The Bluetooth Classic implementation in the Cypress WICED BT stack 2.9.0 [14] and earlier for CYW20735B1 [13] devices does not properly handle the reception of *LMP_max_slot* with a higher ACL Length (*Length=31* as shown in Figure 19) after completion of the LMP setup procedure. This allows attackers in radio range to trigger a denial of service (firmware crash) via a crafted LMP packet.

Impact: An attacker in radio range can exploit this vulnerability to perform DoS and intentionally crash the target device.

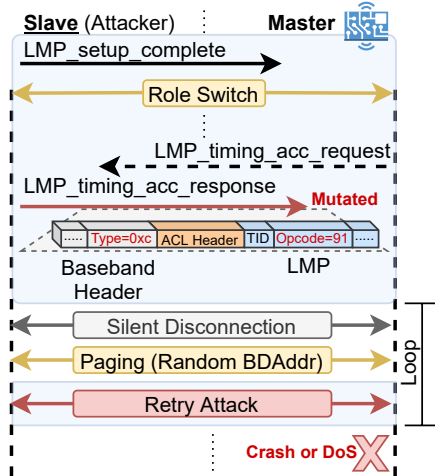
Figure 20: Invalid Timing Accuracy

Impact: This attack causes a denial of service (DoS) attack. Specifically, while the attack is in progress, the target devices are unable to use the Bluetooth service normally.

The impact of this attack does not persist after the attack stops. This is because the target normally tries to recover the BT connection by performing a re-connection to previously disconnected devices (e.g., Intel AX200 under Linux or Windows). In the case of a WCN3990 firmware crash, the Android OS restarts the Bluetooth daemon and re-uploads a firmware image to WCN3990. Finally, for CYW20735B1, it restarts automatically upon any fault due to its watchdog timer being enabled by default. Nevertheless, in all cases, it is not possible to normally use the device while the attack is in progress, as the BT connection can be disrupted continuously. The attacker only needs to know the BDAddress of the target device and no authentication is required to launch the attack.
