# **BRAKTOOTH: Causing Havoc on Bluetooth Link Manager**

## **VULNERABILITY DISCLOSURE REPORT**

August 31, 2021

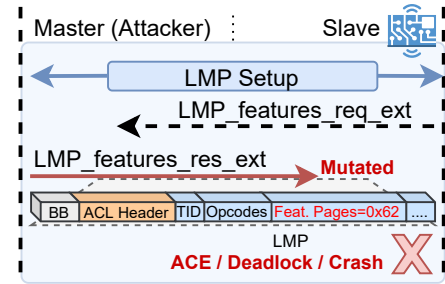
Figure 6: Feature Page Execution

allowing attackers in radio range to trigger arbitrary code execution (ACE) in ESP32 via a crafted Extended Features bitfield payload. As shown in Figure 6, the ACE vulnerability is triggered by simply sending *LMP\_feature\_res\_ext* with an invalid feature page of 0x62 after *LMP Setup* procedure (c.f., Figure 1). Moreover, the contents of extended features in the *LMP\_feature\_res\_ext* can be used to execute code at an arbitrary address within the ESP32 firmware. For example, as described in Section 4.1, such an address may point to the erase function (*nvs\_flash\_erase*) and disabling Wi-Fi (*disable\_wifi\_age*), among others.

**Impact:** The attacker is able to execute arbitrary functions implemented in the target ESP32’s firmware. Once the attacker acquires a dump of ESP32 firmware and the memory layout is known, functions at arbitrary addresses can be called. This allows the attacker to erase user data (NVRAM), call I/O functions that may control actuators, etc. Triggering firmware crashes or a BT deadlock is also possible during repeated attack attempts by executing invalid function addresses. In case of a deadlock, the user needs to manually reset ESP32 to restore BT communications.

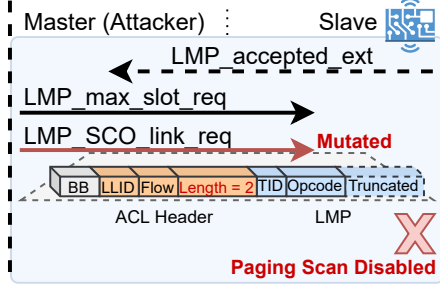
Figure 7: Truncated SCO Link Request

**Impact:** The attacker is able to prevent external parties to connect to the device, requiring the user to manually perform a power cycle on the device to resume normal connectivity. Attack risk is reduced if the user is already connected to

AC6366C or similar chipsets that only allow one active BT connection at a time.

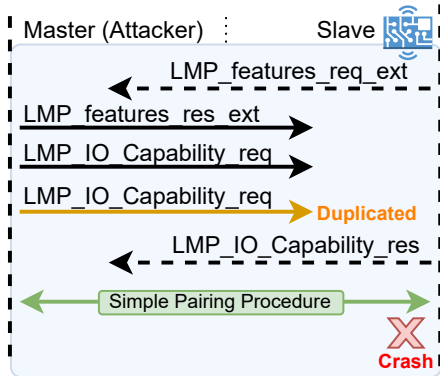
Figure 8: Duplicated IOCAP

The Bluetooth Classic implementation in Espressif ESP-IDF 4.4 and earlier [9] does not properly handle the reception of multiple *LMP\_IO\_Capability\_req* packets during the *pairing process* (see Figure 8). This allows attackers in radio range to trigger memory corruption (and consequently a crash) in ESP32 via a replayed (duplicated) LMP packet. The issue was raised due to the sudden disconnection of ESP32 while its bluedroid host stack was still in the pairing process. The patch provided by Espressif rectifies this issue by handling a sudden disconnection during the pairing procedure (c.f., Table 5).

**Impact:** The attacker can exploit this vulnerability to promptly cause firmware crashes and therefore maintain a DoS while the attack is taking place. Since ESP32 restarts its firmware by default upon receiving a fault, no user interaction is needed to restore BT communication after the attack is stopped.

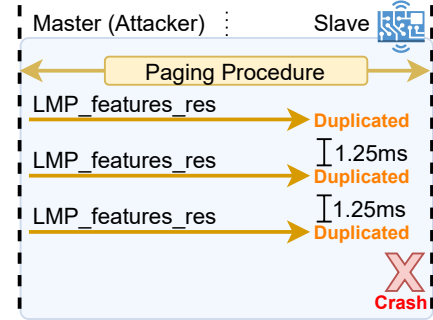
Figure 9: Feature Response Flooding

The Bluetooth Classic implementation in Espressif ESP-IDF 4.4 and earlier [9] does not properly handle the reception of continuous unsolicited LMP responses. This allows attackers in radio range to trigger a denial of service (crash) in ESP32 by flooding the target device with LMP Feature Response data. As shown in Figure 9, *LMP\_features\_res* packets are sent within a BT transmission slot of 1.25ms, which effectively floods the Slave with unsolicited responses. This attack vector is also effective against a range of other BT chipsets such as **JBL TUNE500BT** [21] and **Xiaomi MDZ-36-DB (Actions Semi. ATS2815)** [38, 41]. See Table 2 for all the targets affected by V4.

**Impact:** The attack triggers a firmware crash on ESP32 and a shutdown on **JBL TUNE500BT** and **Xiaomi MDZ-36-DB**. In the case of a shutdown, the user needs to manually power on the device again to restore communication. Furthermore, since all targets accept multiple BT connections, the attack can also be triggered while the target is already connected to another device. For example, it is possible to immediately stop audio from playing on JBL TUNE500BT and Xiaomi MDZ-36-DB. The attacker, however, needs to know the BDAAddress of the target to launch the attack.

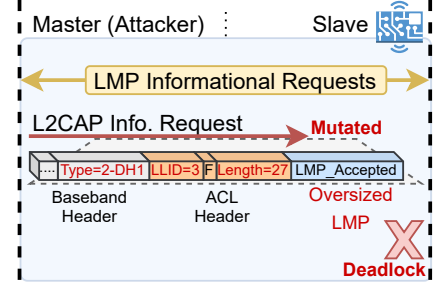
Figure 11: LMP 2-DH1 Overflow

**Impact:** The attack causes a BT deadlock on Laird CSR8811 and a firmware crash on CSR8510 operating as a standard BT dongle. While the dongle firmware crash is automatically recovered by the OS, the deadlock requires the user to perform a power cycle to restore normal BT communication. The attack does not affect Bluetooth Low Energy (BLE) communication in CSR8811.

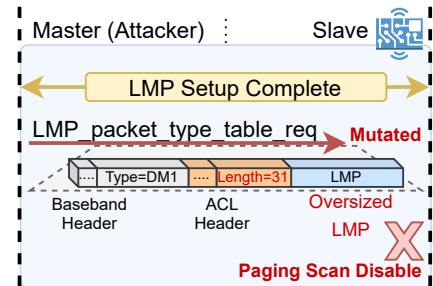
Figure 12: LMP DM1 Overflow

The Bluetooth Classic implementation on Bluetooth AB5301A [5] (tested with AB32VG1 dev. kit [4]) with *unspecified* firmware versions does not properly handle the reception of oversized DM1 LMP packets. This allows attackers in radio range to prevent new BT connections (disabling the AB5301A inquiry and page scan procedures) via a crafted LMP packet. Following Figure 12, an arbitrary LMP packet

(*LMP\_packet\_type\_table\_req*) is sent with an ACL length of 31, which is much higher than the expected 17 byte limit for DM1 transport. Due to a lack of check of DM1 length, an undefined behaviour on the target baseband implementation was observed. This eventually disables the paging scan procedure and hence blocks new connections. If the user is already connected to AB5301A and the attack is started (multiple BT connections are allowed), the active connection is not disrupted, but new connections or reconnection is not possible. As compared to V5 (Section 8.5), this attack works with any overflown LMP packet rather than a specific LMP packet.

**Impact:** The impact of this attack is similar to V2 (Section 8.2), in which connections to the target are not accepted due to the page scan procedure being disabled after the attack (see Figure 1). Therefore, the user needs to manually perform a power cycle (restart) of the device to restore normal BT connectivity.

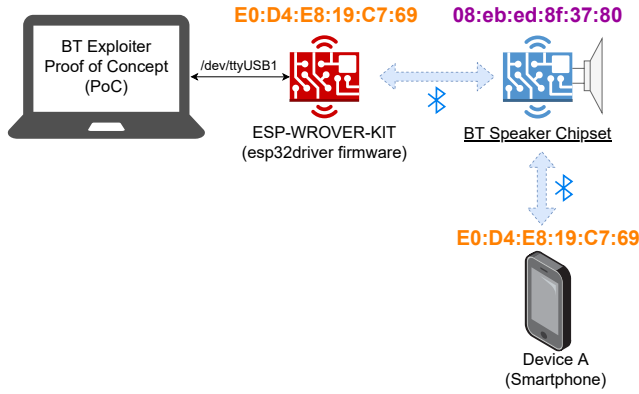
Figure 16: Same Host Connection

When reaching Actions Semi during the disclosure period, the company has informed us that they recommend the product vendors to only allow one audio BT connection. However, when we tested an ATS chipset based product *Xiaomi MDZ-36-DB*, we observed that multiple BT connections are allowed, albeit only one device can play audio at a time. Normally, connections with repeated host BDAddress are rejected on *LMP Setup* procedure (c.f., Figure 1). However, this procedure is successful when testing *Xiaomi MDZ-36-DB* with repeated host BDAddress, leading the audio device to an undefined state.

**Impact:** An attacker in radio range can exploit this vulnerable behaviour to perform DoS and intentionally deadlock the target device.

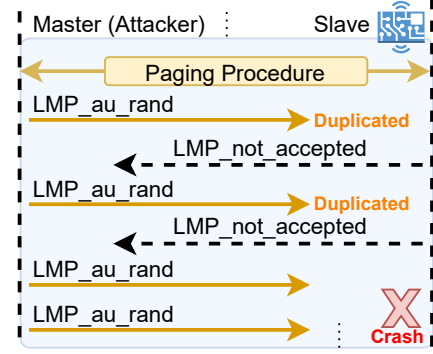
Figure 17: LMP AU Rand Flooding

**Impact:** An attacker in radio range can exploit this vulnerable behaviour to perform DoS and intentionally crash or deadlock the target device.

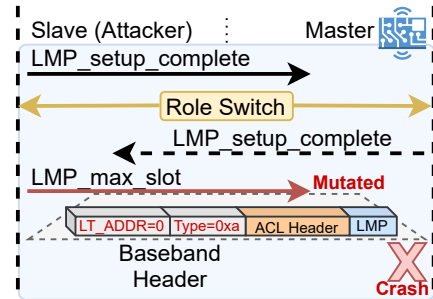
Figure 18: Invalid Max Slot Type

The Bluetooth Classic implementation in the Cypress WICED BT stack 2.9.0 [14] and earlier for CYW20735B1 [13] devices does not properly handle the reception of *LMP\_max\_slot* with an invalid Baseband packet type and *LT\_ADDRESS* (see *Type* and *LT\_ADDR* fields in Figure 18). The vulnerability is triggered after completion of the LMP setup procedure, allowing attackers in radio range to trigger a denial of service (firmware crash) via a crafted LMP packet.

**Impact:** An attacker in radio range can exploit this vulnerable behaviour to perform DoS and intentionally crash the target device.

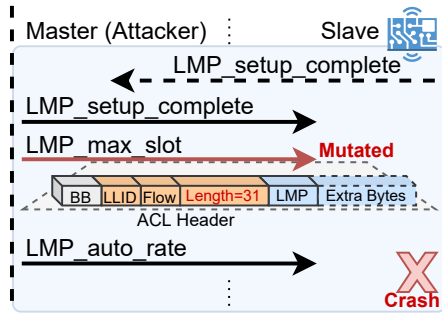
Figure 19: Max Slot Length Overflow

The Bluetooth Classic implementation in the Cypress WICED BT stack 2.9.0 [14] and earlier for CYW20735B1 [13] devices does not properly handle the reception of *LMP\_max\_slot* with a higher ACL Length (*Length=31* as shown in Figure 19) after completion of the LMP setup procedure. This allows attackers in radio range to trigger a denial of service (firmware crash) via a crafted LMP packet.

**Impact:** An attacker in radio range can exploit this vulnerability to perform DoS and intentionally crash the target device.
