First Notice of Loss

Claim Number: CEN23LA157

Make: Acro Sport

Model: II

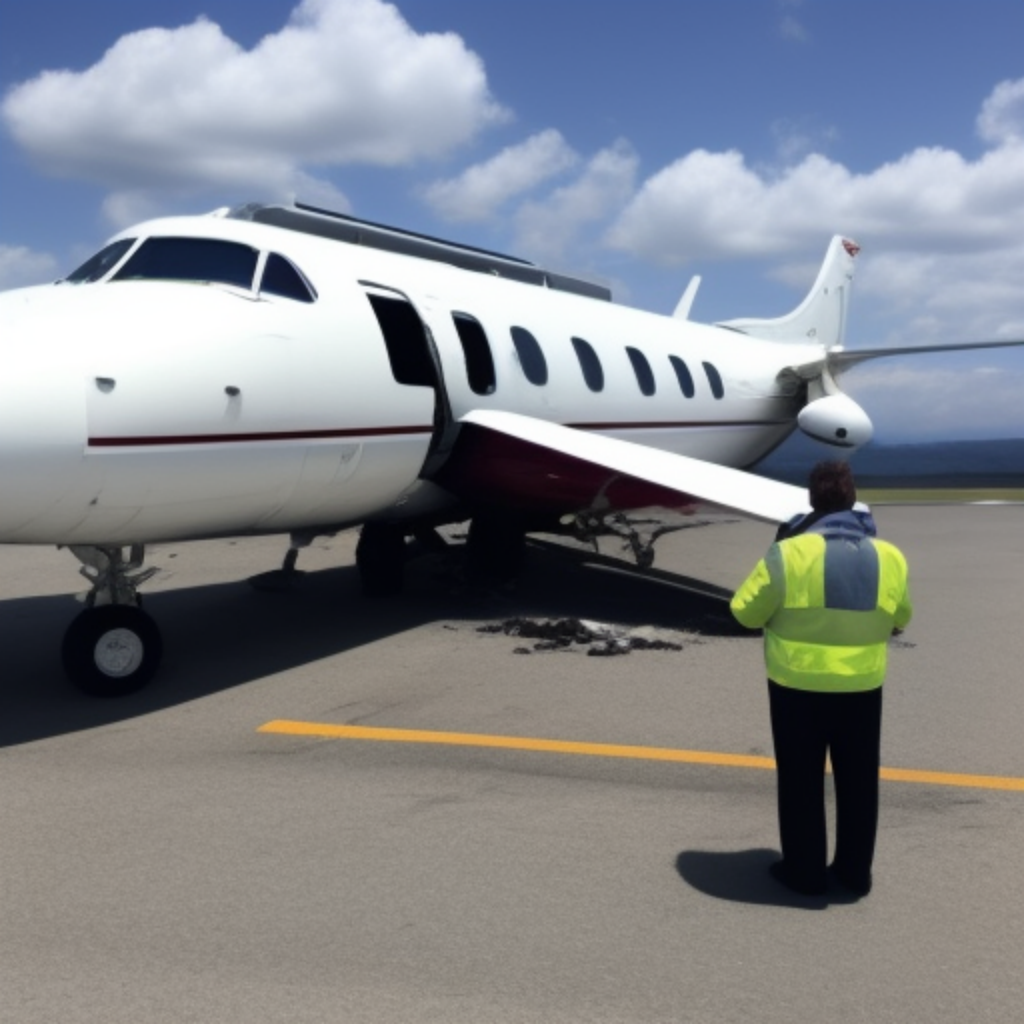
Cause: The pilot's failure to maintain directional control during landing in a gusting crosswind.

Damage: Substantial
