Automated Coconut Rhinoceros Beetle Roadside Damage Survey on Majuro, October 2023

Aubrey Moore PhD

December 1, 2023

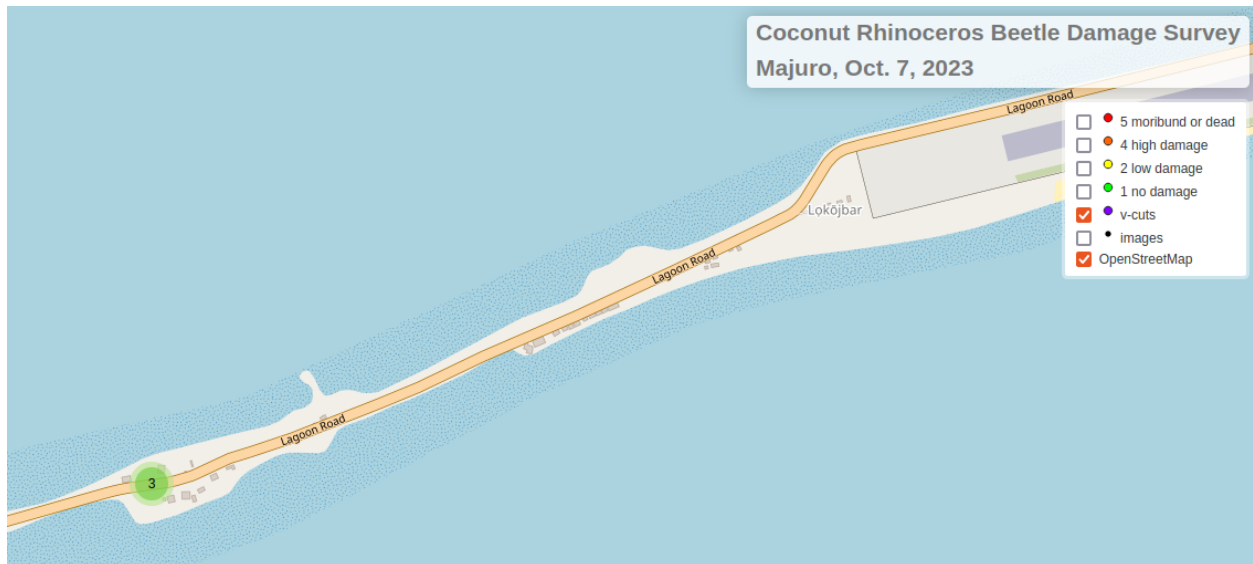
A [revised interactive web map](#) has been generated. This map shows only 3 v-shaped cuts Fig. (2, 3, 4), tightly clustered at a location just east of the airport (Fig. 1).

Figure 1: This screenshot of the web map shows the location of the cell phone where 3 images containing v-cuts were detected.

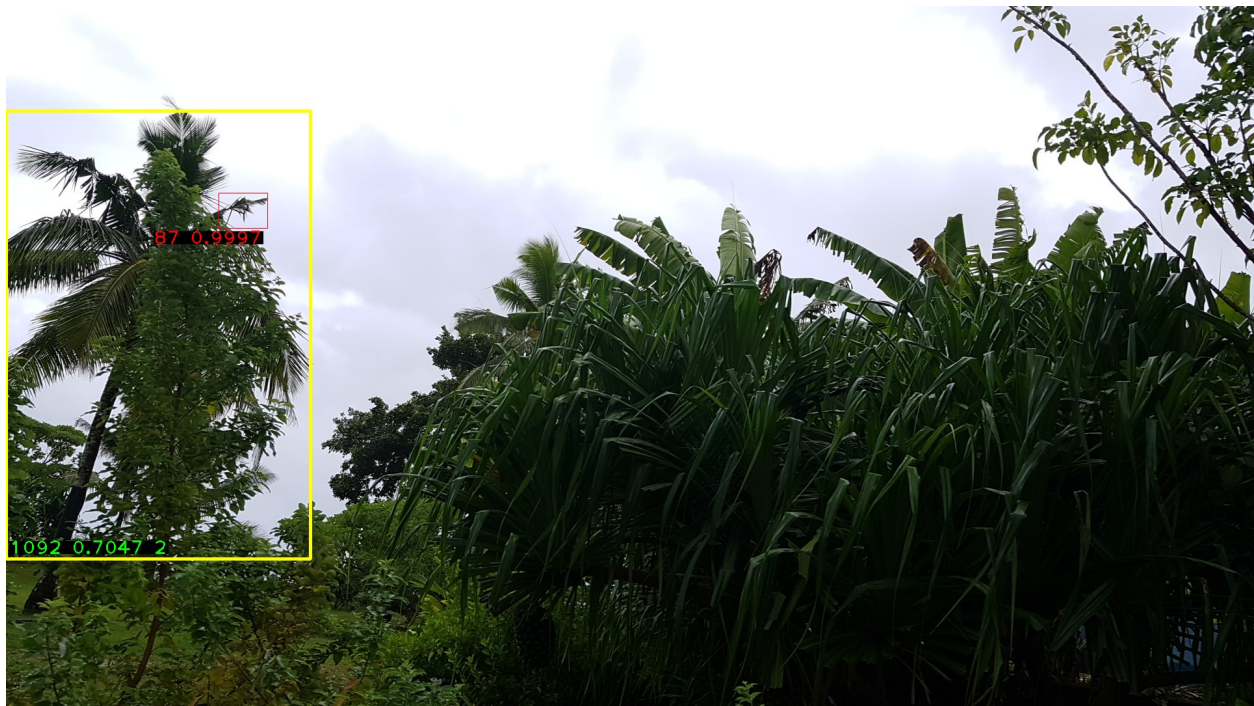
Figure 2: Although only one v-shaped cut in the coconut on the left was detected, this tree has several other damage symptoms. Note that there is a second coconut palm to the right of this tree, almost occluded by banana and pandanus, which also has probable CRB damage.

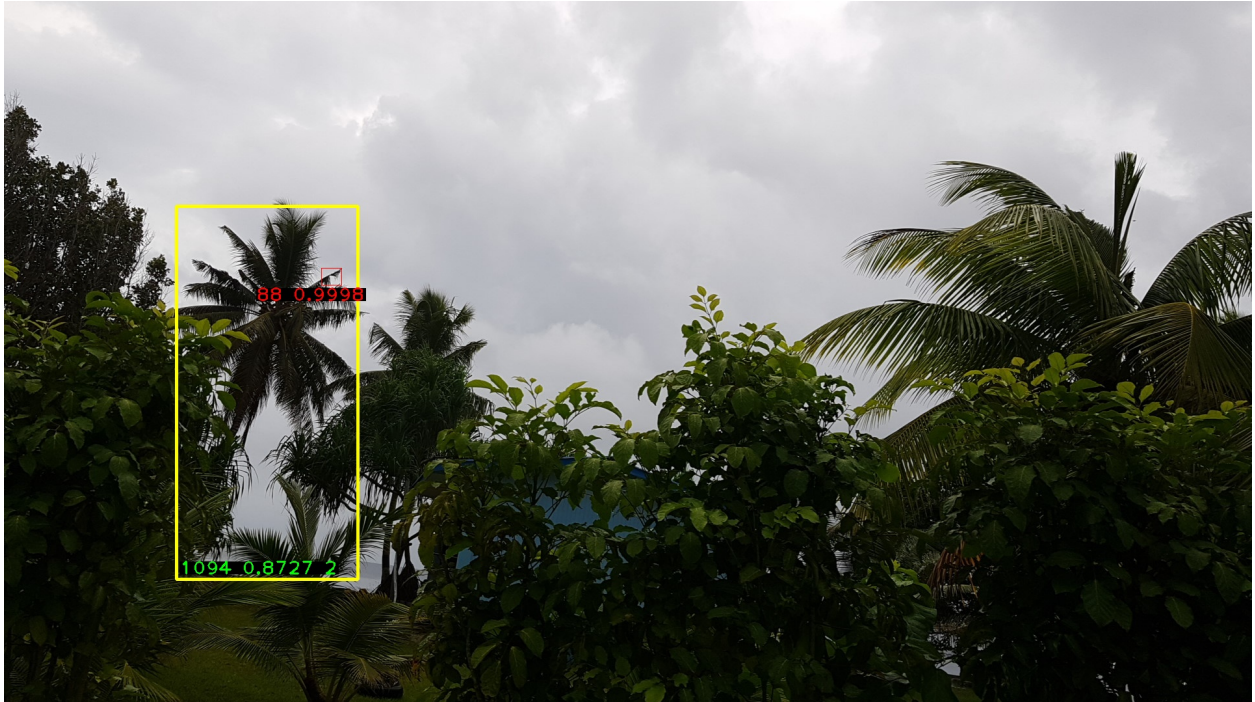
Figure 3: This image was recorded just 3 seconds after the one shown in Fig. (3). Note that the palm at the right of the image also shows CRB damage symptoms.

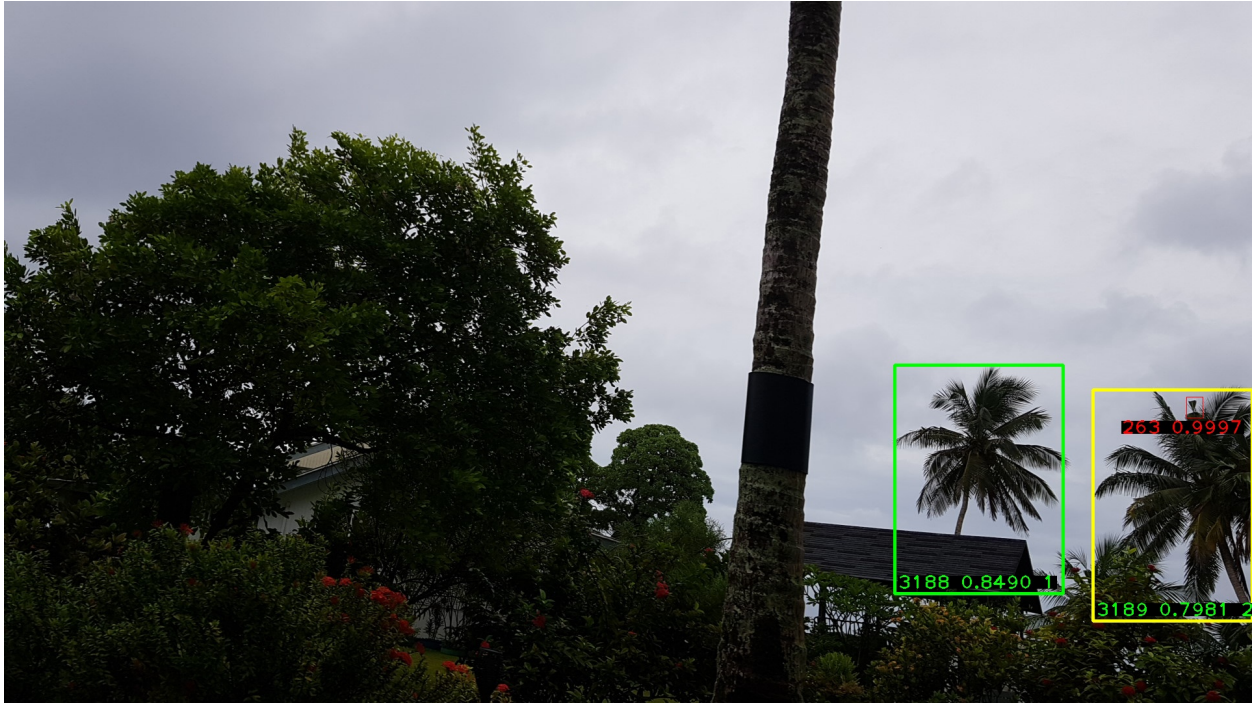
Figure 4: This image, containing a v-shaped cut, was captured 1.5 h after the previous 2, on the return trip (from west to east). The damaged tree is on the south side of the road whereas the previous detections were on the north side of the road.
